606 Pierce Street
Marietta, Georgia 30060
770-795-7432
770-795-7433 fax
www.ieiusa.com
sweiland@ieiusa.com

Disaster Recovery: After a tornado struck the Atlanta Motor Speedway, IEI had a rare opportunity to see and understand, first-hand, the outcome of this type of damage.

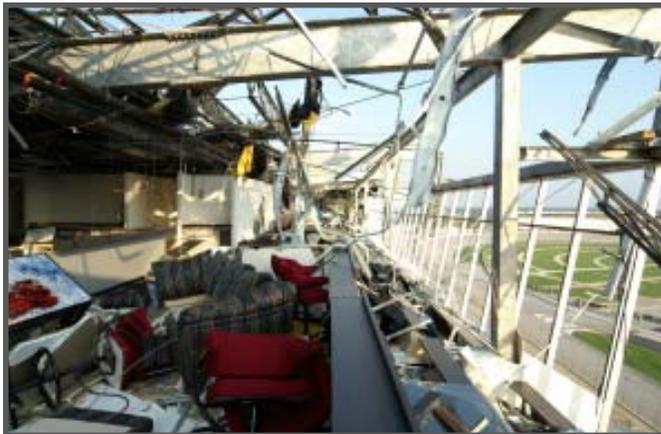
The Champions Skybox: Often a building appears more heavily damaged than it actually is from a structural standpoint.

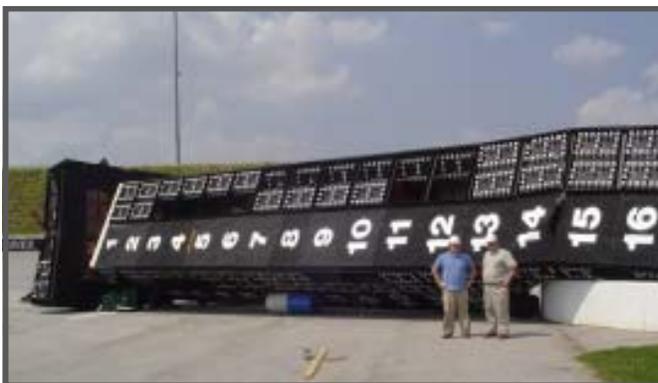
IEI President Scott L. Weiland, P.E. (right) and Stephen L. Morgan, E.I., in front of a downed scoreboard.

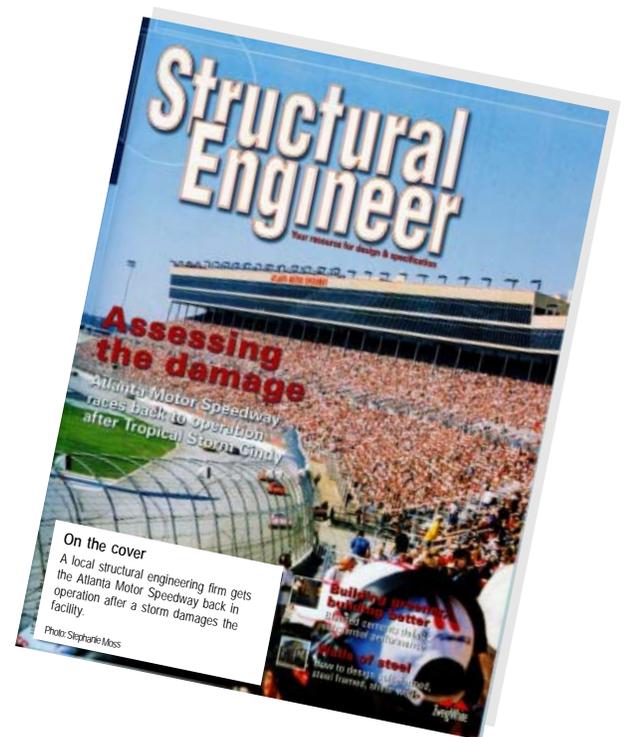
On the cover
A local structural engineering firm gets the Atlanta Motor Speedway back in operation after a storm damages the facility.

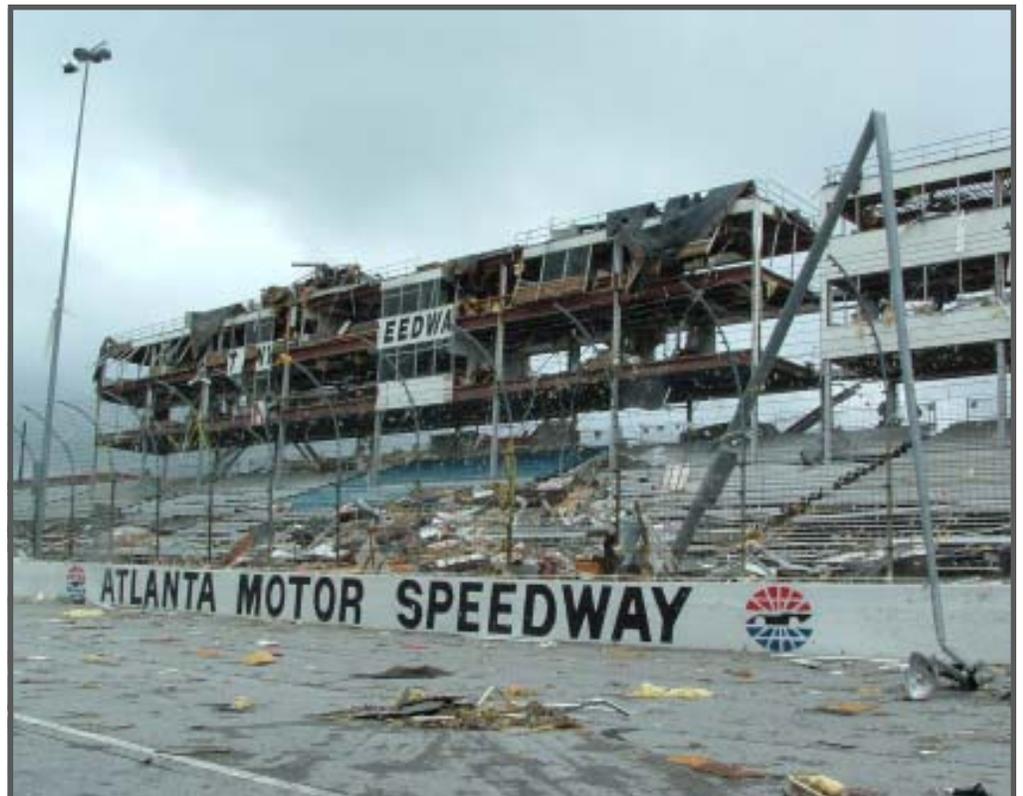
Despite the appearance of destruction, the damage to Weaver Grandstand and the skyboxes typically was non-structural.

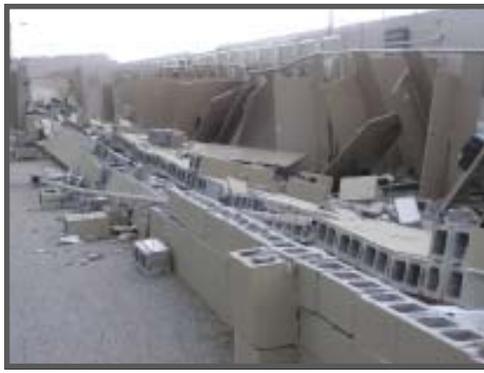
Typical damage to un-reinforced masonry.

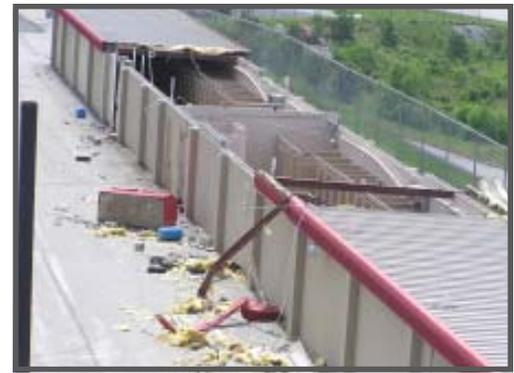
Damage to unreinforced masonry buildings resulted from connection failures caused by the tornado's uplift forces.

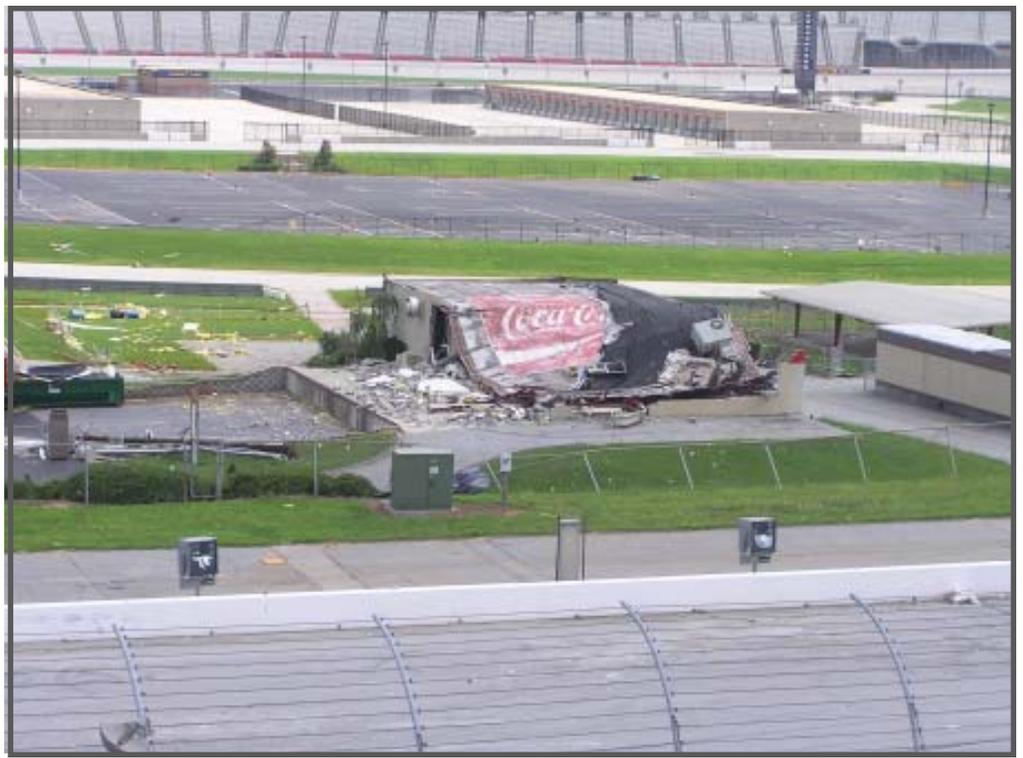
Collateral damage to several buildings, including this infield concession building, were caused by steel beams and joists that were lifted off adjacent roof structures. In this case, a projectile beam caused a load-bearing masonry wall and the roof it supported to collapse.
