# **Building Envelope Inspection**

## **Reducing Your Risk & Liability**

**SAME Southeast Tri-Regional  
Joint Engineering Training Symposium (JETS)**

**Thursday October 13, 2022**

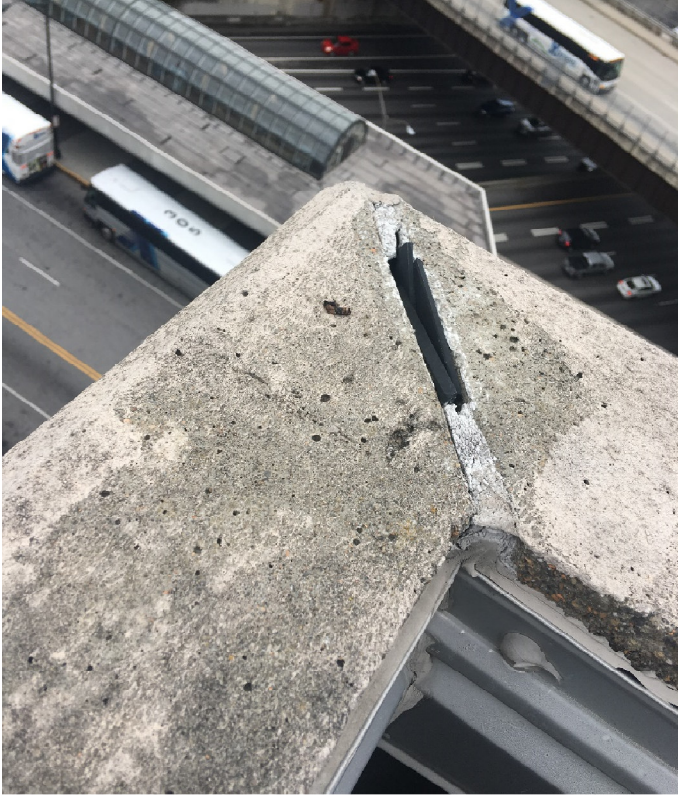
Sealants

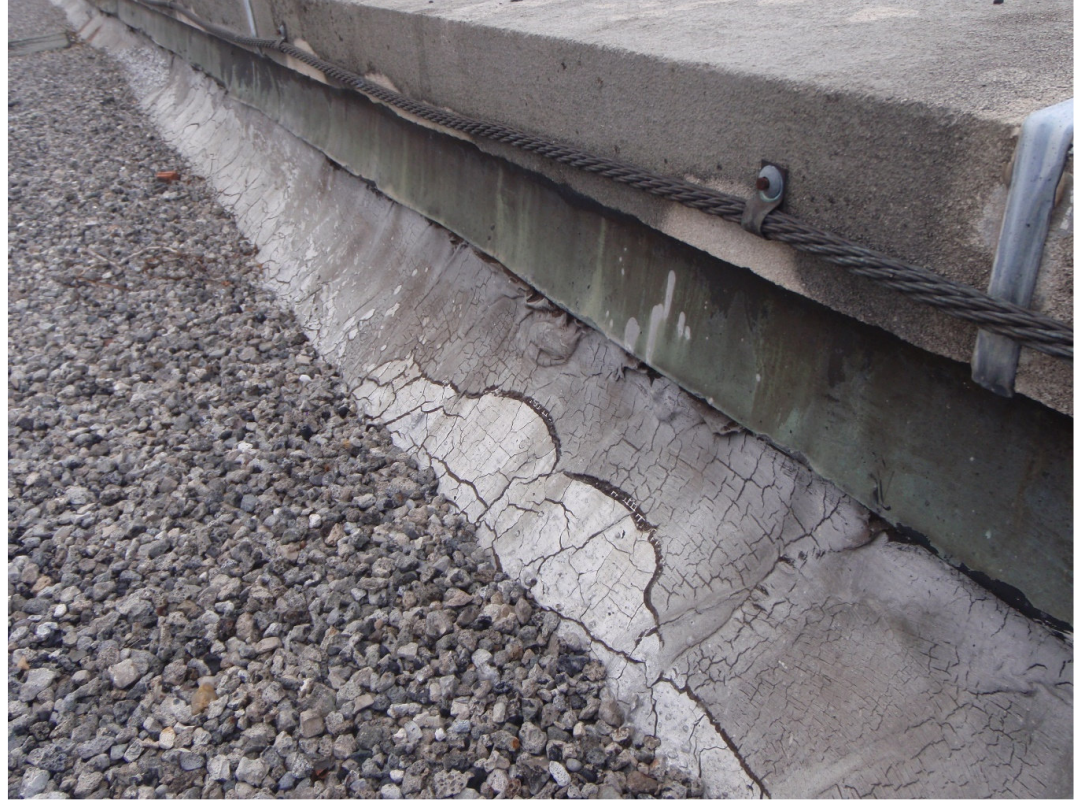
Roofing/Flashing

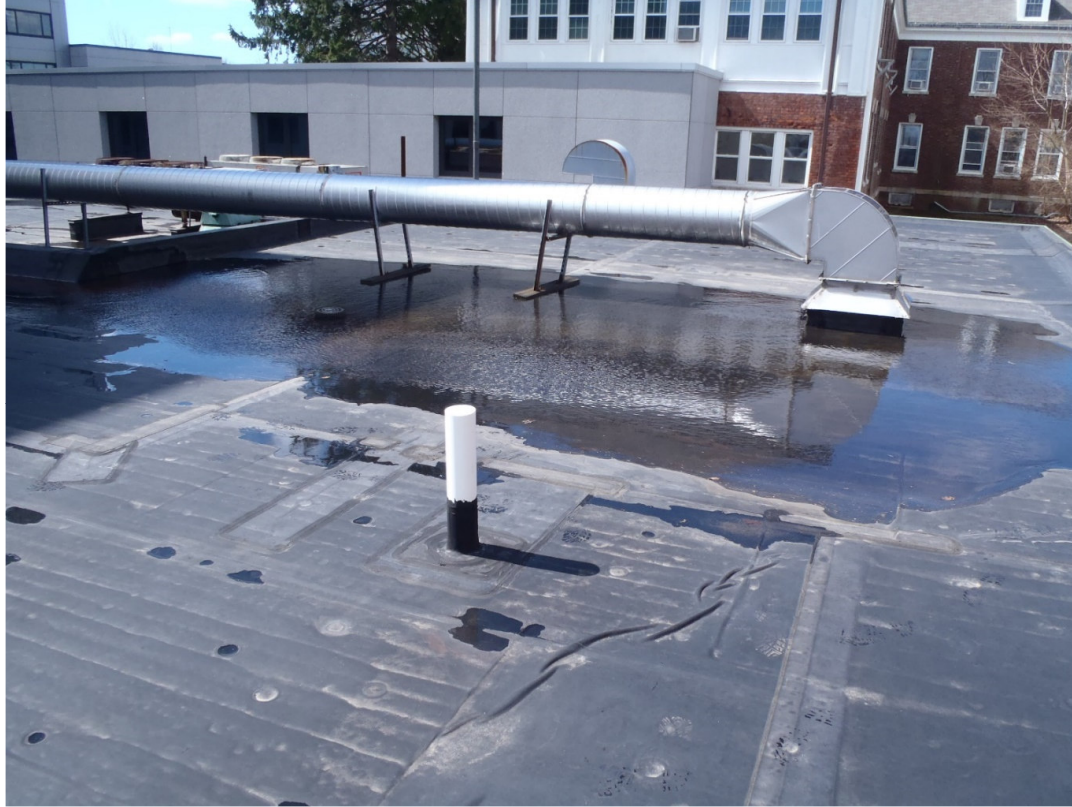
Ponding > 48 Hours

- **Ponding:** Most common factor in roofing failure
- **Water Shedding:** Can make up for shortcomings in design, construction, durability, & maintenance.
- **Degradation:** Asphalt & Polymeric materials
- **Freezing:** Erodes surface aggregate
- **Voids:** Manufacturers warranty

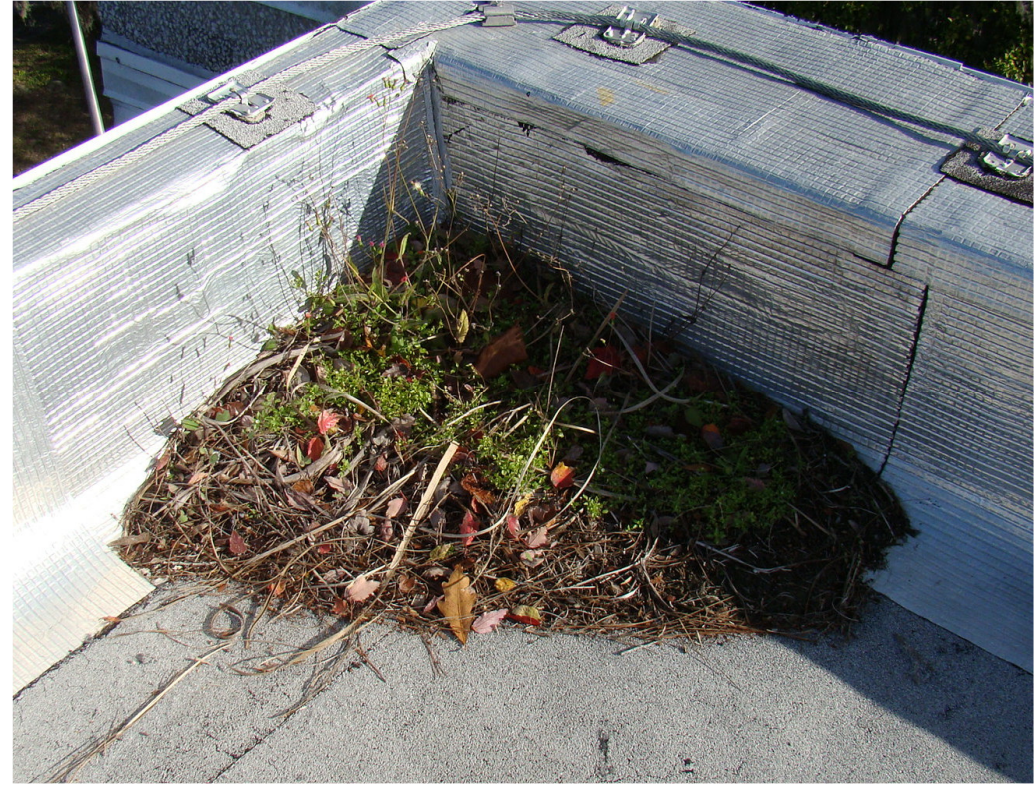
- Improper roof slope
- Improper drains, overflow drains, & overflow scuppers
- Clogged drains & scuppers
- Poor Housekeeping
- Roof collapse
- Promotes organic growth

Organic Growth

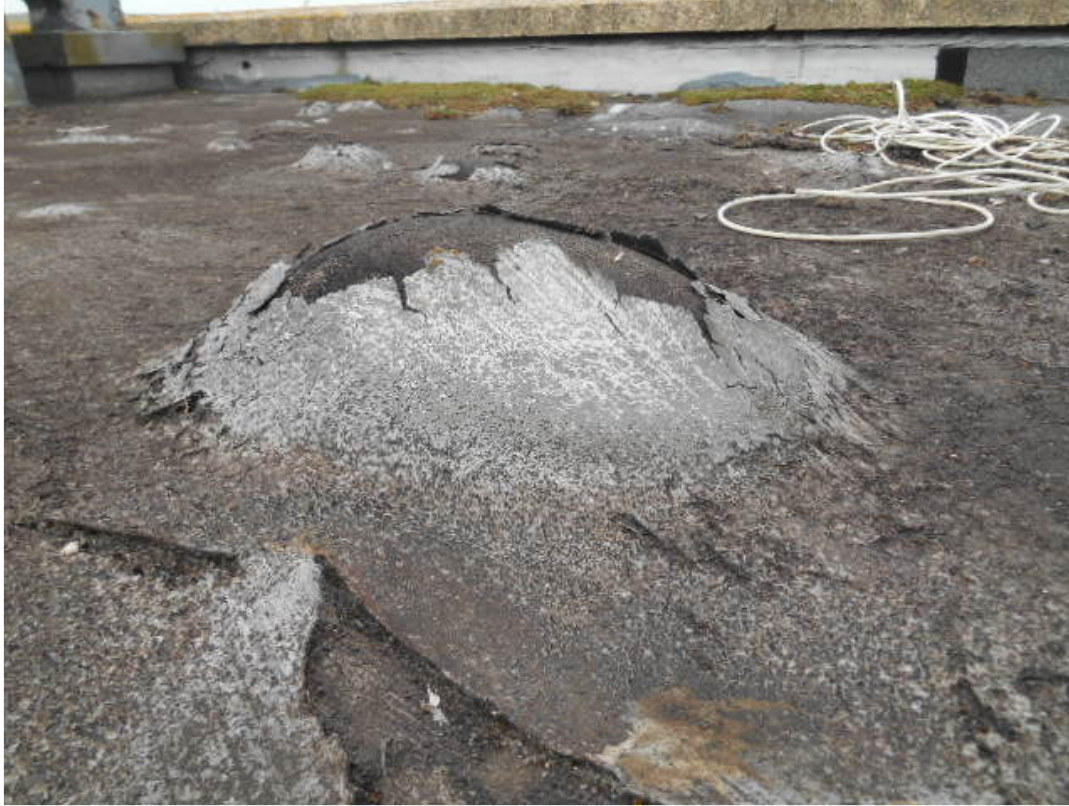
Blistering

- Blistering
- Splits
- Ridging/  
Wrinkling
- Slippage

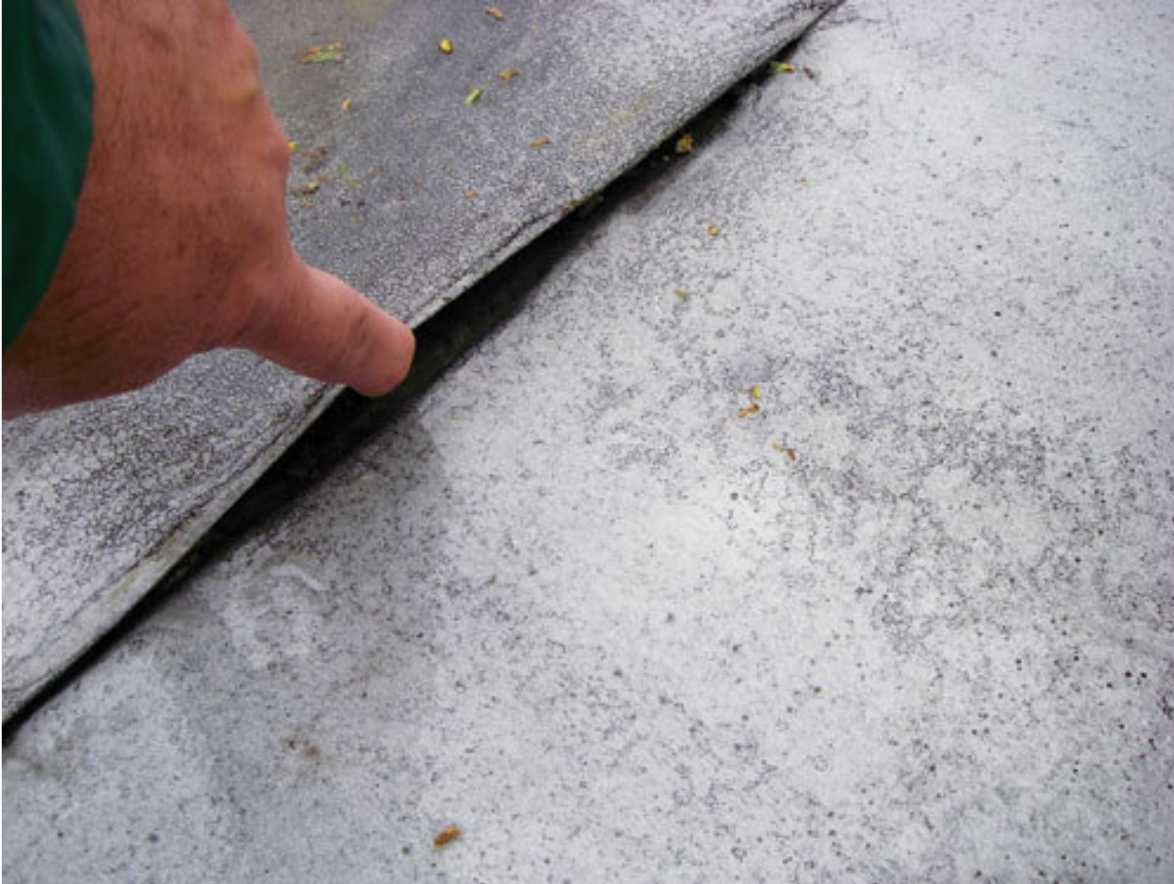
- **Defective Lap Seams**
- Shrinkage
- Checking
- Blistering
- Delamination
- Slippage
- Splitting

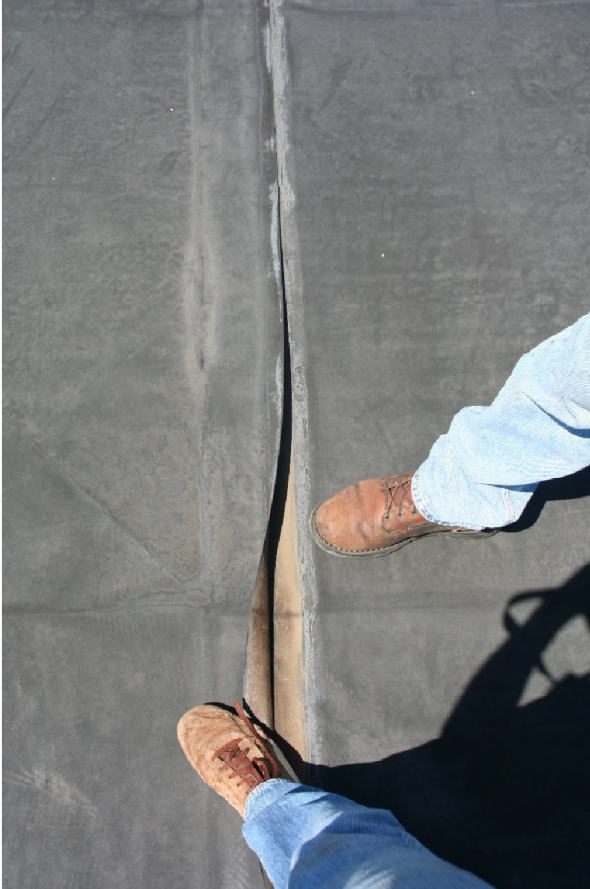
- **Lap-Seam Failure**
- Flashing
- Other Common Problems – 8%
  - Puncture
  - Shrinkage
  - Wind Uplift
- Minor Problems @<3%
  - Fastening
  - Blistering
  - Embrittlement

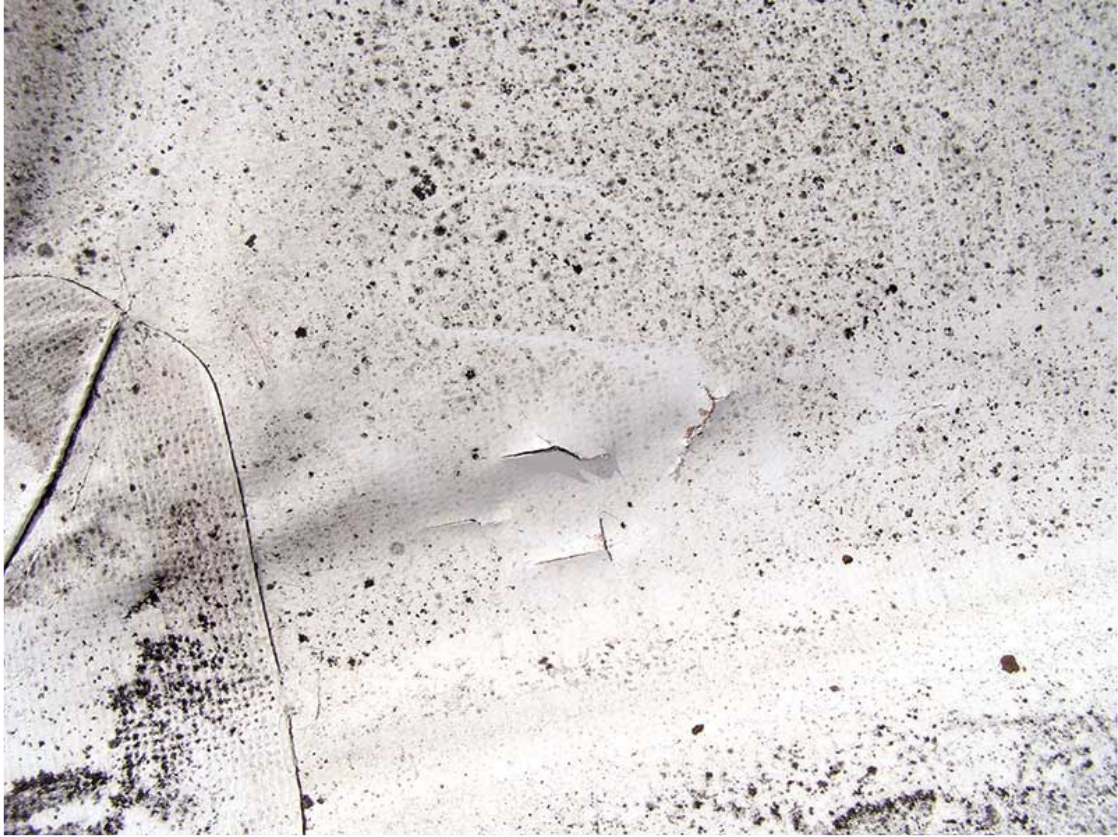
- **Embrittlement**
- **Puncture**

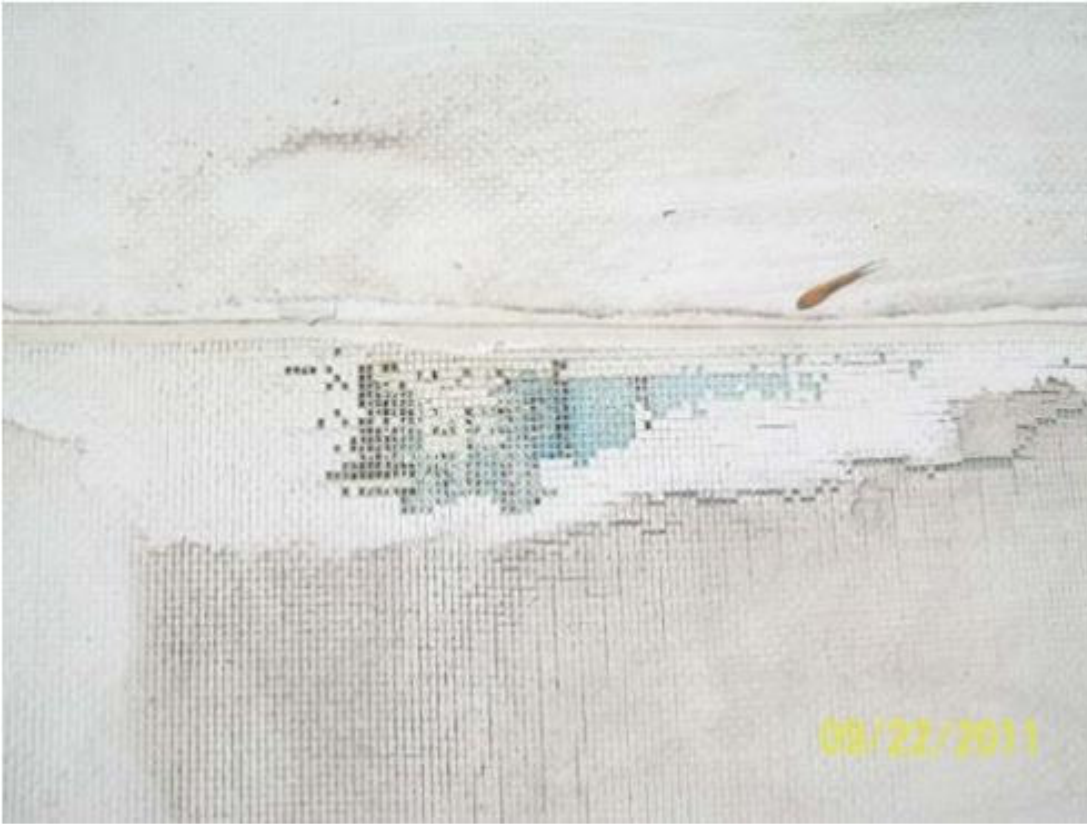
- **Premature Aging**
  - Erosion of Top Surface
  - Small Holes/Slits
  - Cracking
  - Separation
- **Seam Failures**
- **Newest Roofing Material**

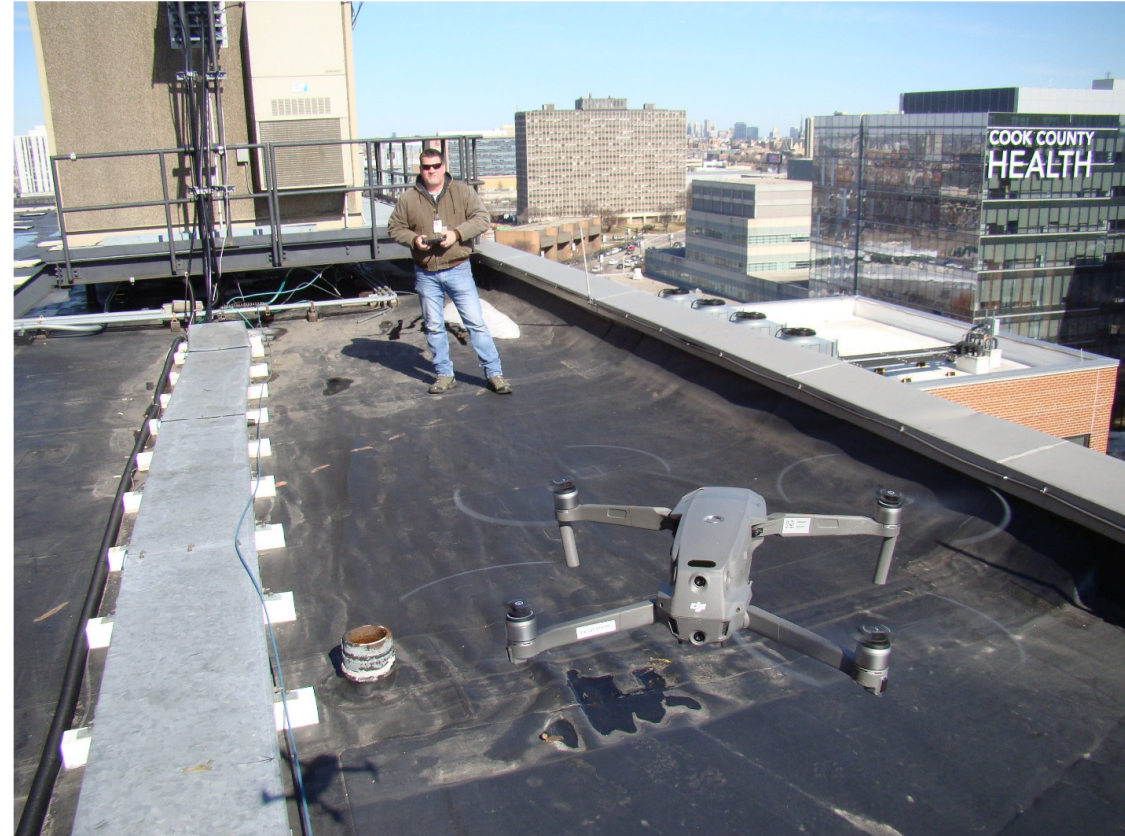
- **Infrared Camera (IR)**
- **Best After Dusk**
  - Insulation and Moisture Heats Up During the Day
  - Dry Insulation cools off faster than Wet Insulation
- **Daylight Waiver Required**
- **Height to See Major Portions of Roof**
- **Safer and More Accurate than Handheld**

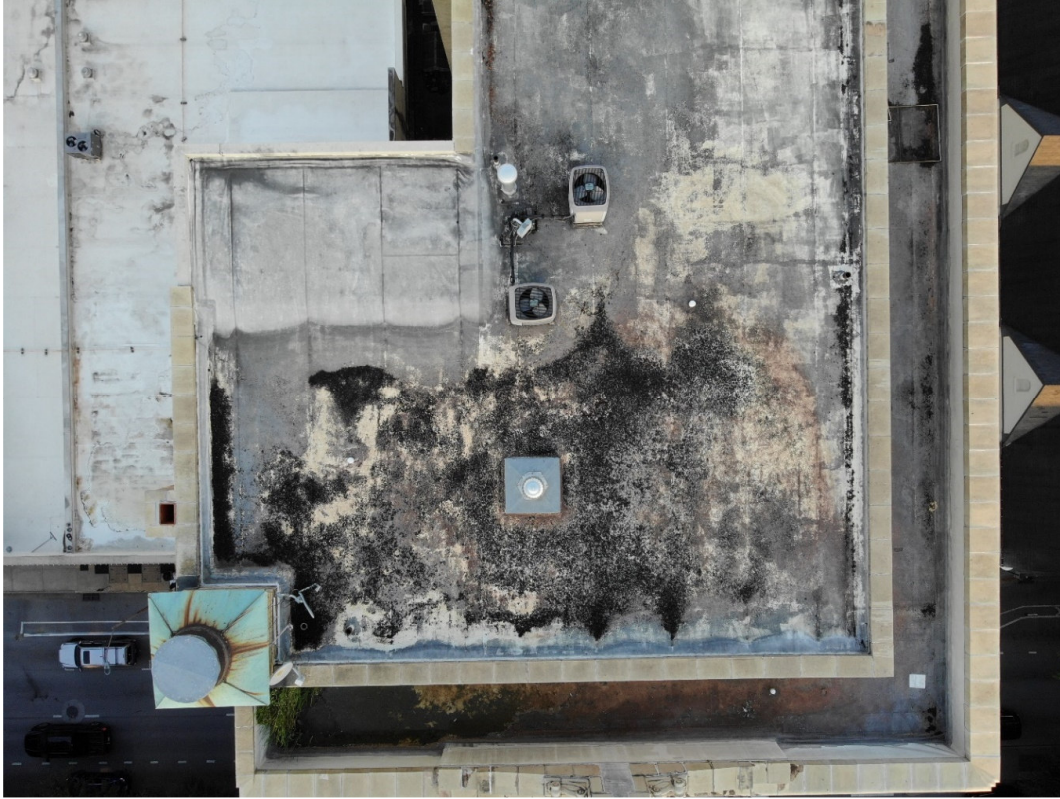
Visual Red-Green-Blue (RGB)

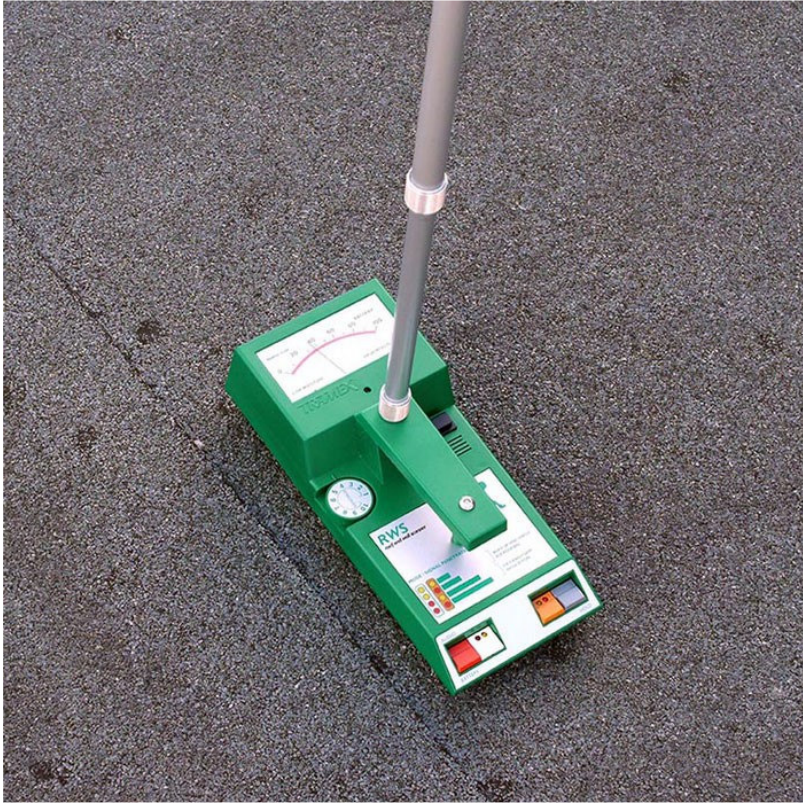
Impedance Meter

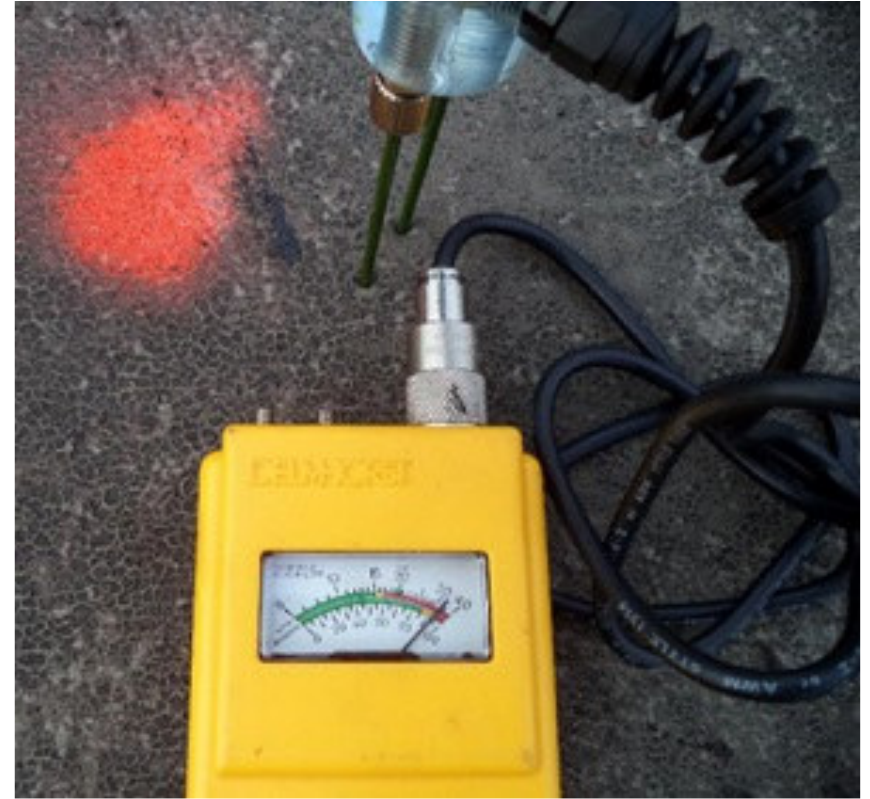
Pin-Type Meter

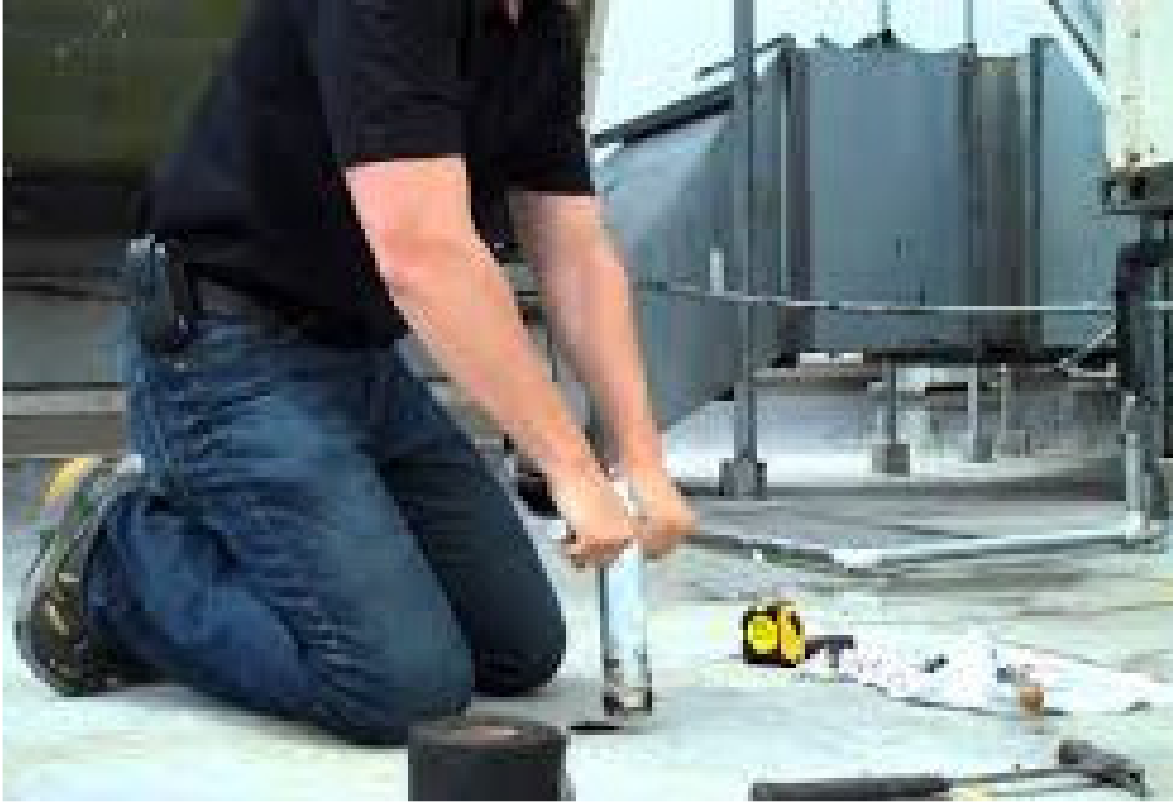
Roofing Core

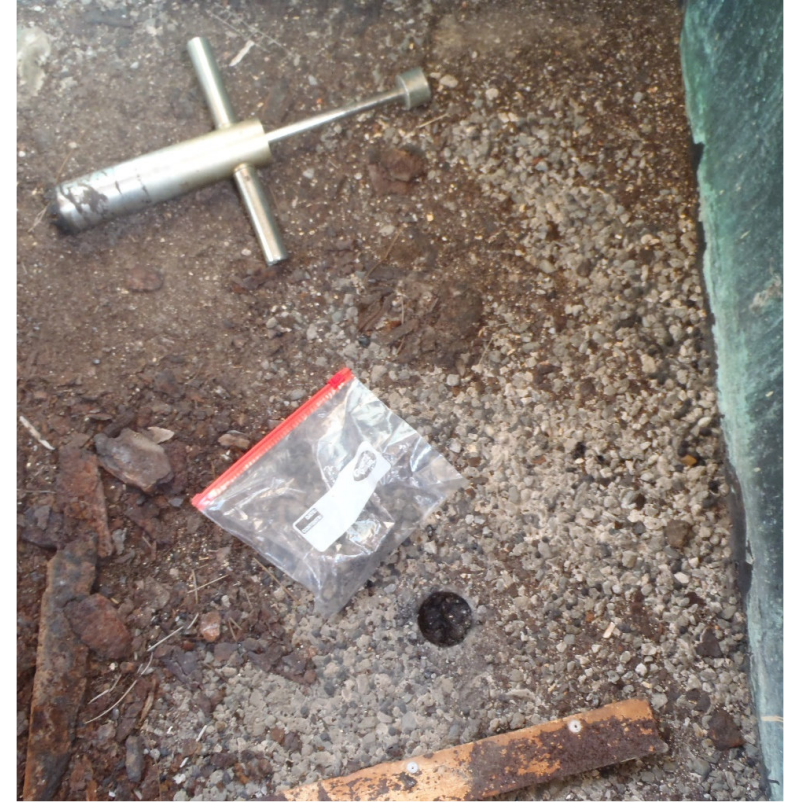
Sample

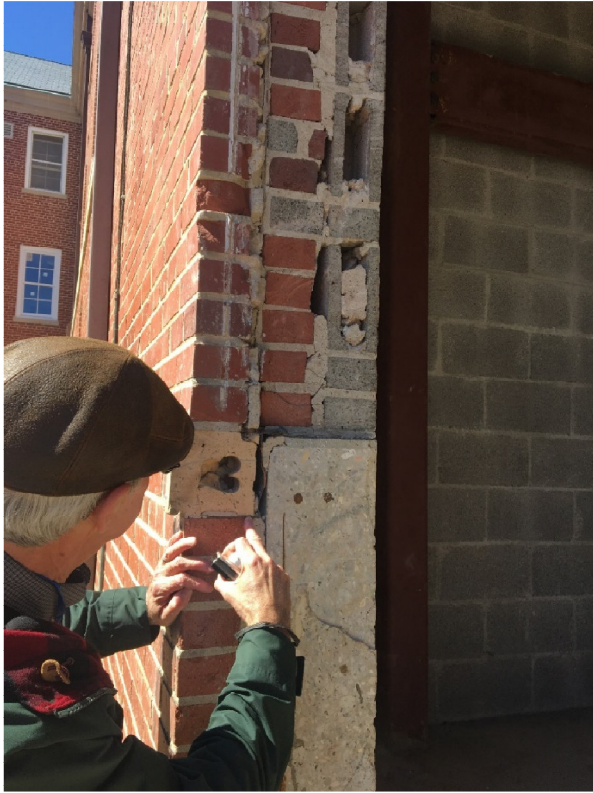
Mass Wall

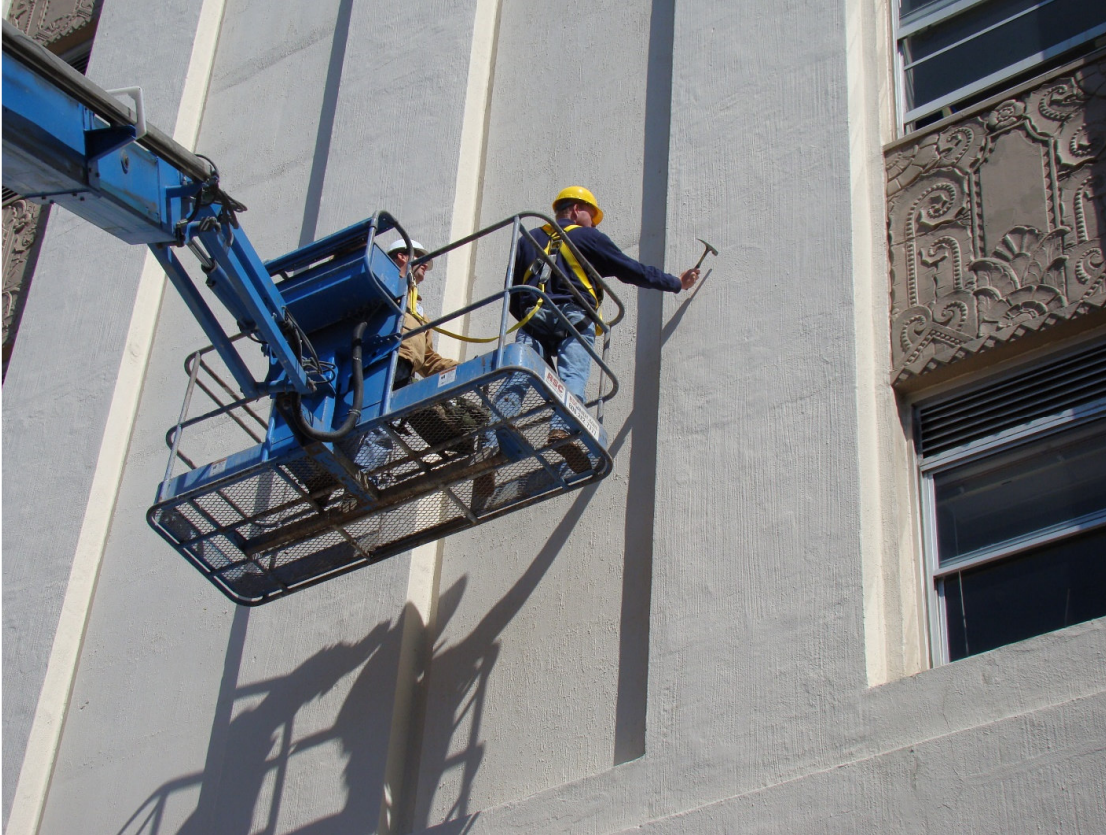
Boom Lift

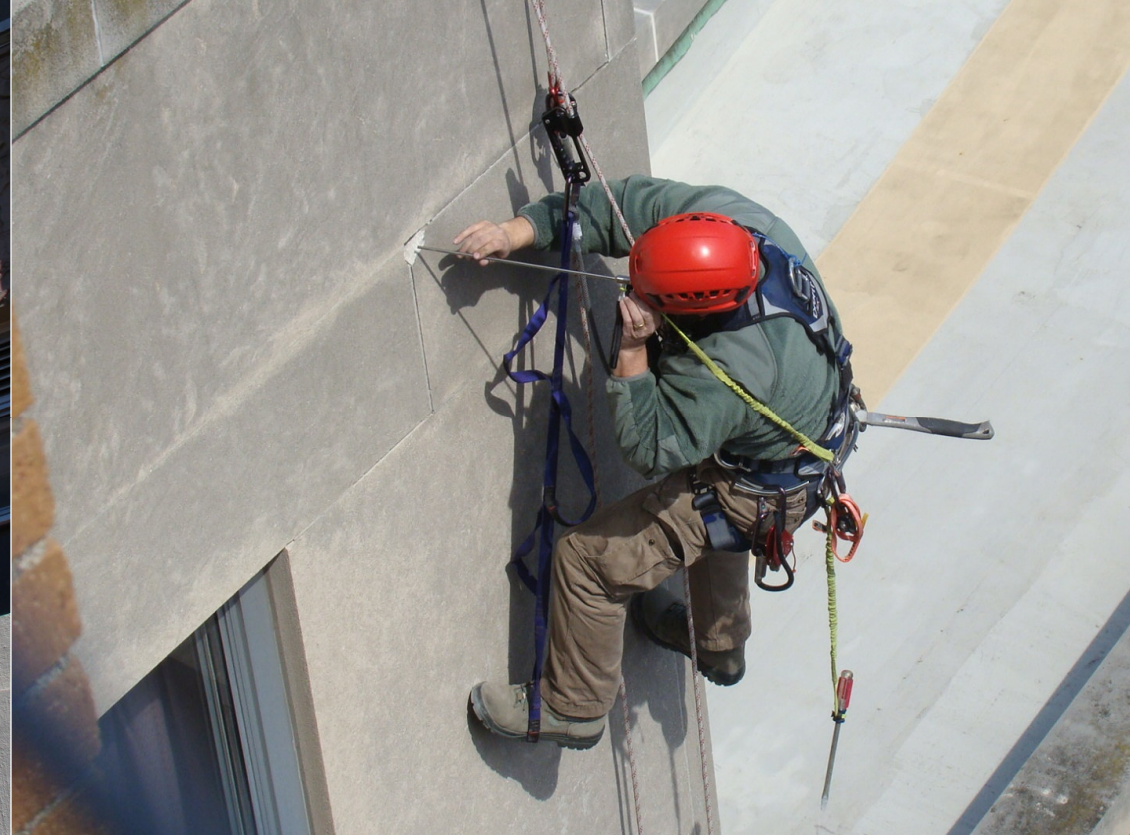
Rope Access

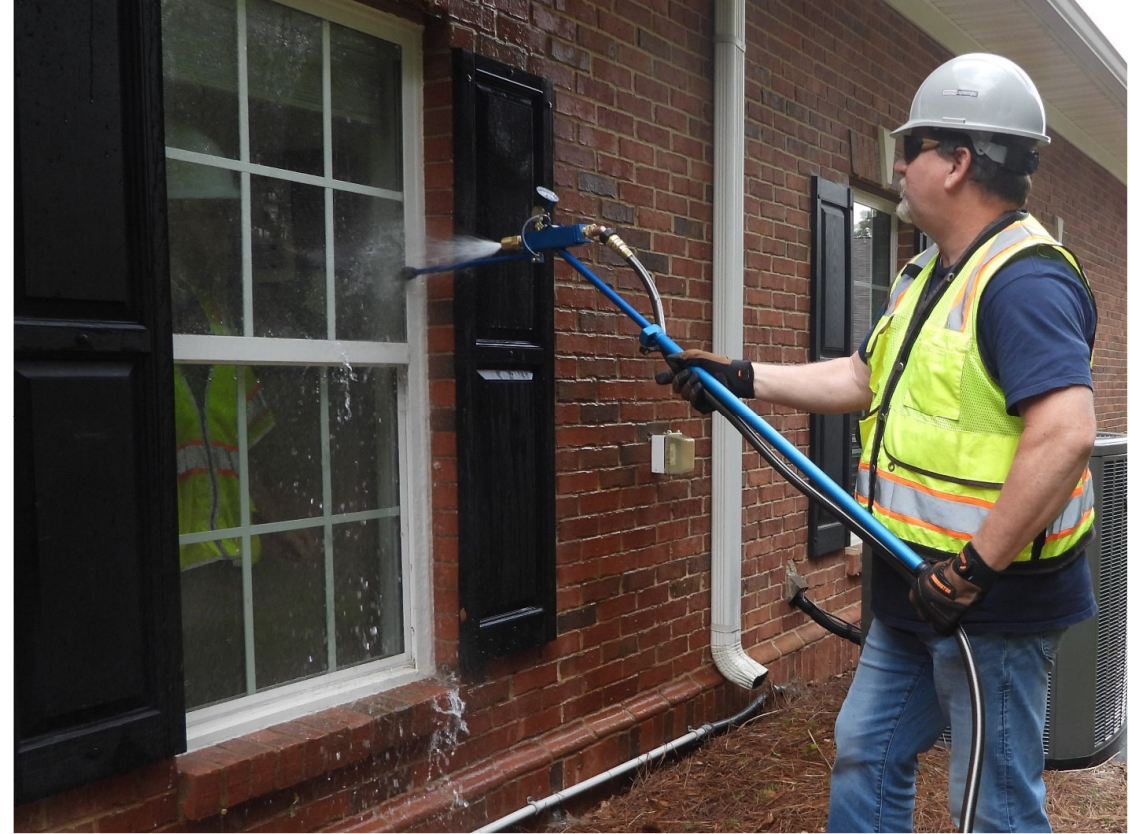
- Duplicate a Leak
- Work from Bottom to Top
- Observer on Inside
- AAMA 501.2 Spray Wand

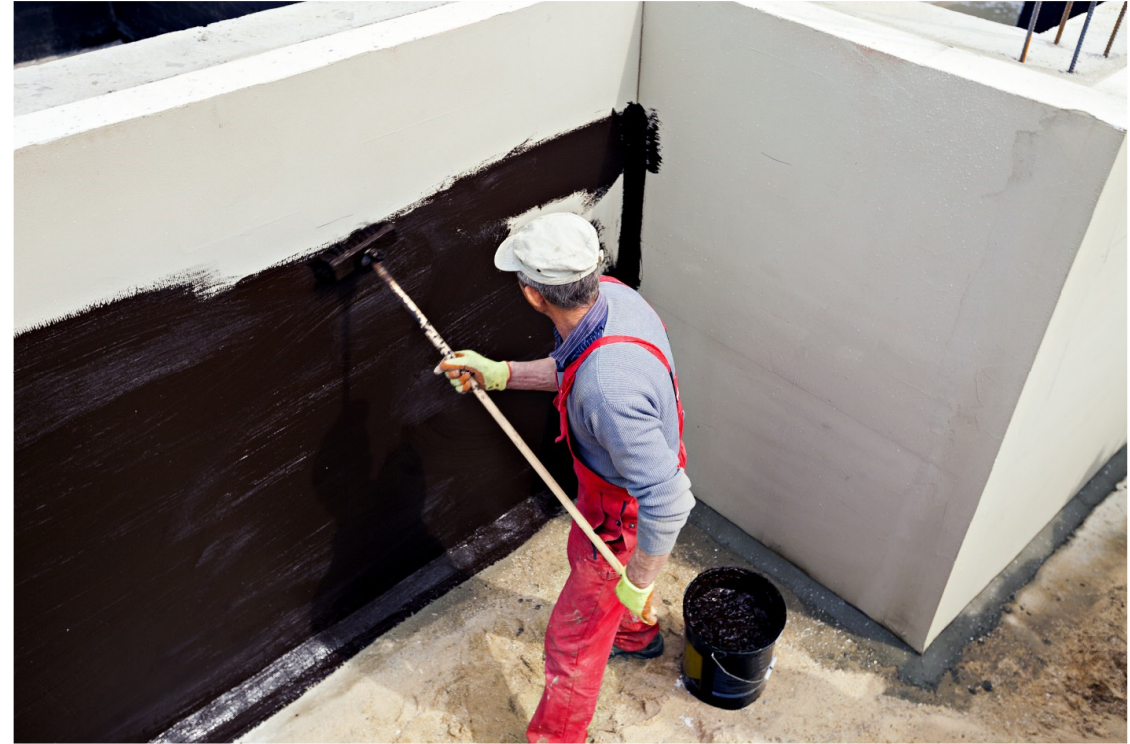
- **External Membranes**
  - Fluid-Applied
  - Sheet Applied
- **System Requirements**
  - Embedded Waterstop at Joints
  - Wrap Entire Foundation
  - Protection Board
  - Drainage System
