BUILDING FACADE INSPECTION

BY SCOTT L. WEILAND, PE

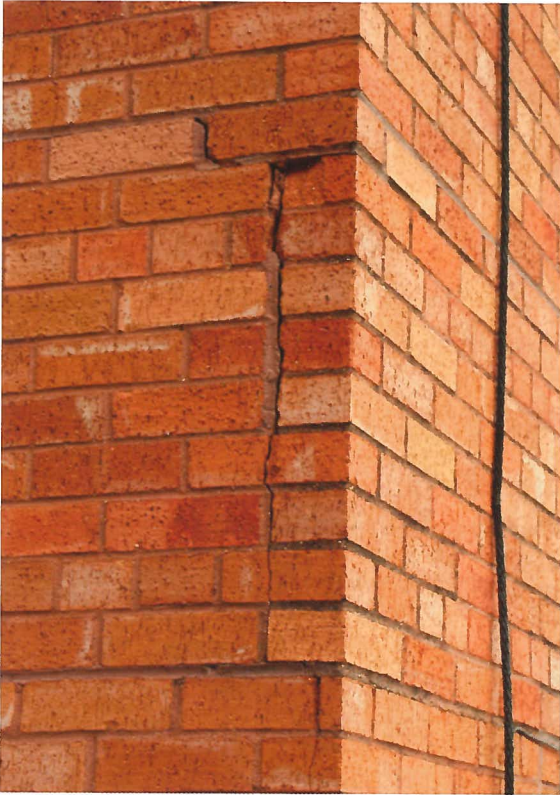
Cracked corner brick resulting from lack of expansion joints in brick veneer

While façades can degrade locally through environmental exposure to chemicals and moisture pressure and freezing, most deterioration can be traced to differential movements within the façade and supporting structure. Using multiple materials in combination often leads to such movement. If not accommodated by frequent horizontal and vertical expansion joints and flexible interconnections parallel to the plane of the façade, internal stresses can develop, resulting in façade cracks, spalls, and deformation. The following movements are known to occur.

Thermal – All materials expand and contract with changes in temperature. Fired clay, such as brick and terra cotta, and some stone products, such as granite and limestone, have thermal expansion coefficients similar to that of concrete masonry units (CMU). Marble and steel have coefficients higher than that of CMU. Aluminum, often used in window and curtain wall framing, has a thermal expansion coefficient approximately three times that of CMU. Exterior cavity walls have the insulating value of an air space and thus will experience a larger temperature differential between the interior wythe, which is exposed to conditioned air, and the exterior wythe, which is exposed to the atmosphere, than a solid un-insulated wall. This can be greatest on a dark-colored, south-facing wall, where surface temperatures can be as much as 40°F above ambient. An insulated 4-inch veneer will have an average temperature roughly equal to the exterior surface temperature. A solid, uninsulated wall will have a lower mean temperature than the exterior surface due to the competing interior and exterior temperatures.
