The Truth About Parking Structure Maintenance: How to Protect Your Investment

**CPMA Annual Conference & Tradeshow
Harrah's Cherokee Casino
Wednesday October 6, 2021**

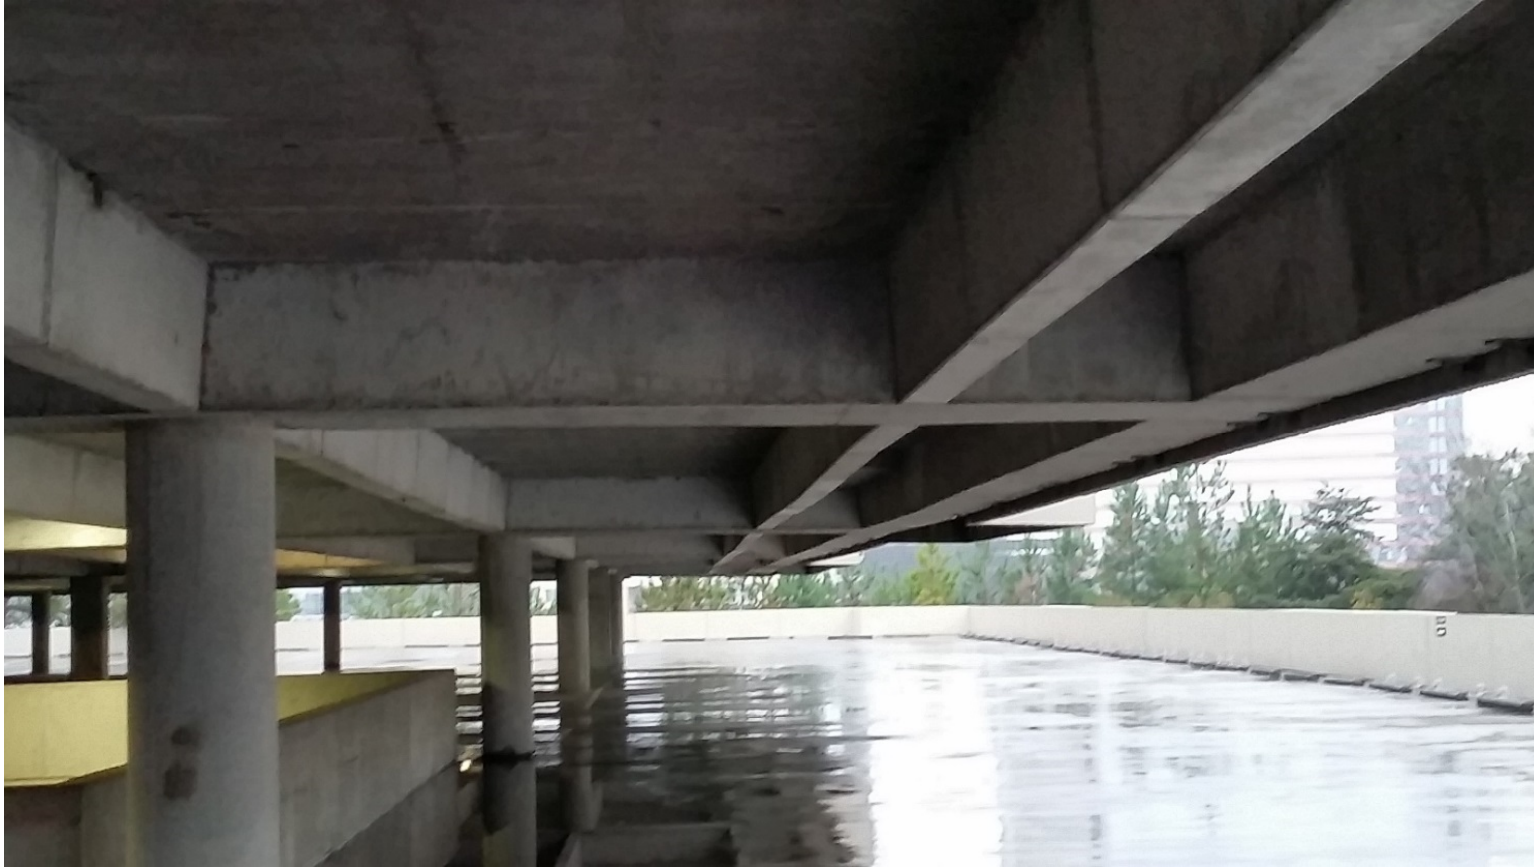
Cast-in-Place

- **Advantages**
 - Flexible Geometry
 - Monolithic, Fewer Joints
 - Reduced Maintenance Costs
 - Longer Life Expectancy
 - Higher Durability
- **Disadvantages**
 - Higher Initial Investment
 - Longer Schedule
 - More Labor Intensive
 - Difficult Quality Control
 - Weather Dependent

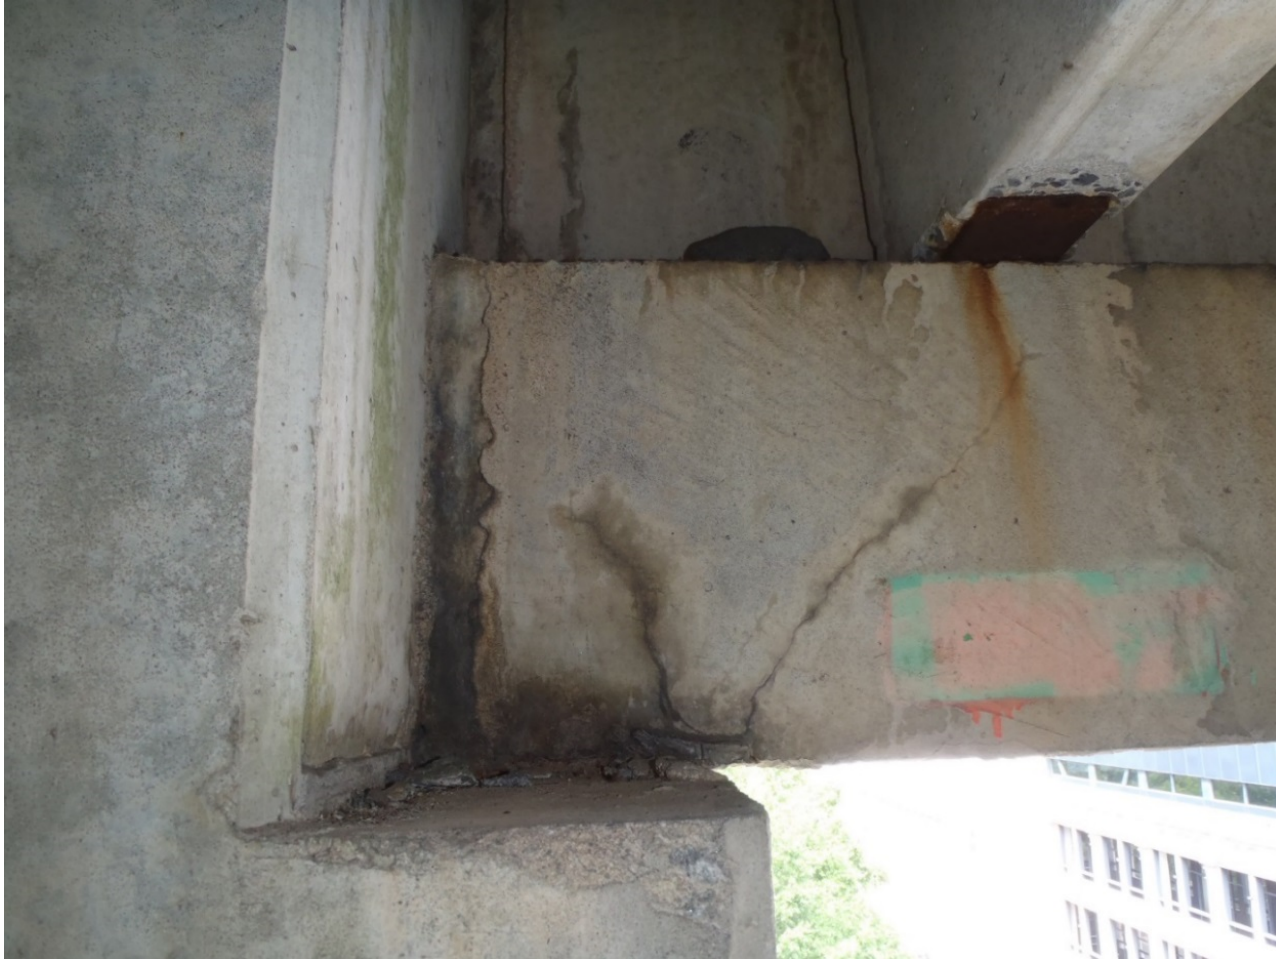
Precast Concrete - Disadvantages

- **Disadvantages**
 - May be no local plant
 - Geometry not Flexible
 - Lower Perceived Ceiling heights
 - Shearwalls (Closed In)
 - More Joints
 - Prone to Thermal Expansion & Contraction Damage
 - Corrosion of Steel Embedments
 - Higher Maintenance Costs

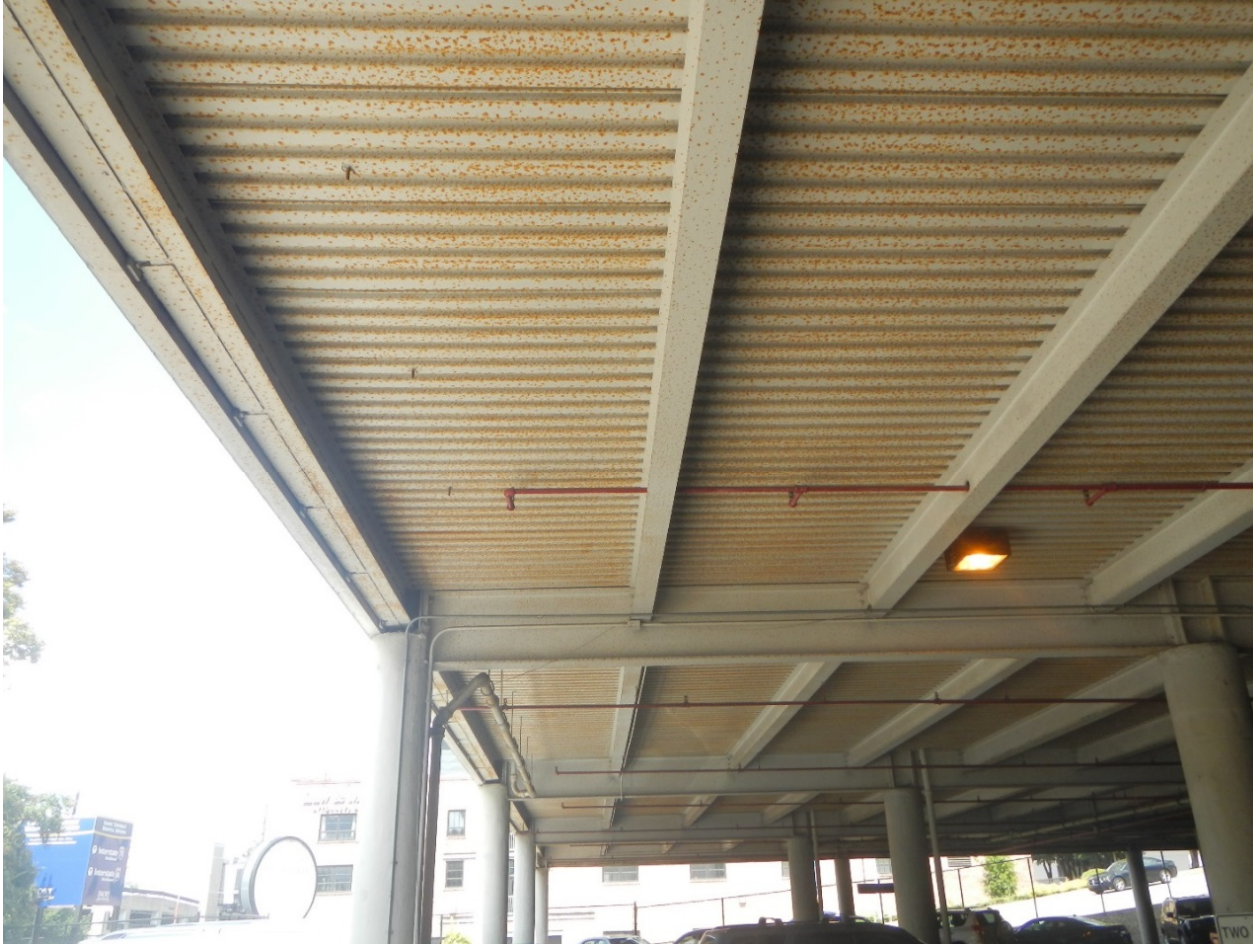
Structural Steel

- **Advantages**
 - Lower Initial Cost than Precast
 - Accelerated Construction Schedule
 - Fabricated in Controlled Environment
 - No Shearwalls (Open)
- **Disadvantages**
 - Corrosion Issues
 - Higher Maintenance Costs
 - Not Suitable for Fire Protection

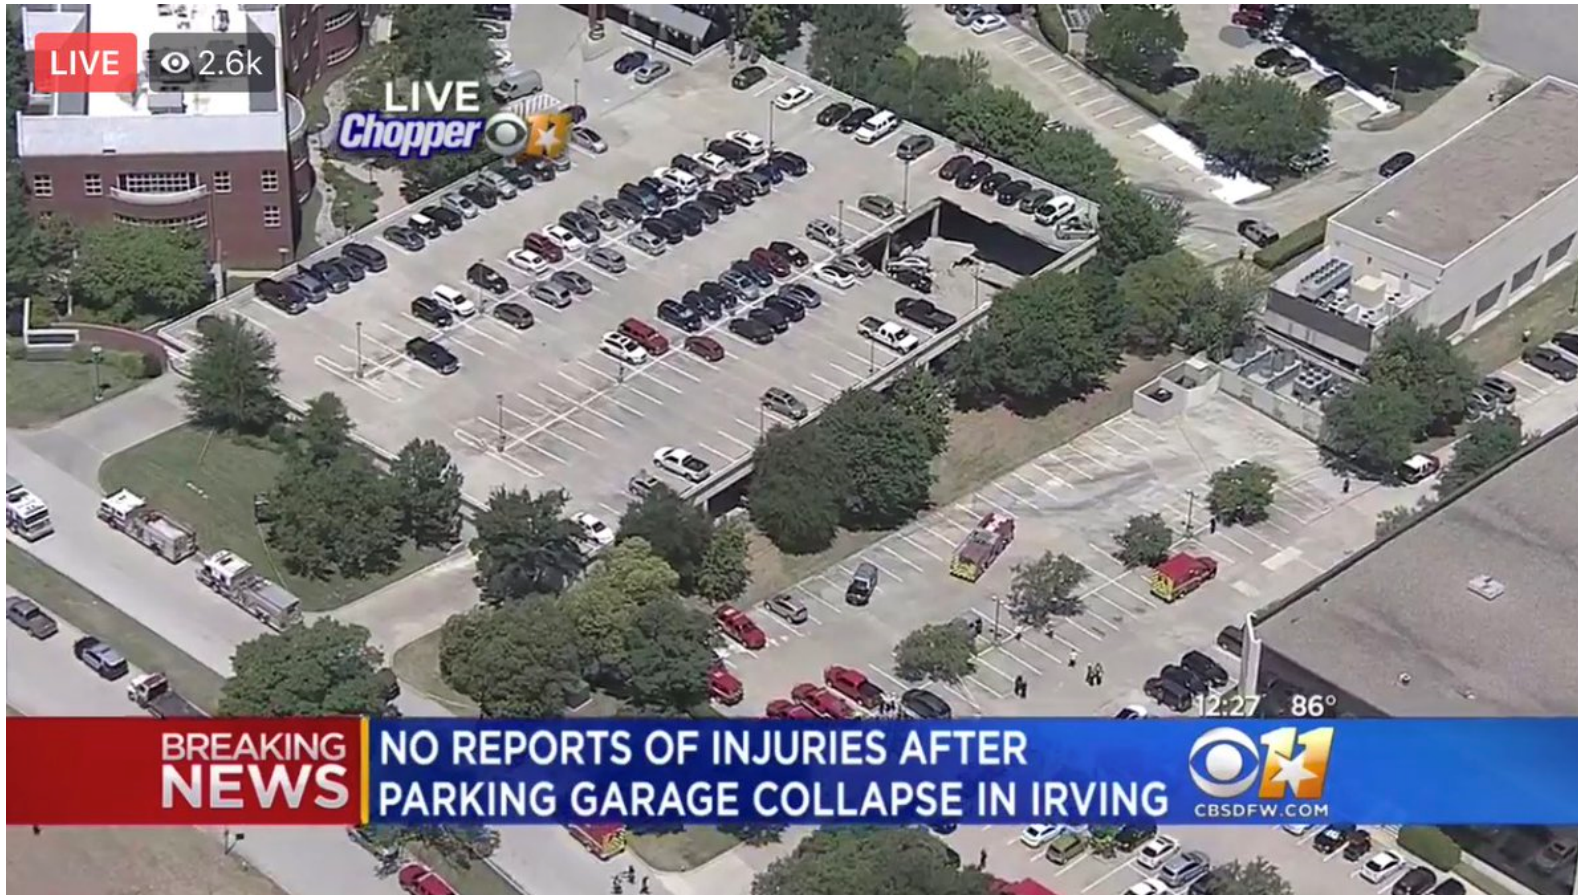
Irving Texas, O'Conner Ridge Blvd. Collapse

- Old Parking Structure
- Expansive Soils in TX
- Exterior Columns Leaning
- Cracks Sealed with Sealant
- No OSHA Report
- Demolished

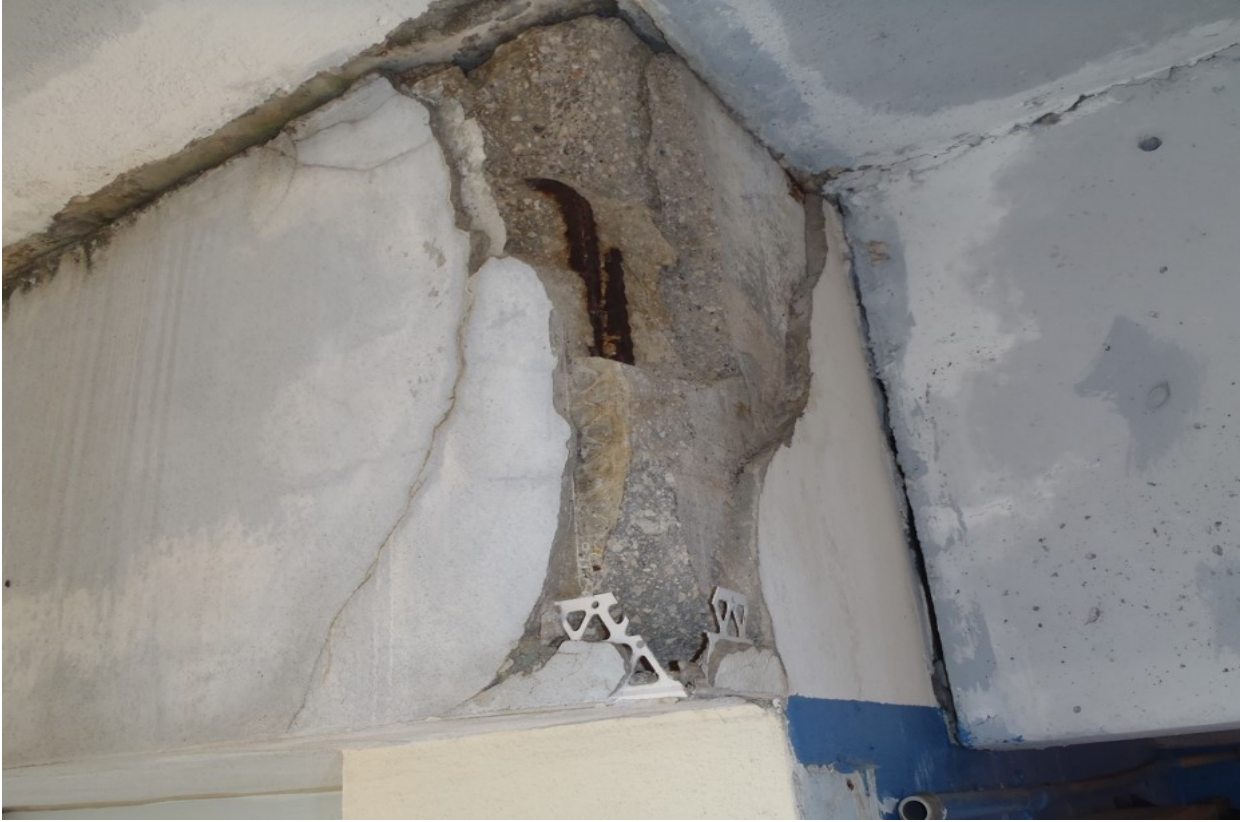
Rust Expansion & Spalling

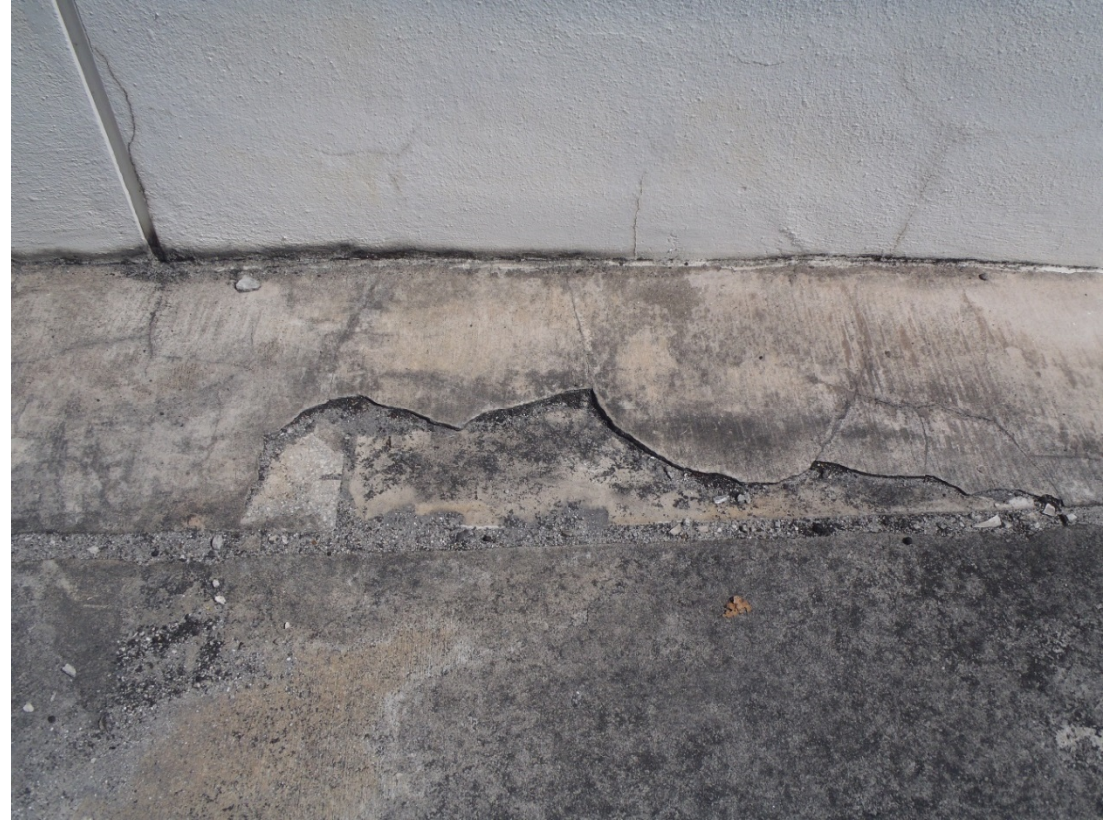
Topping Delamination

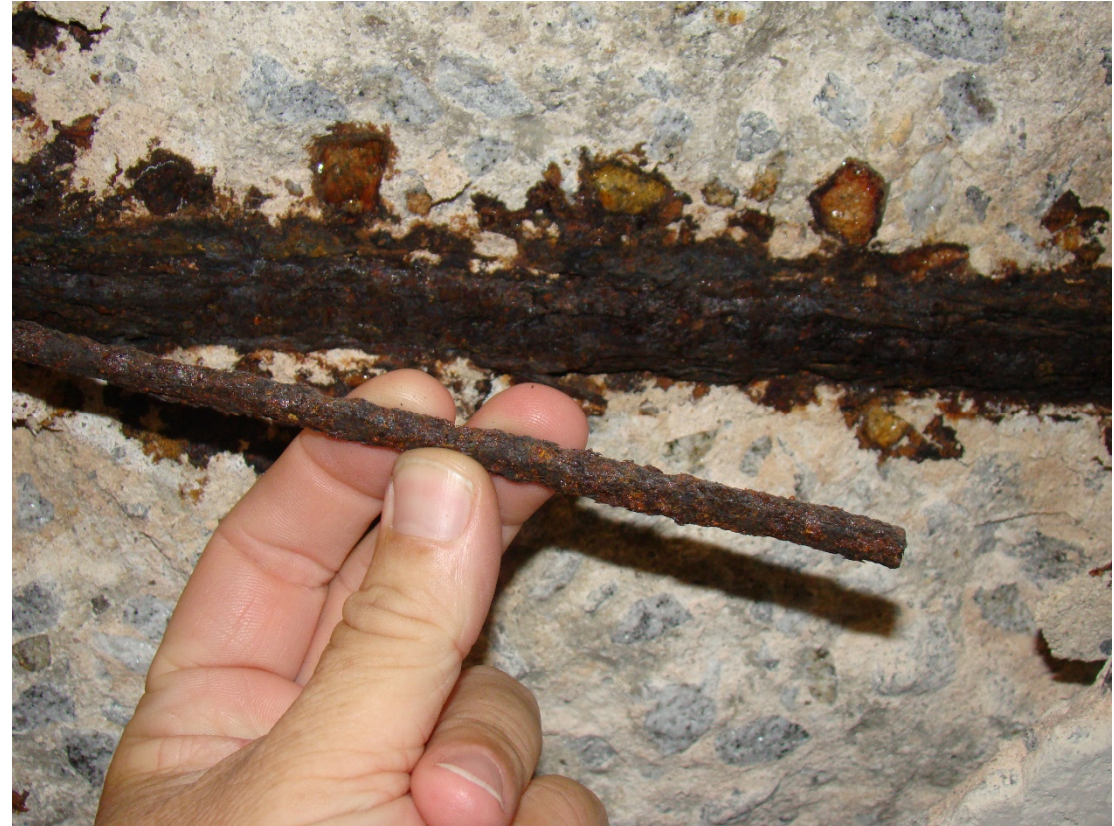
Section Loss

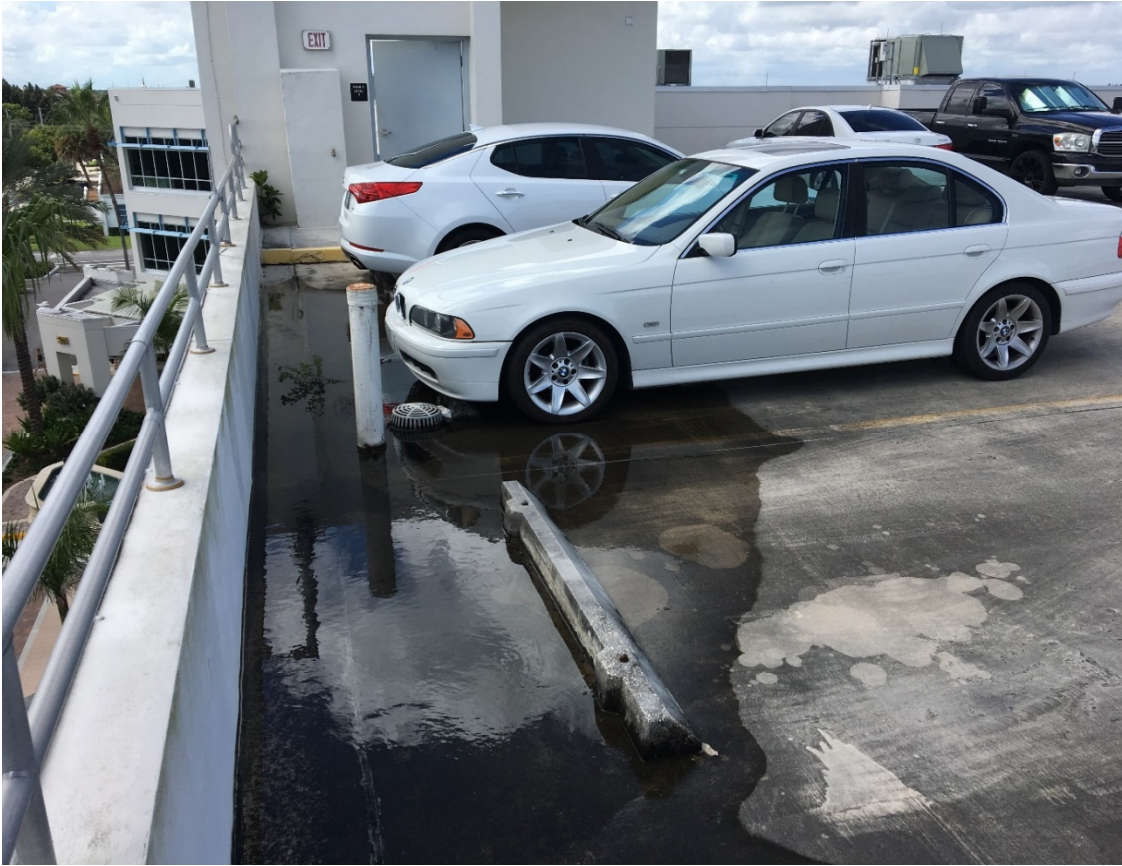
Ponding

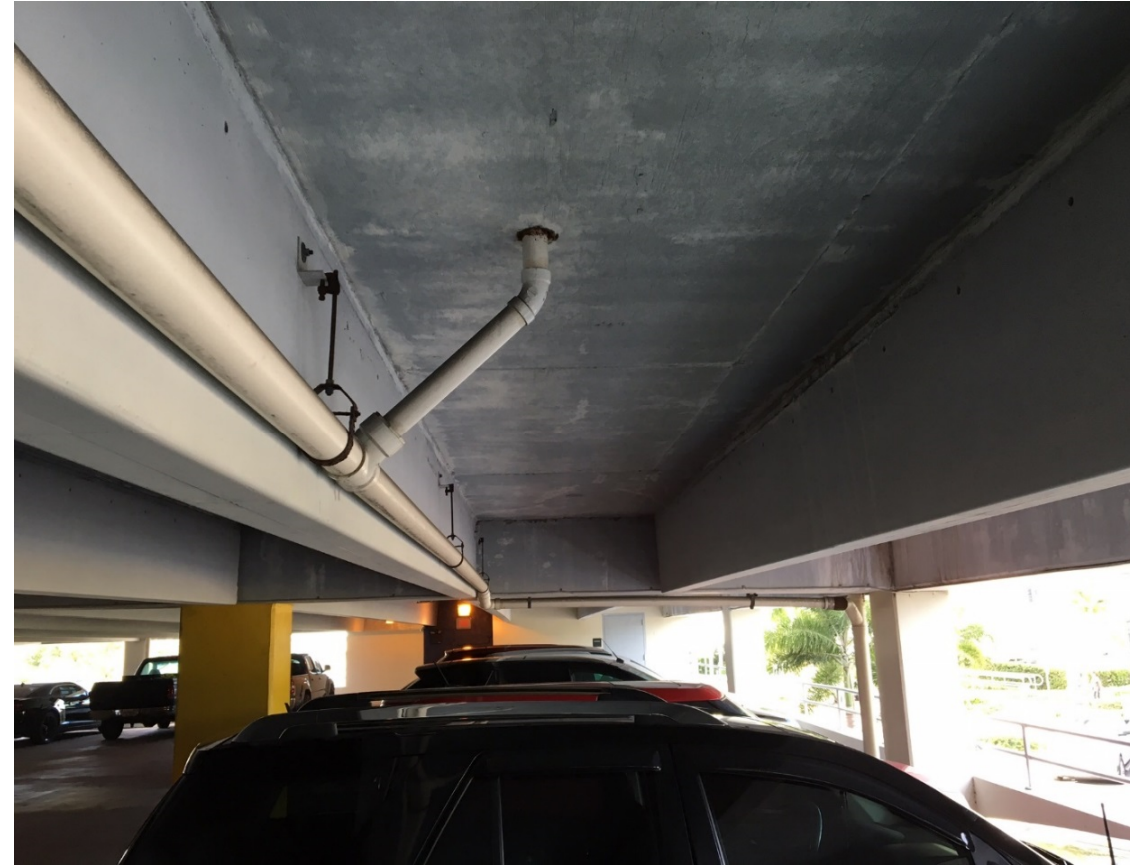
Supplemental Drain

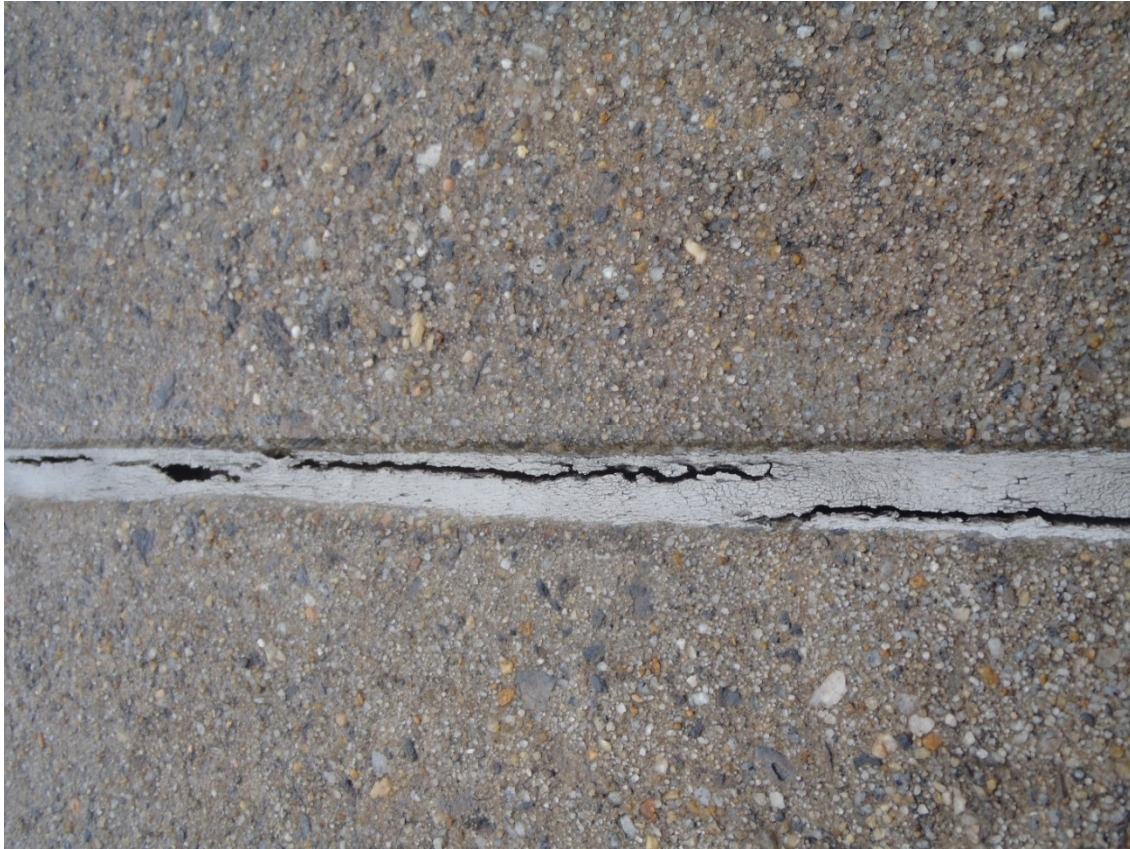
Cohesive Failure/Aged & Weathered

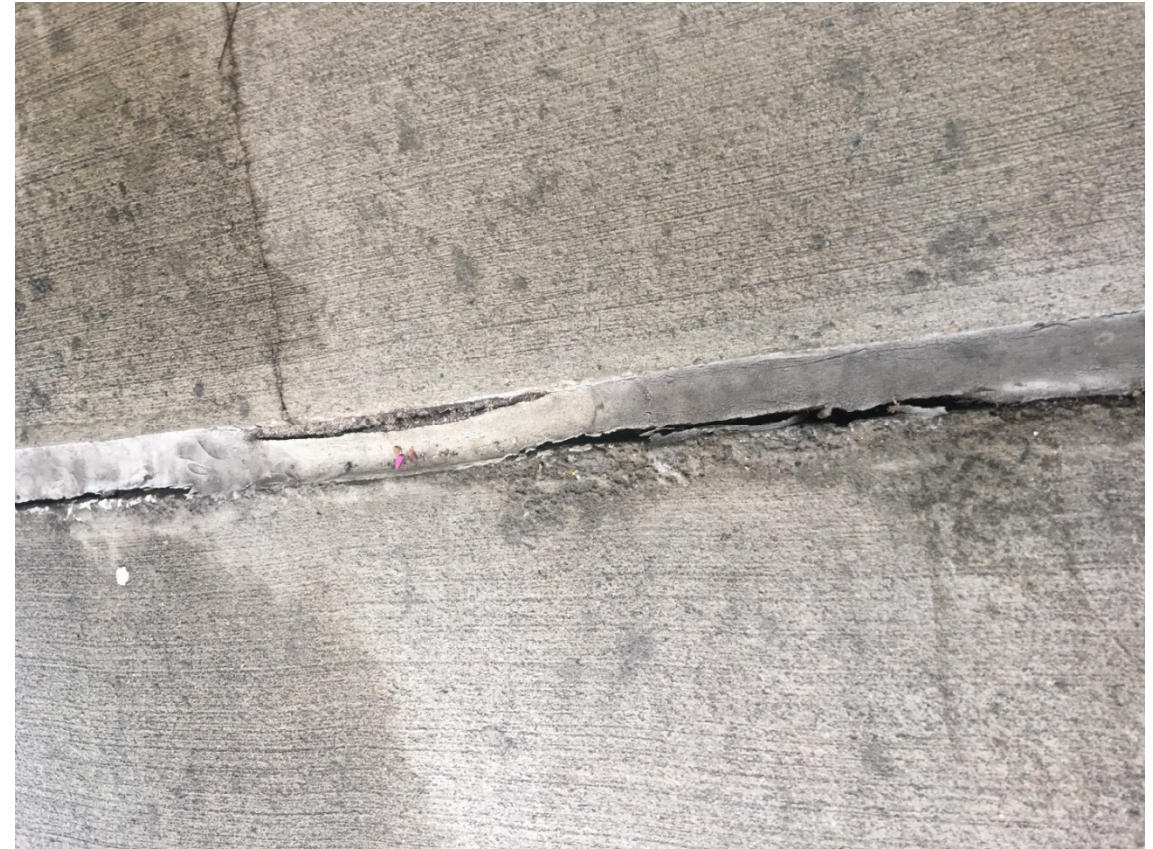
Adhesive Failure

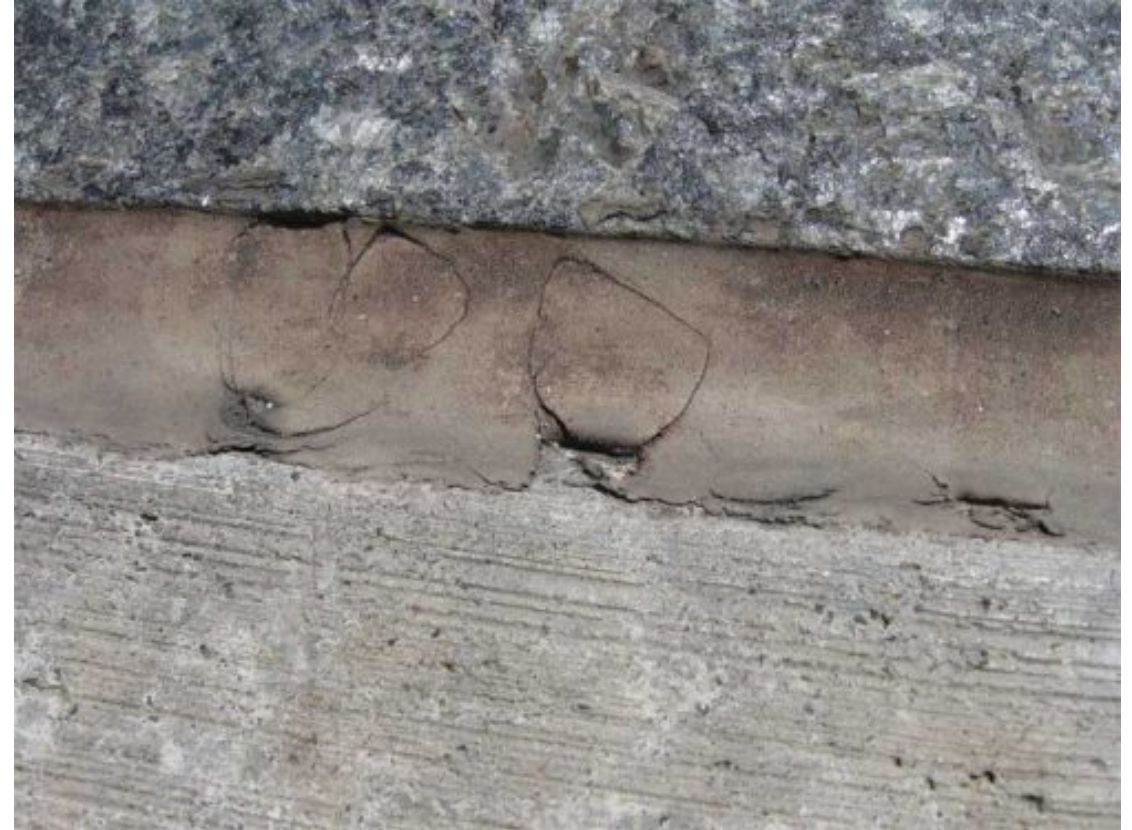
Heel Damage

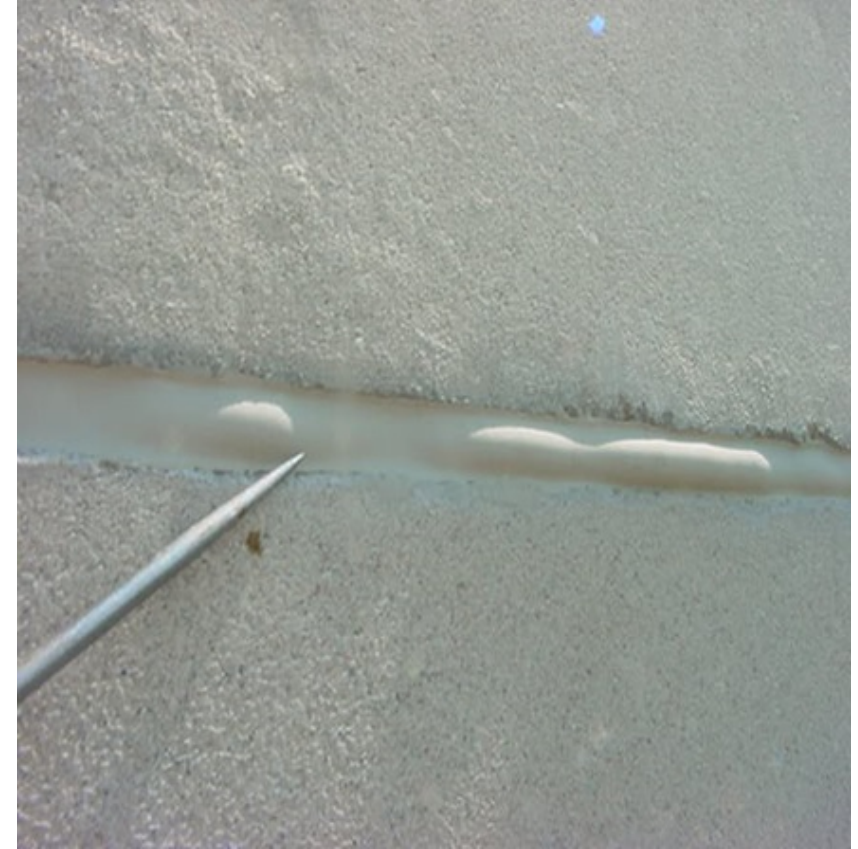
Bubbles
Photo by BASF

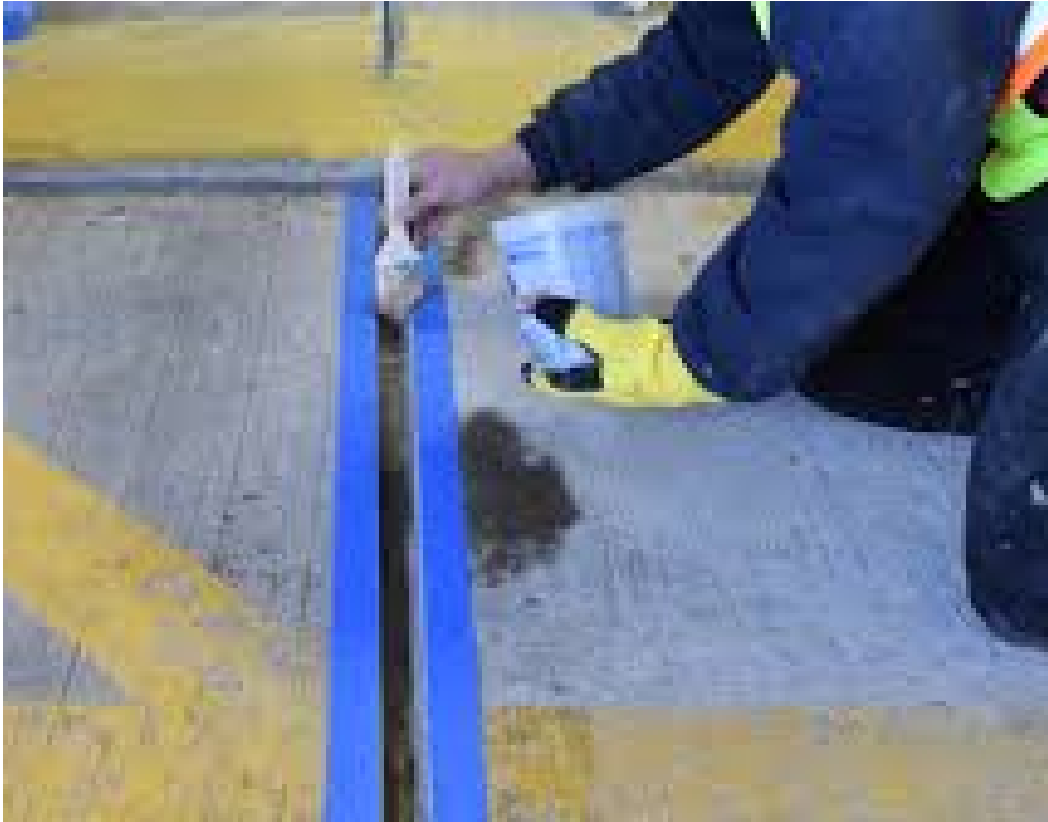
Priming Joint

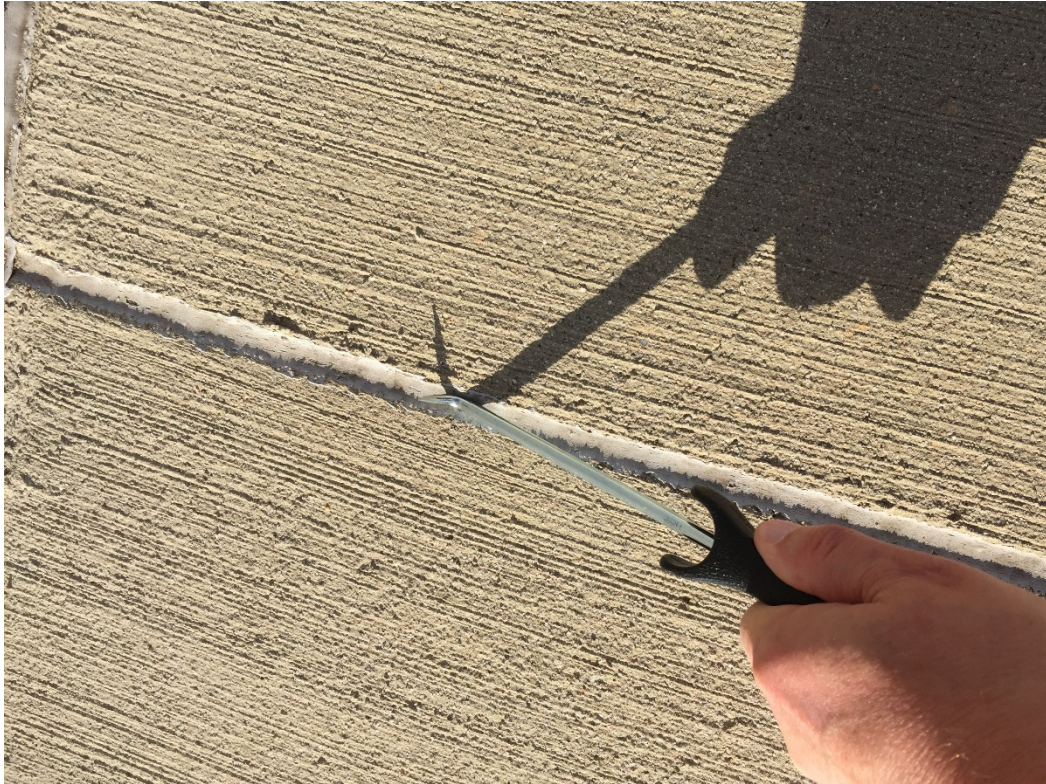
Probing NDT

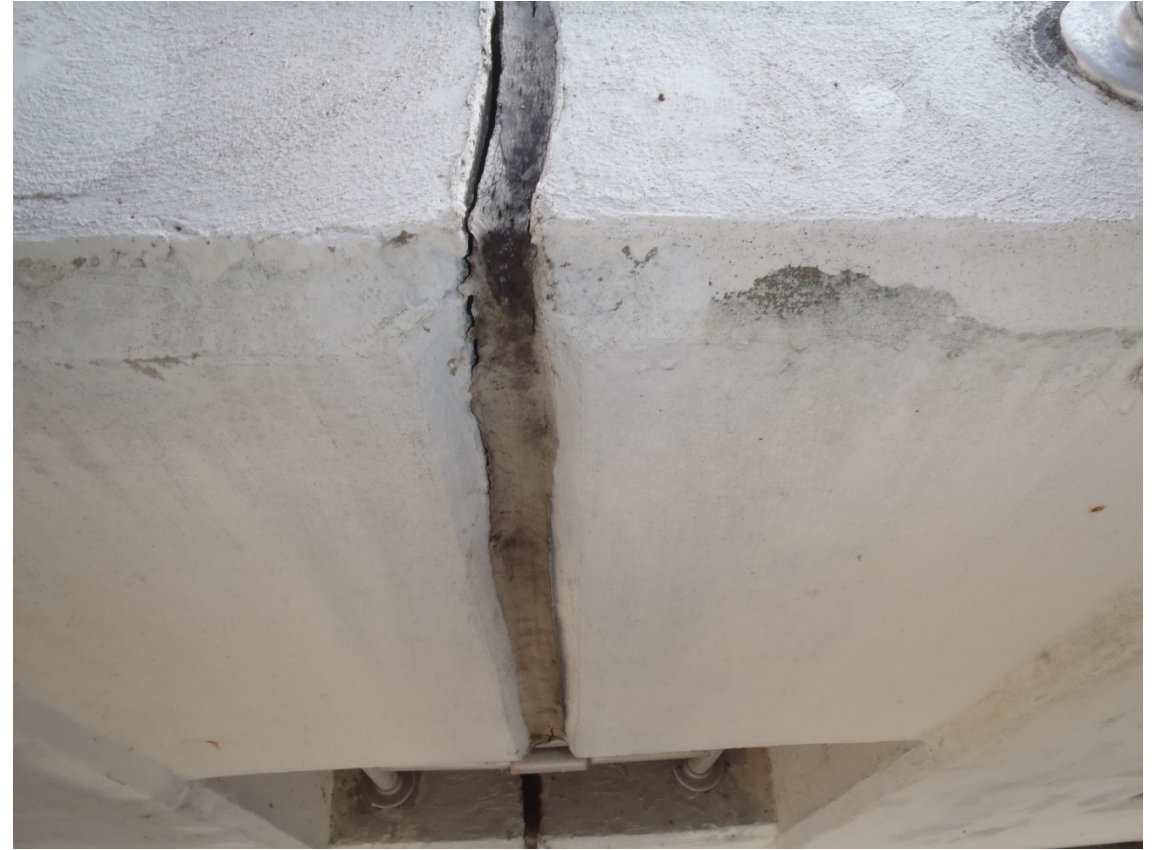
Vertical Joint

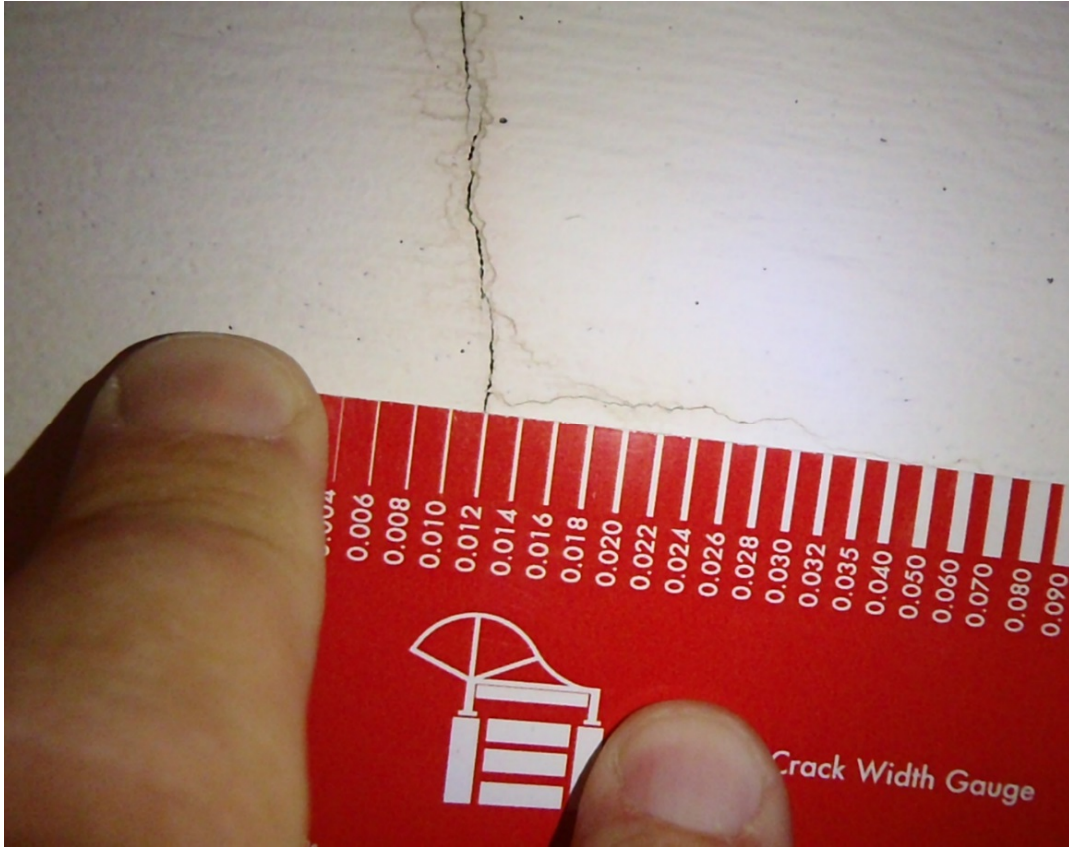
$.013'' \leq \text{Cracks} < .035''$

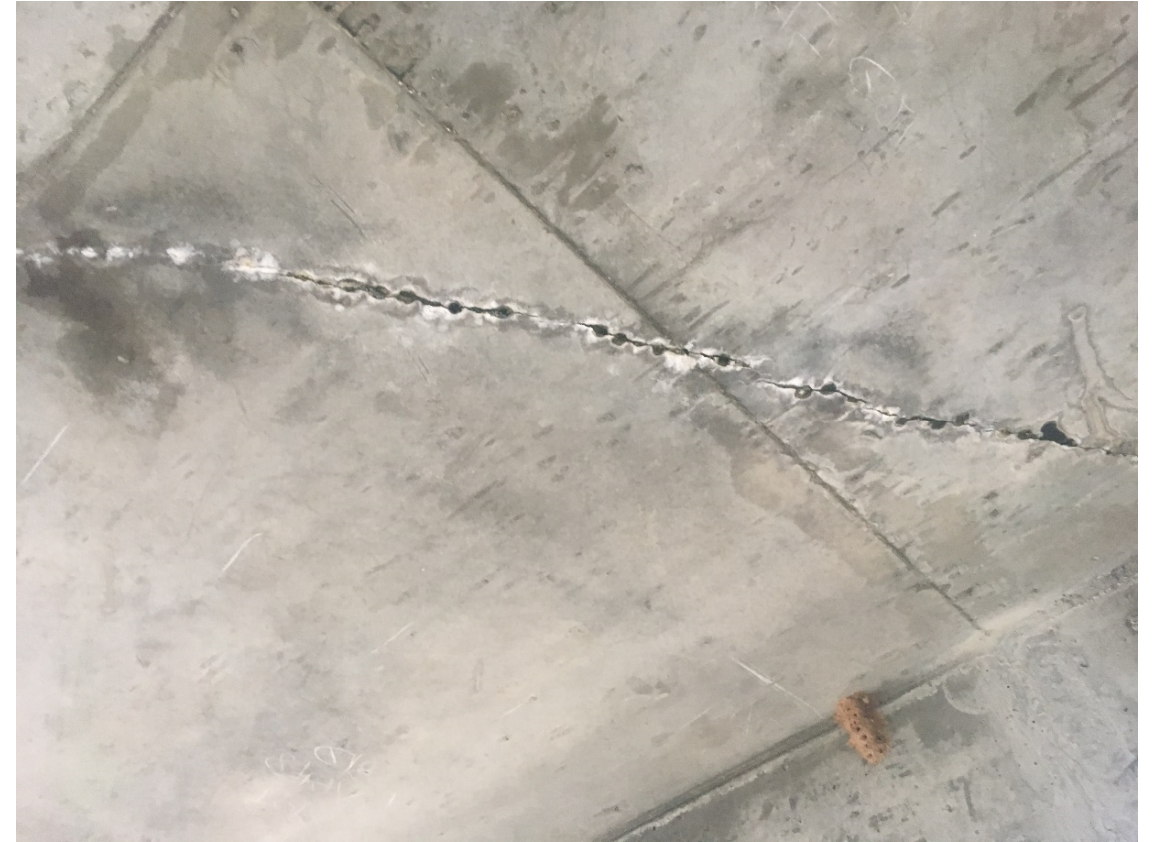
Cracks that Leak $< .035''$

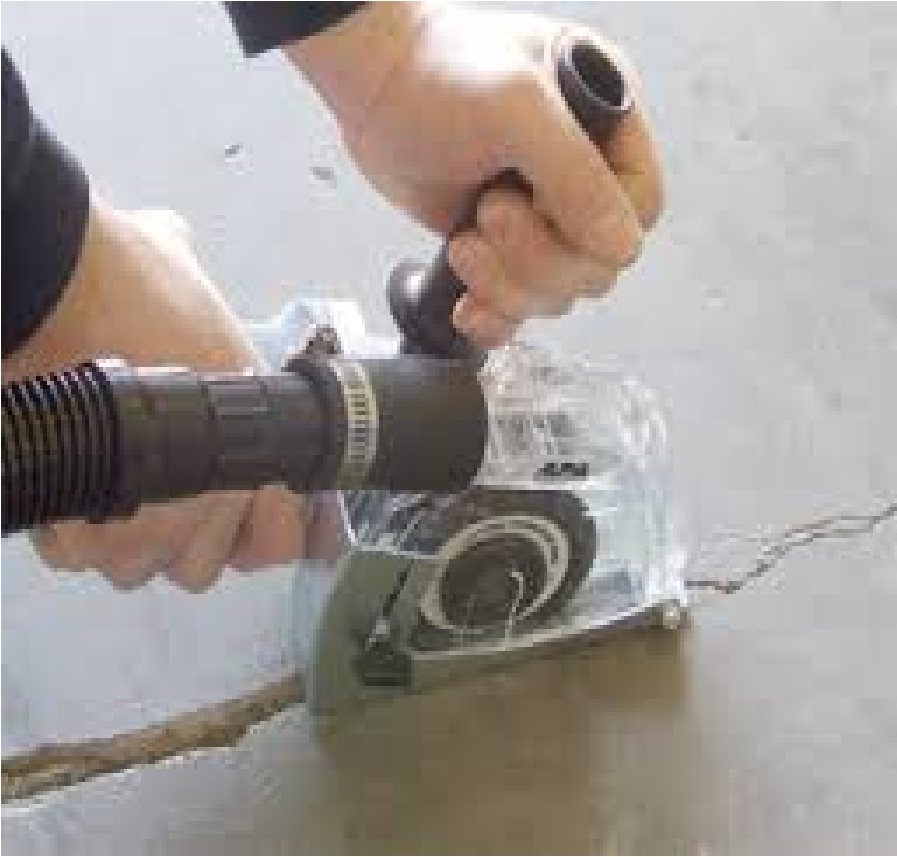
Crack Chasing

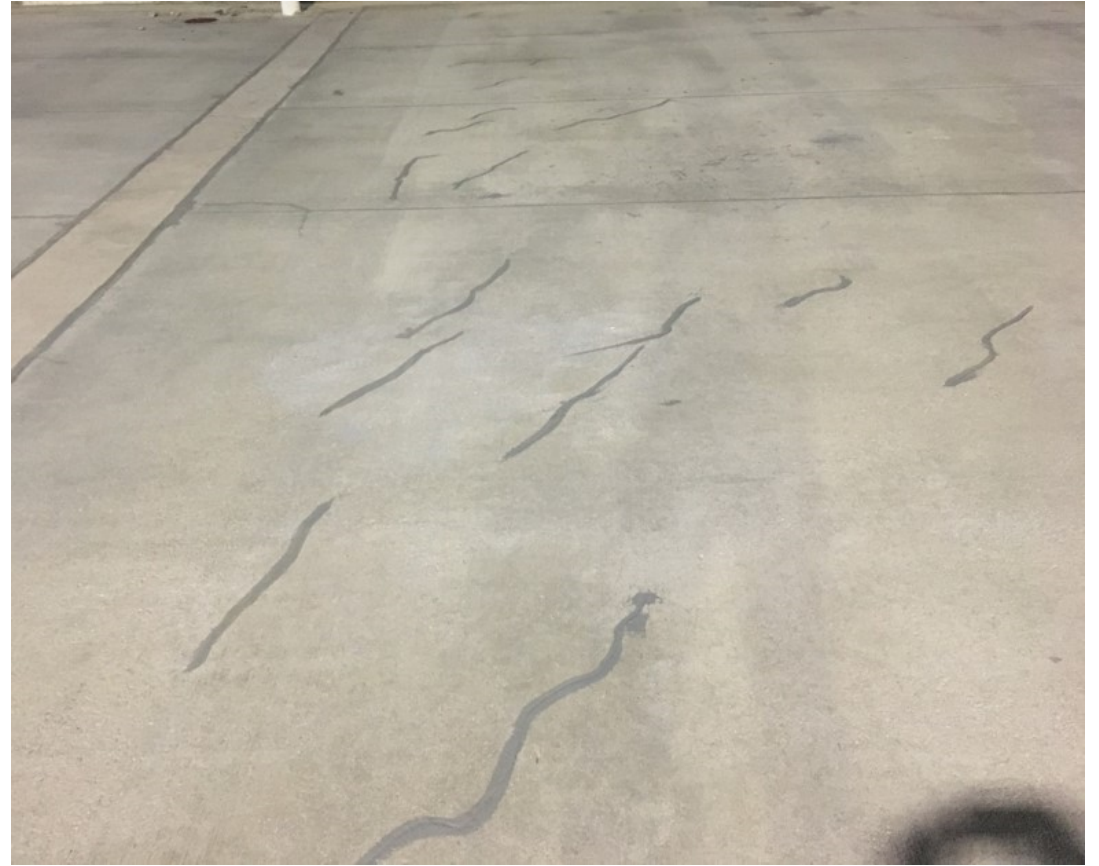
Crack Sealant

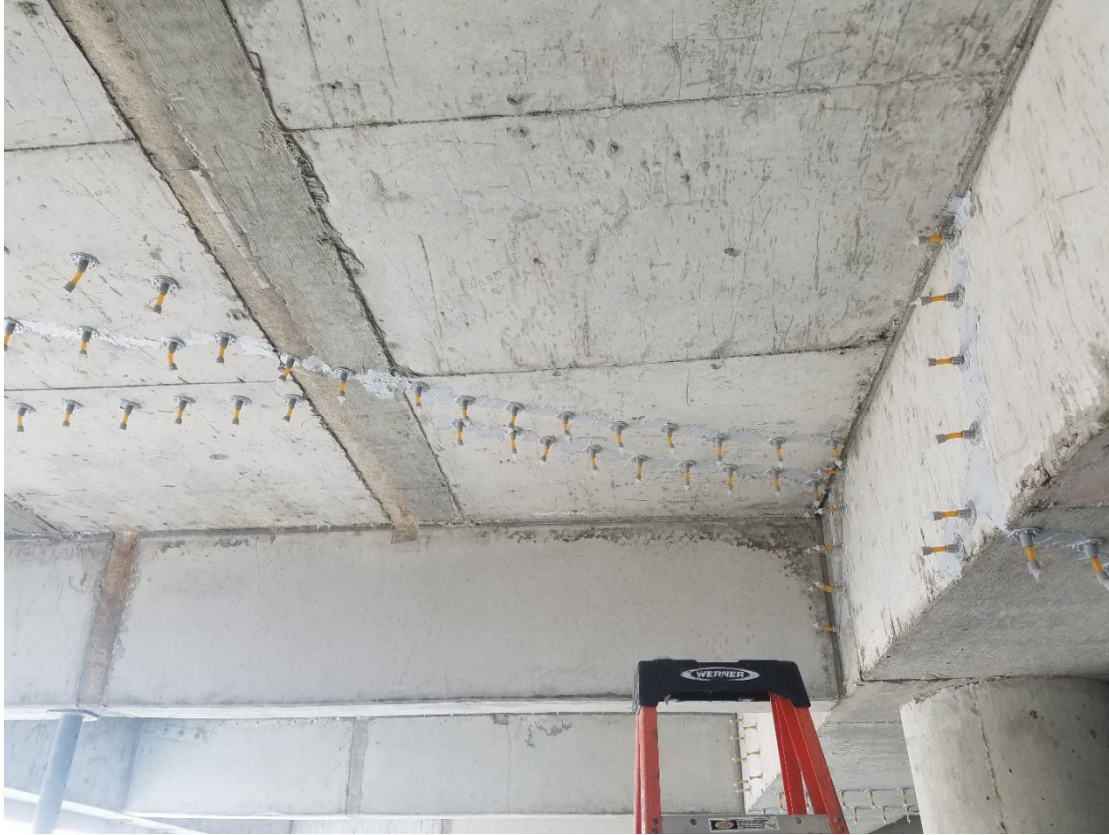
Cracks $\geq .035''$

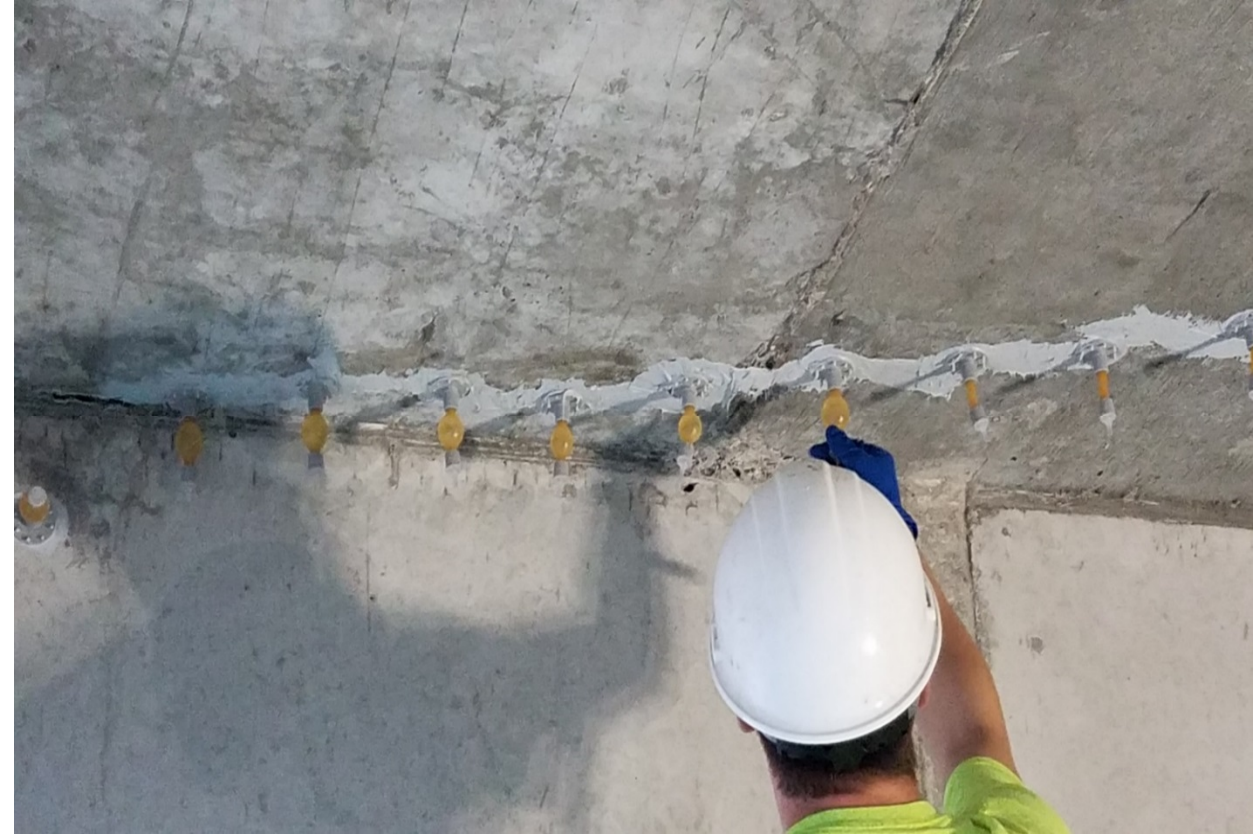
Inflatable Injection Port

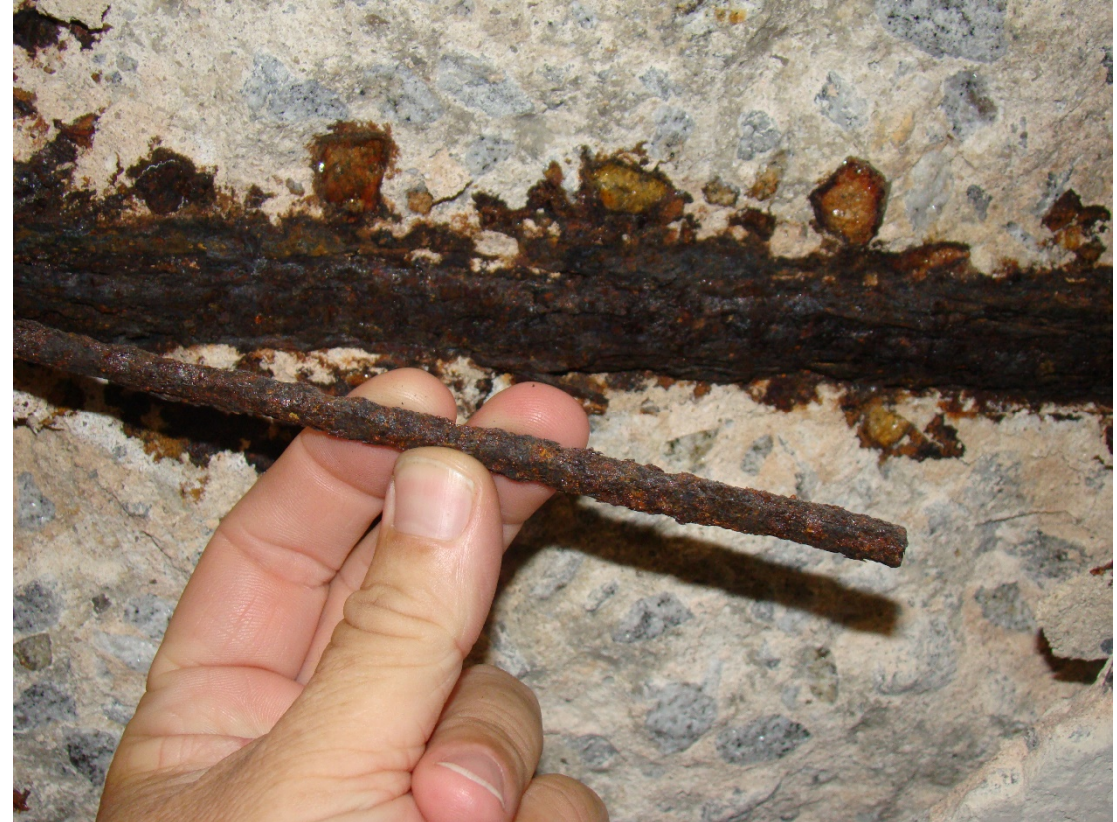
Section Loss
