The Truth About Parking Structure Maintenance: How to Protect Your Investment

**CPMA Annual Conference & Tradeshow
Harrah's Cherokee Casino
Wednesday October 6, 2021**

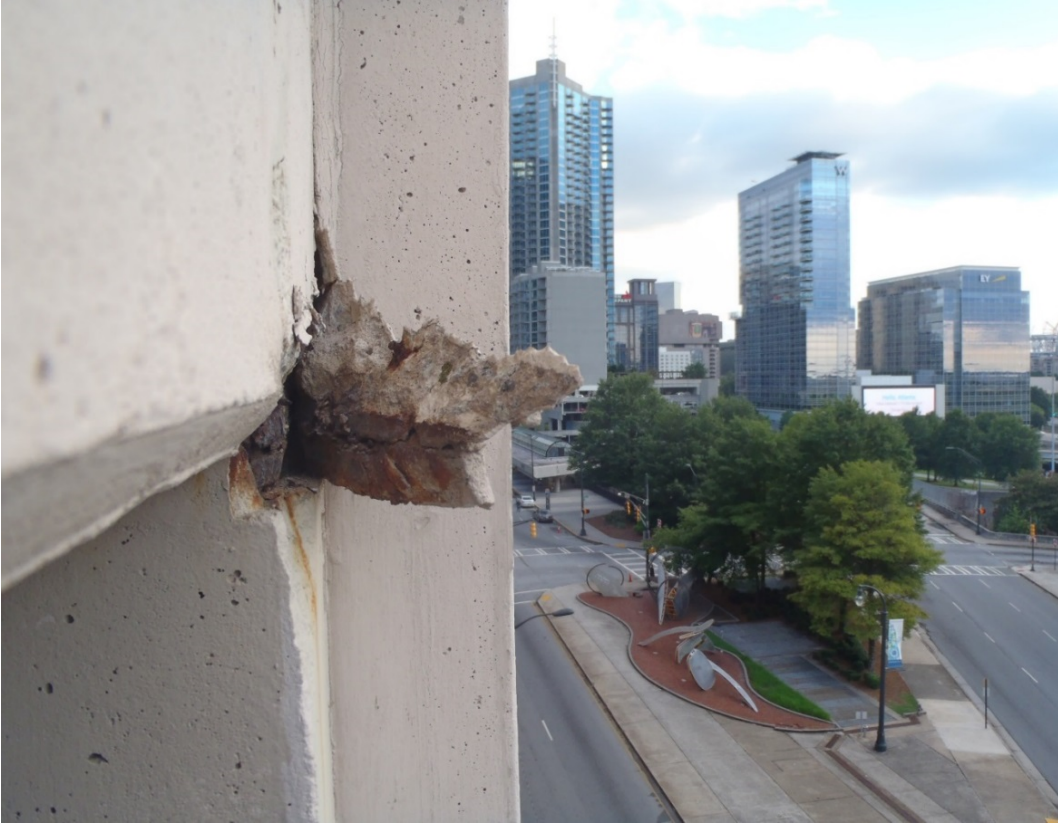
Spall Over Sidewalk

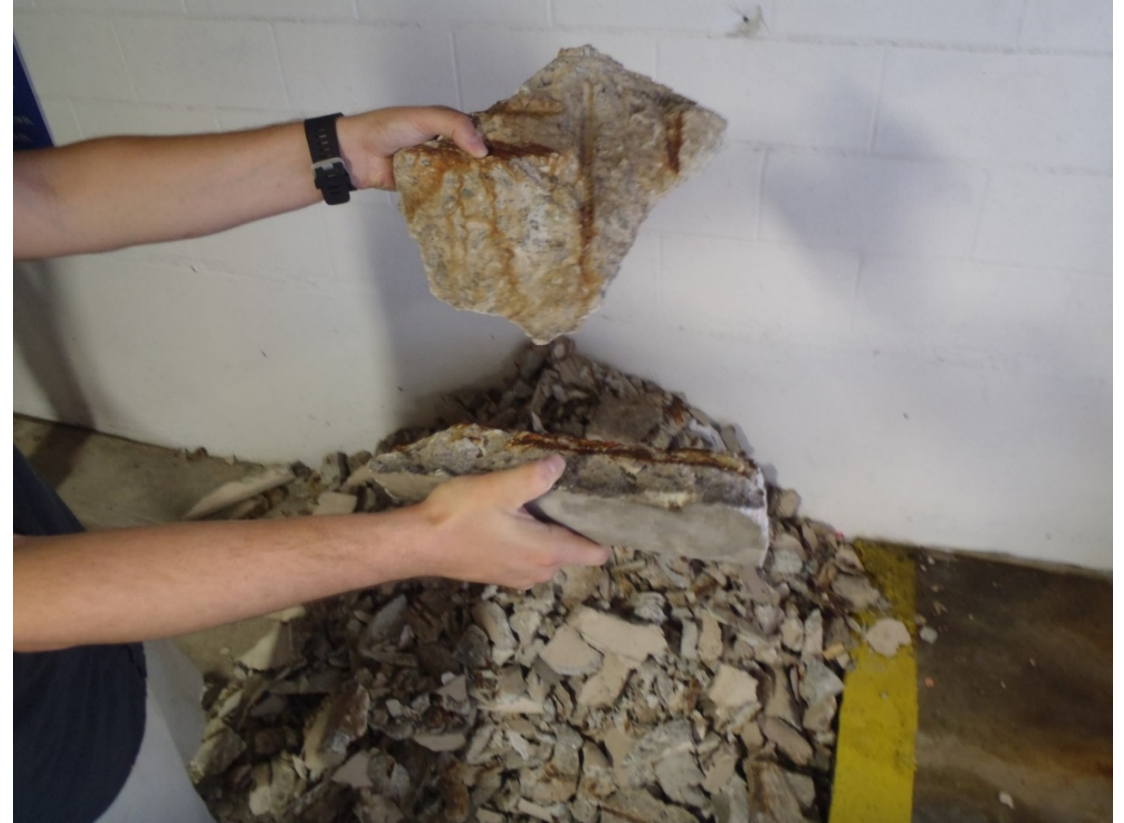
Spall Size

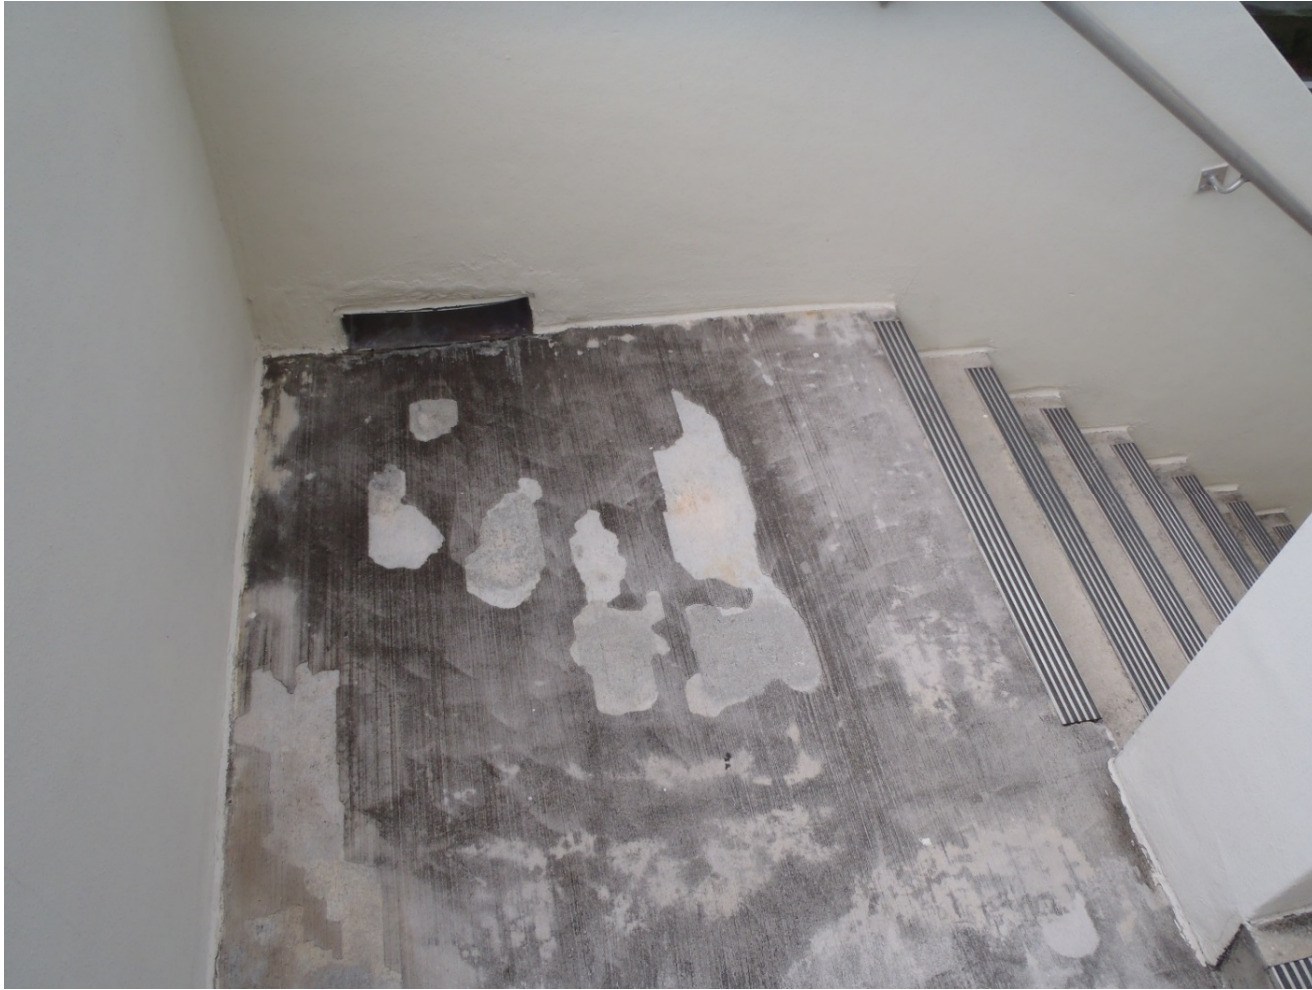
Common Deficiency: Scaling

- Loss of surface mortar
- Freeze-Thaw Damage
- Inadequate air entrainment
- Ponding water

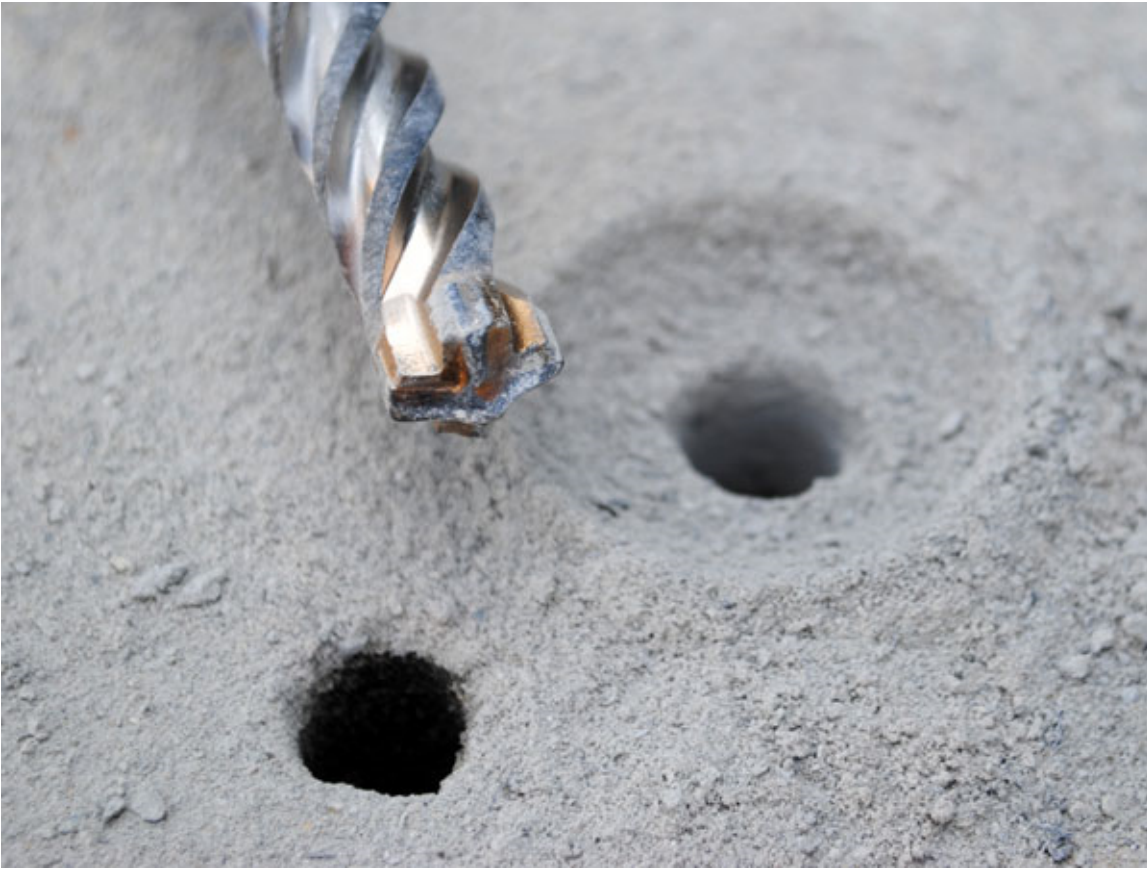
Dust at Various Depths

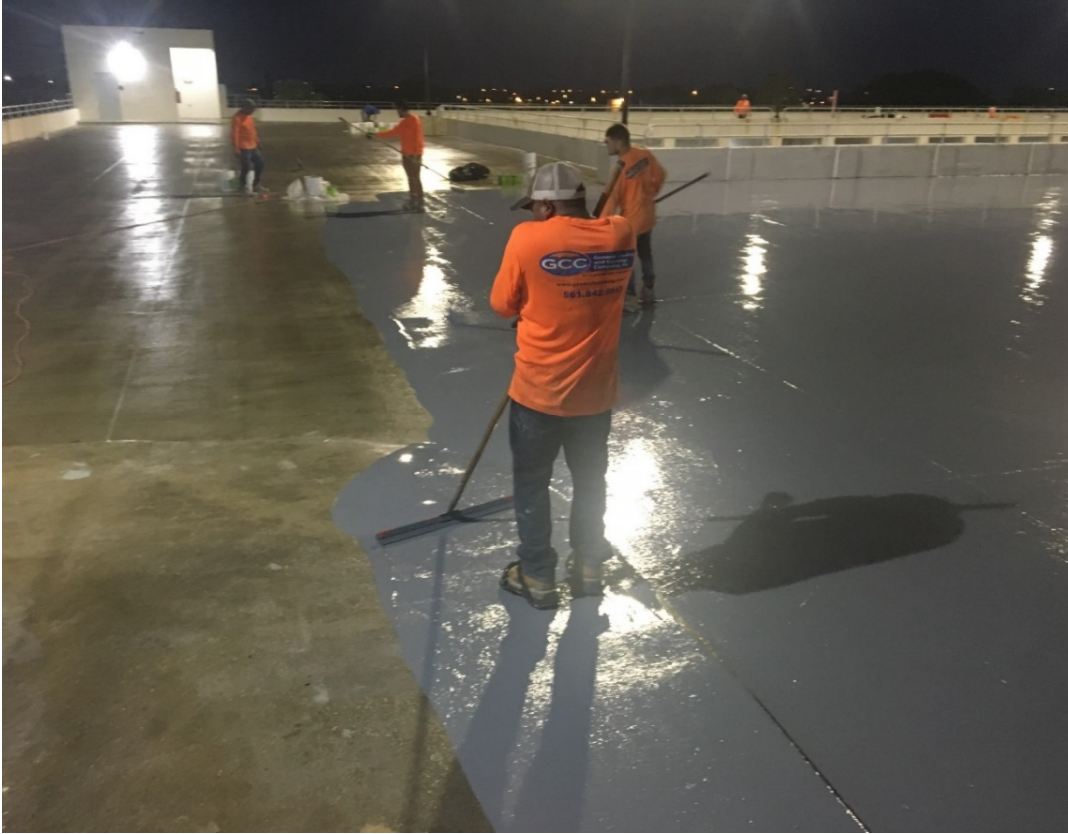
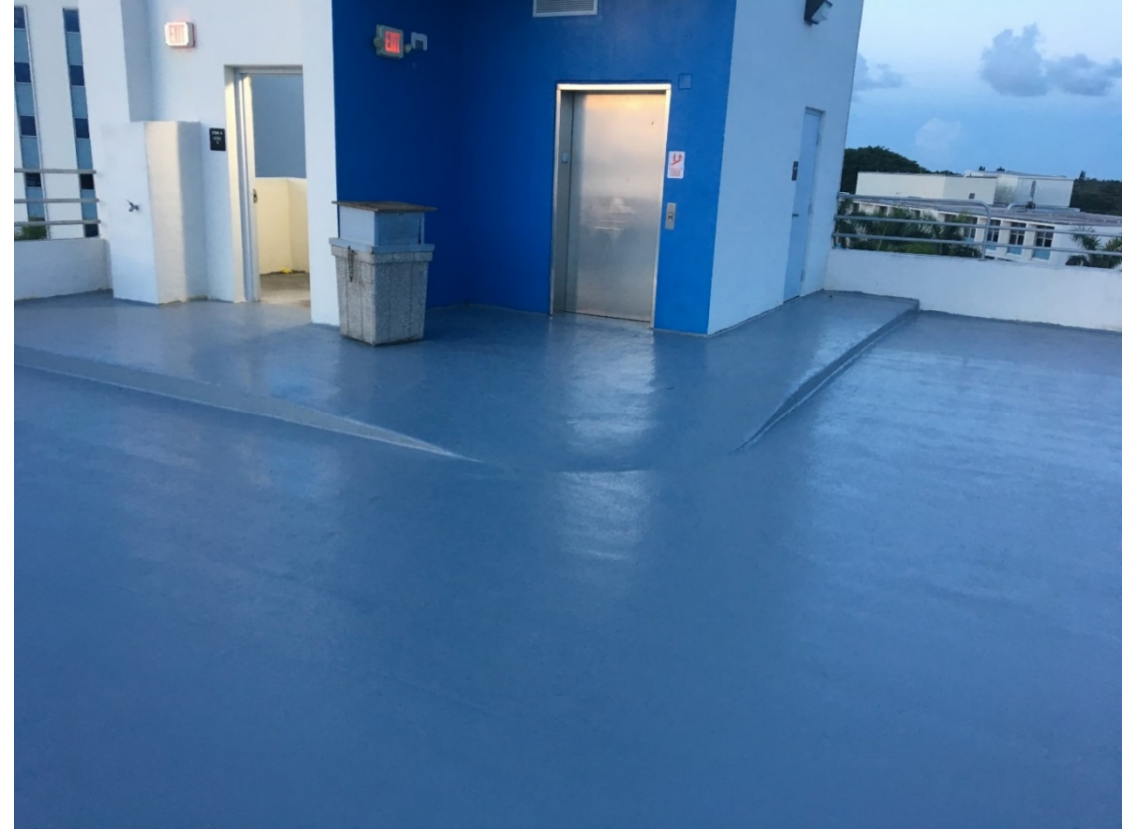
Traffic Bearing Membrane

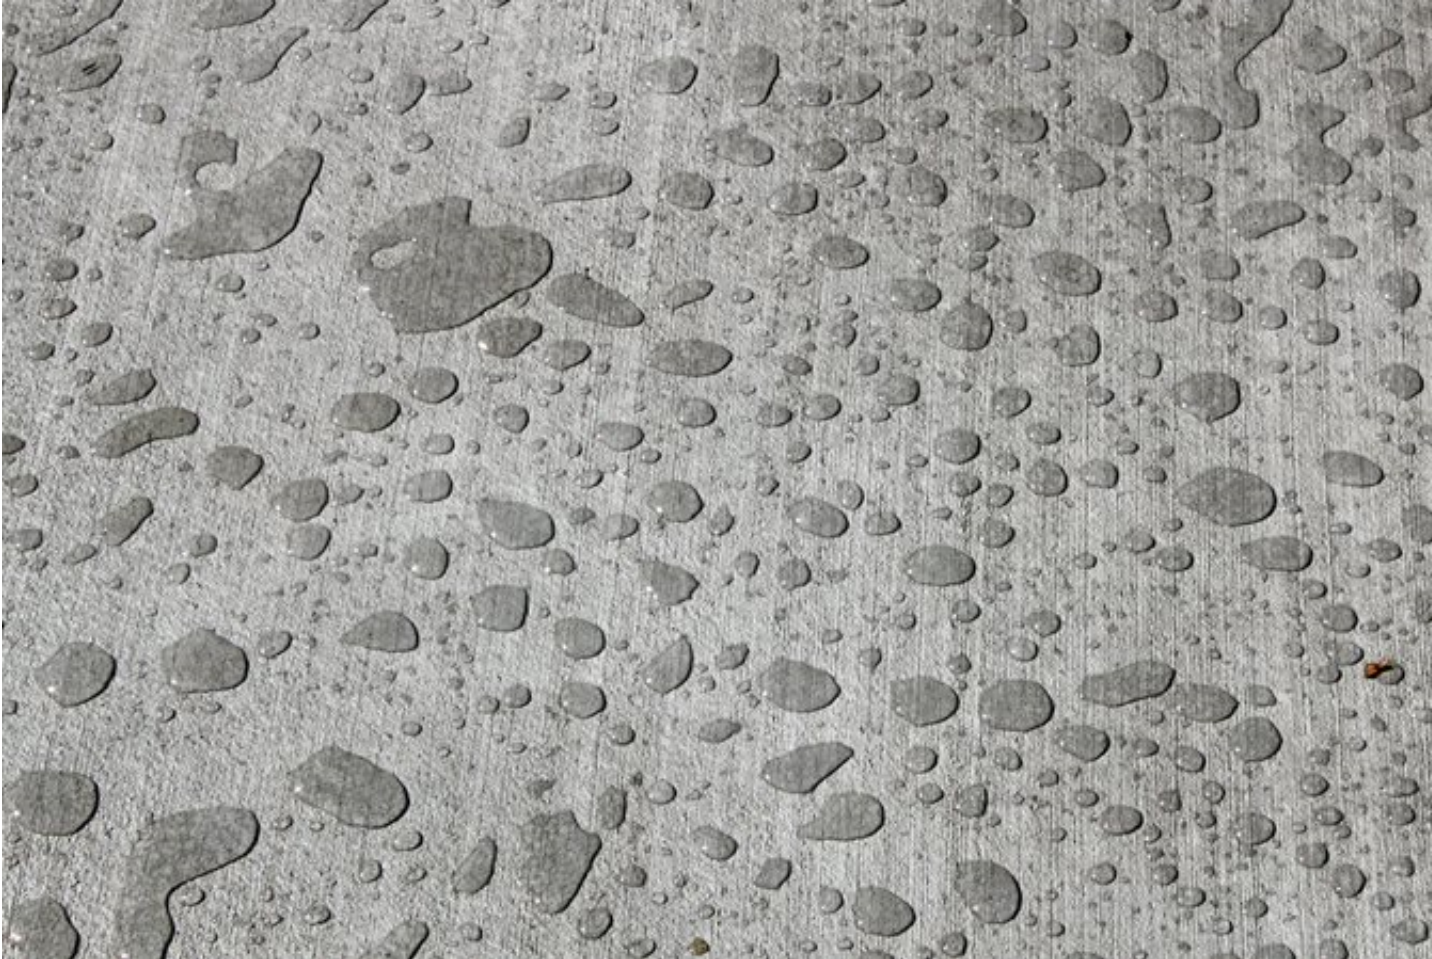
Common Deficiency: Better Option

- **Silane Sealer**
 - Water Retardant
 - Breathable
 - Fills Pores of Dense Concrete
 - Minimizes penetration of water and chemicals
 - Reapply 5 to 10 years

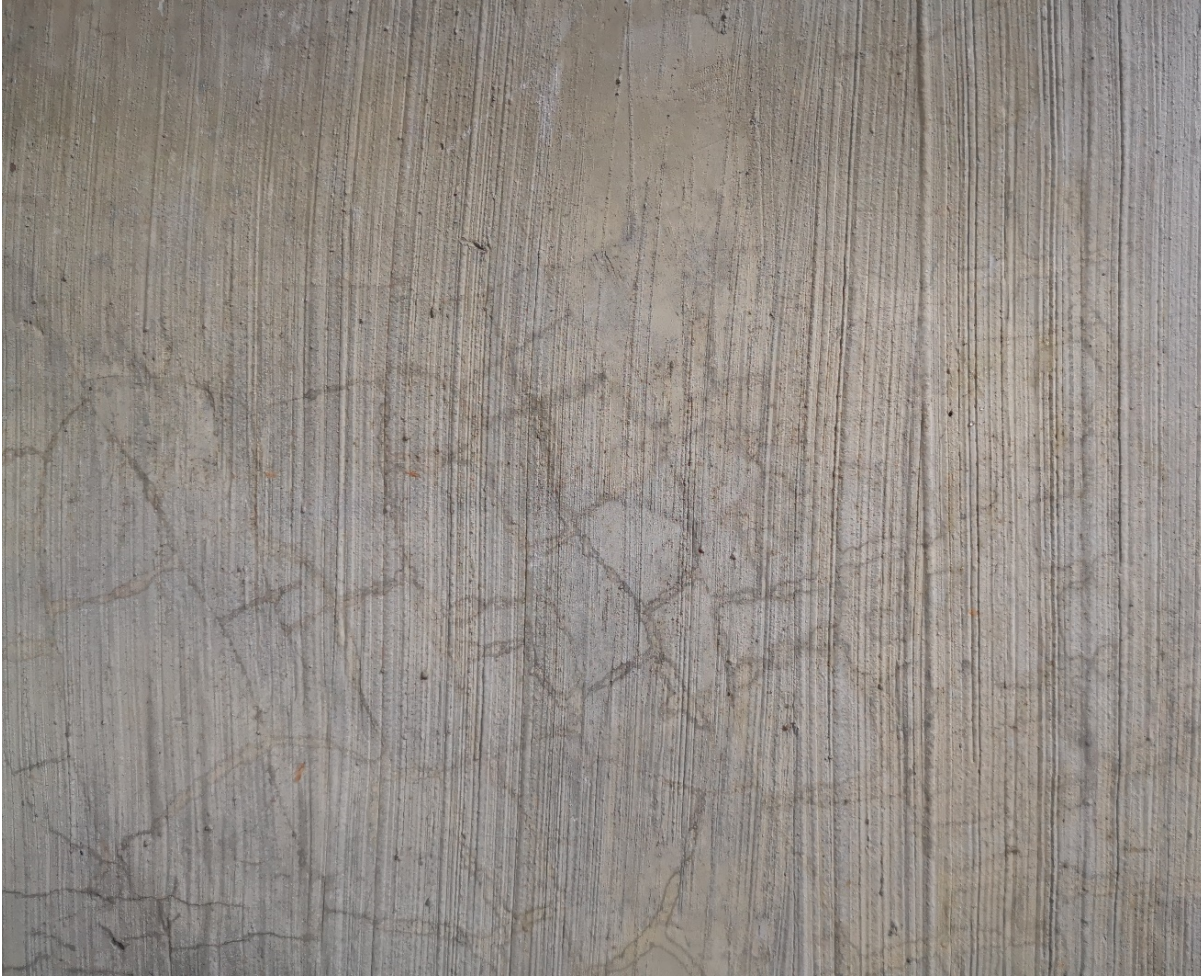
Common Deficiency: Crazeing

- Shrinkage of the surface layer of paste
- Fine random cracking
- Does not affect structural Integrity
- Rarely affects durability
- Unsightly

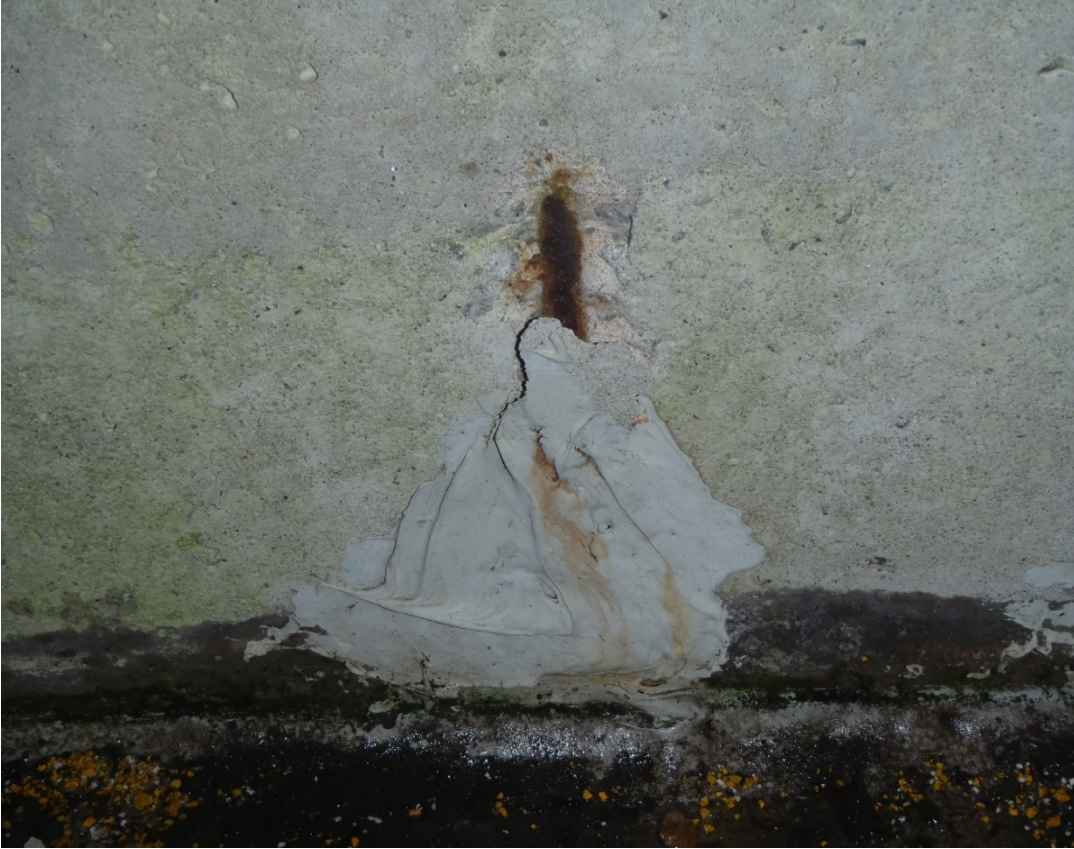
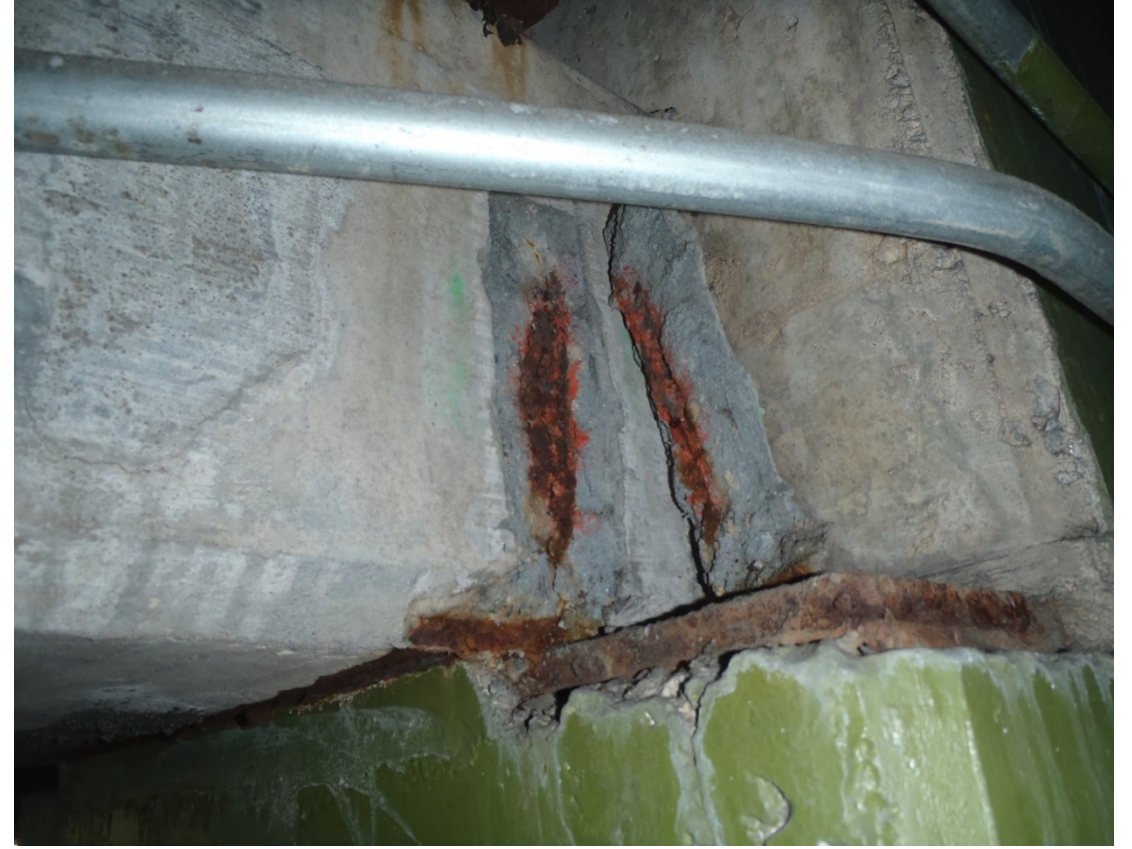
Improper Surface Preparation

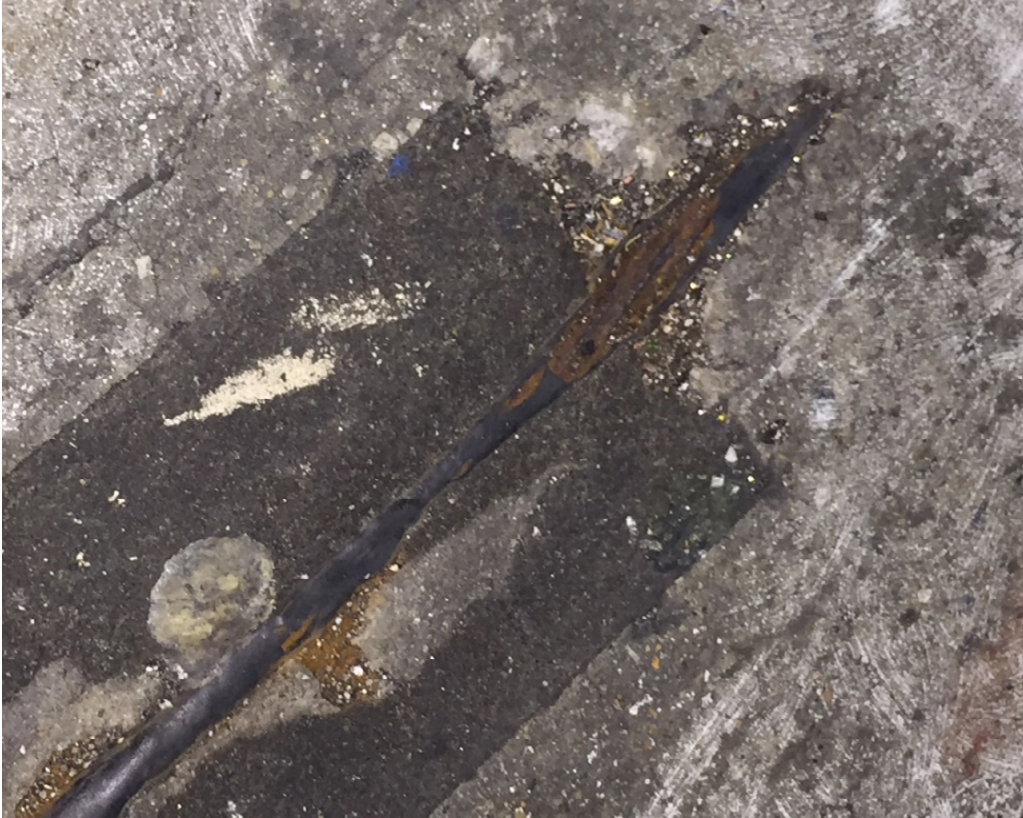
Exposed Post Tensioning (PT)

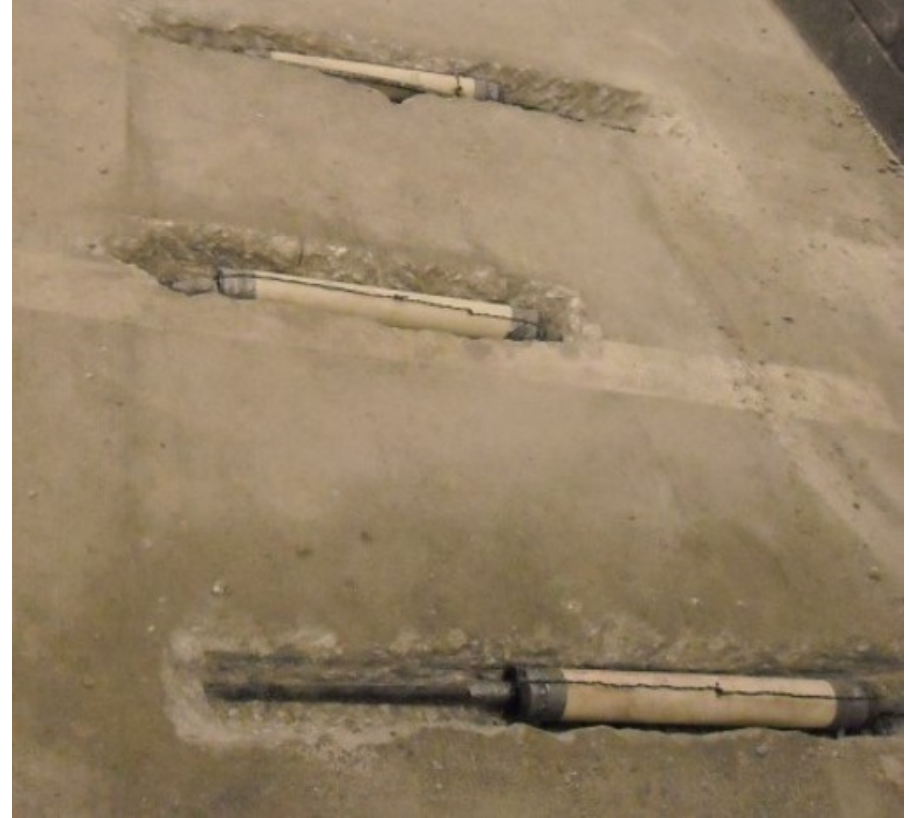
PT Strand Splice

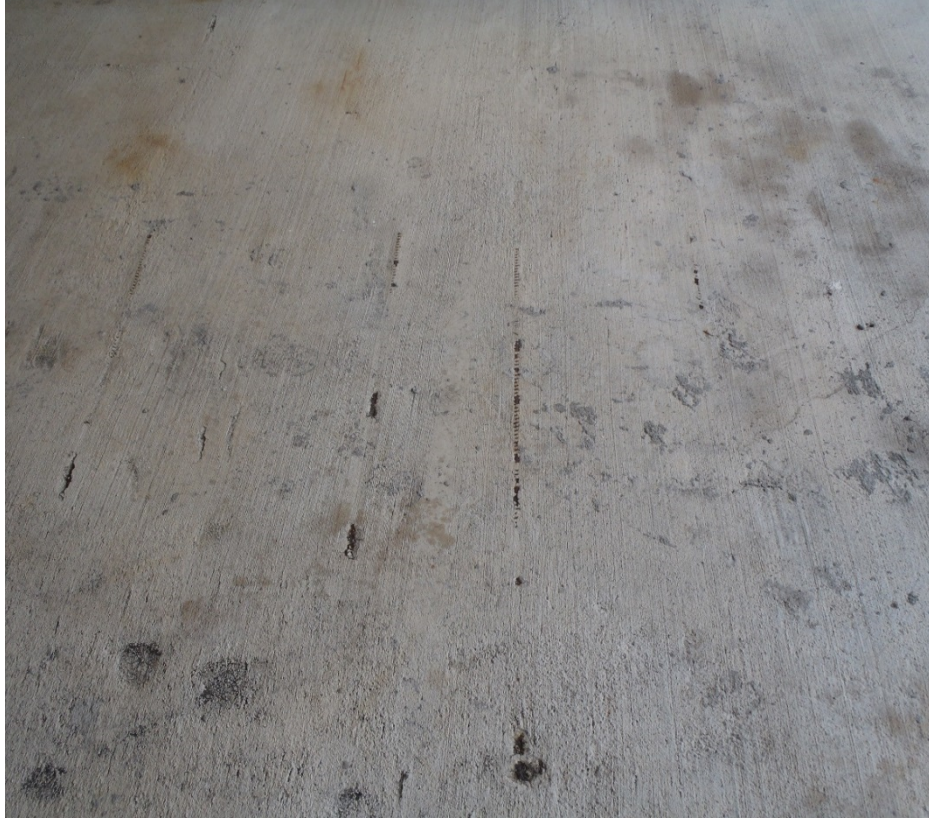
Exposed Reinforcing Steel

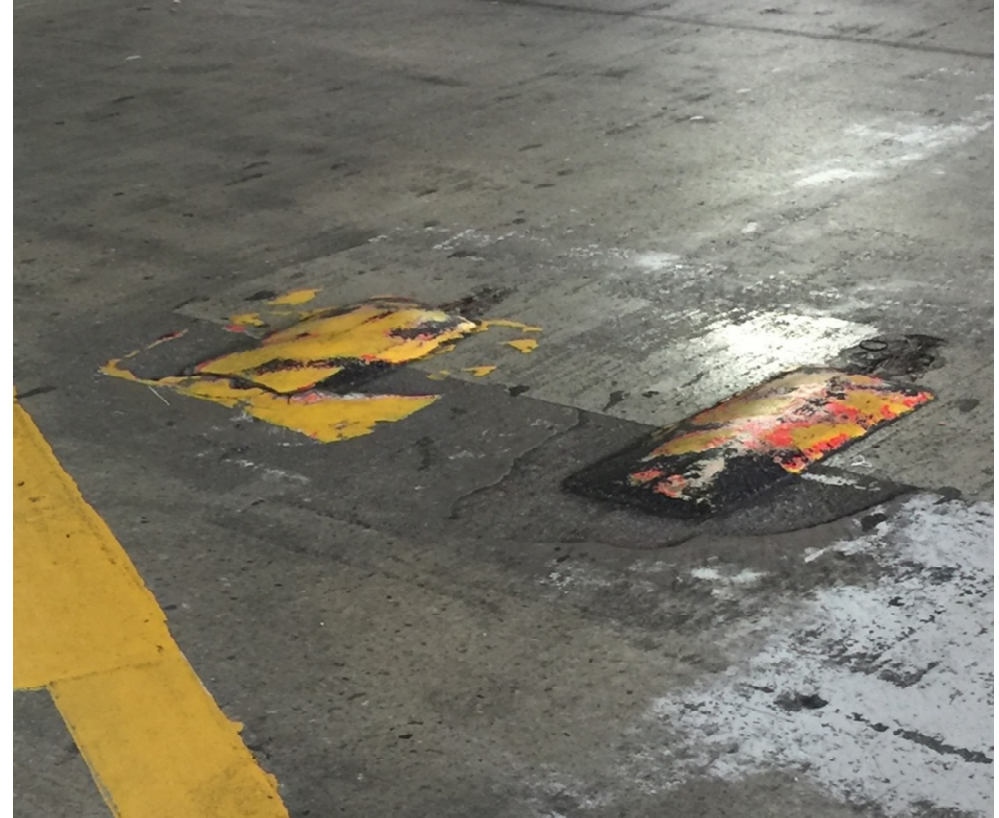
Patch to Increase Cover

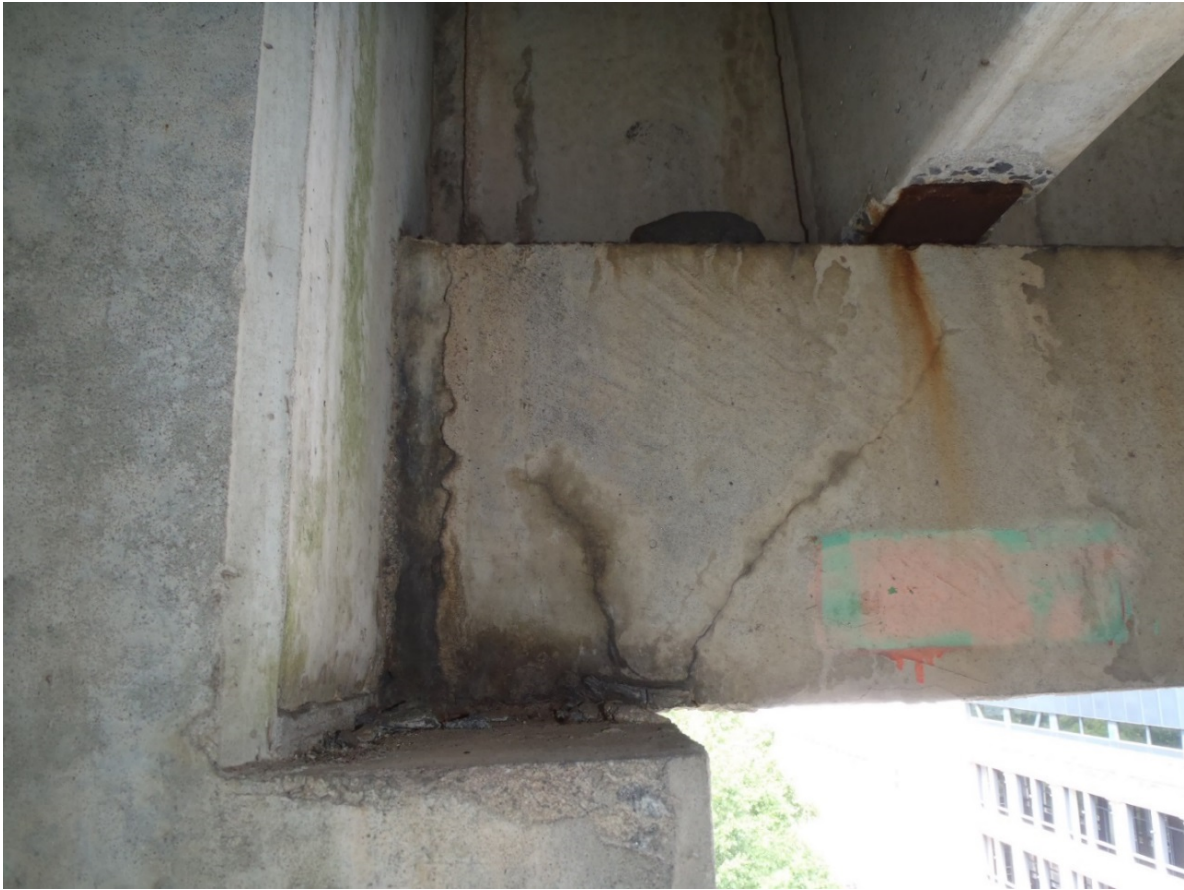
Shear Crack

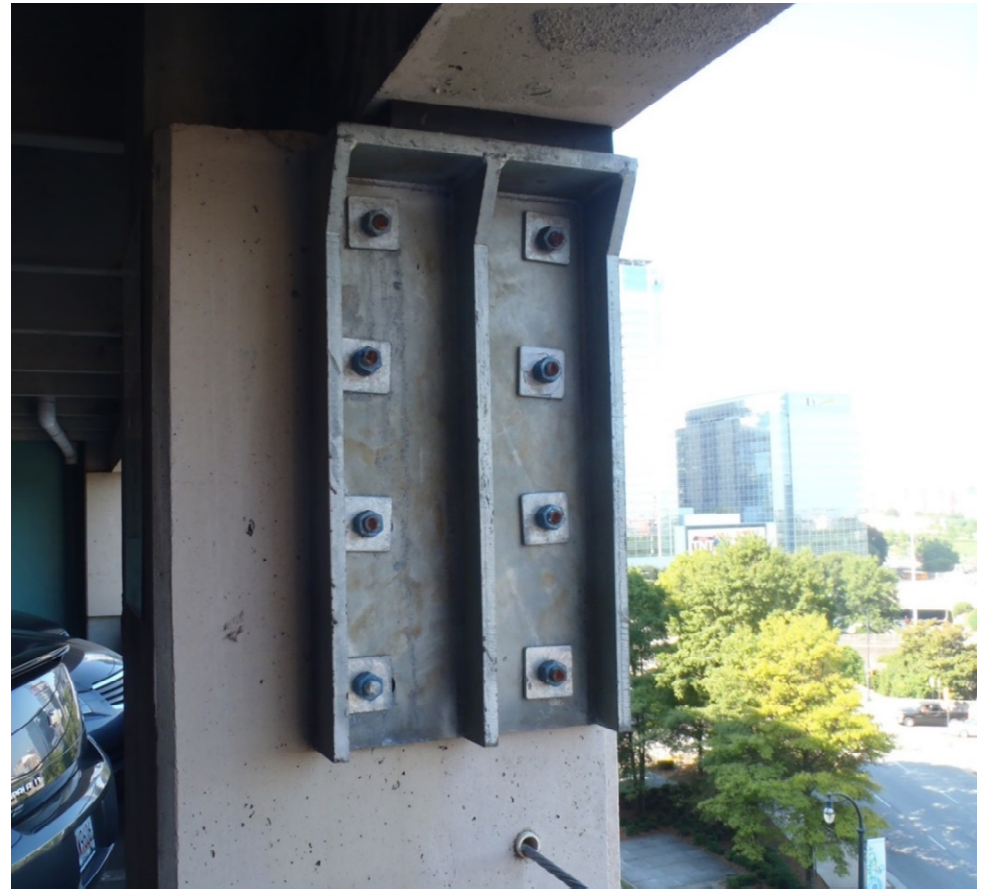
Seat Repair

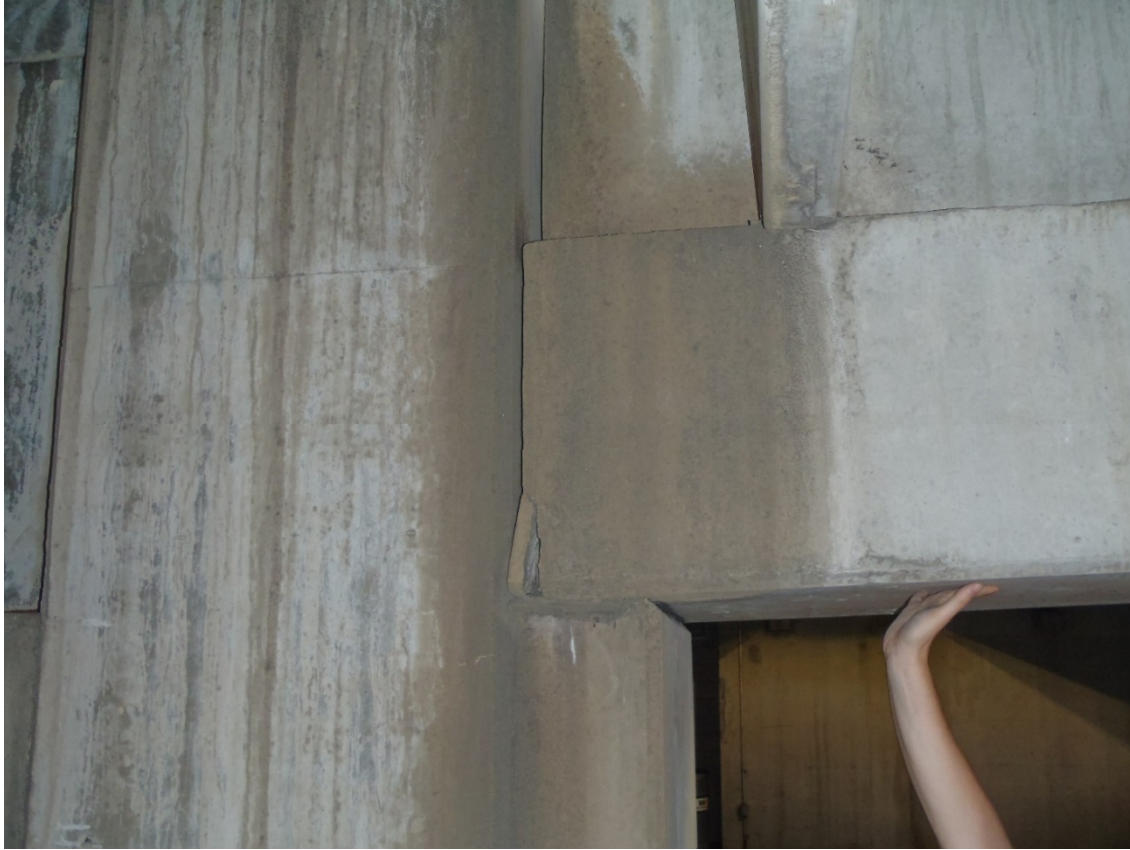
Precast Beam Haunch

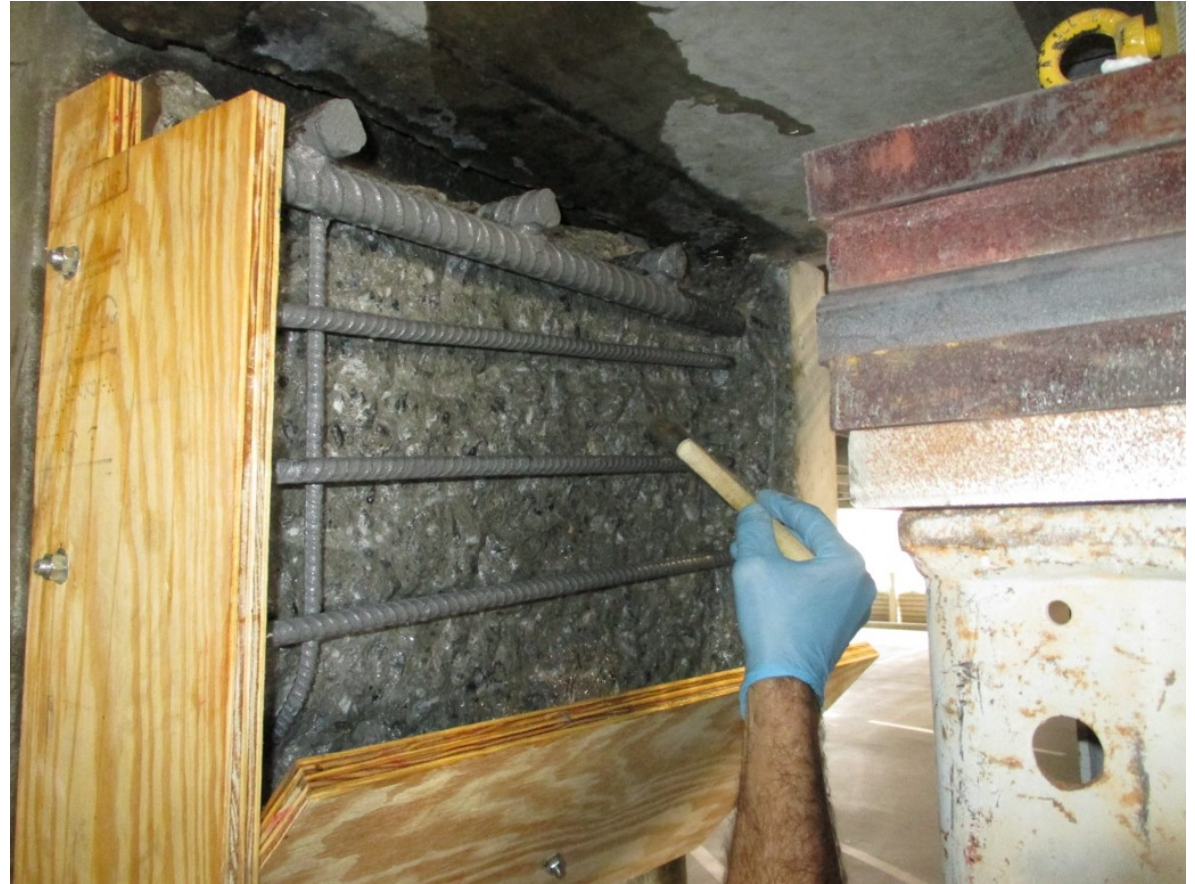
Applying Epoxy Bonding Agent

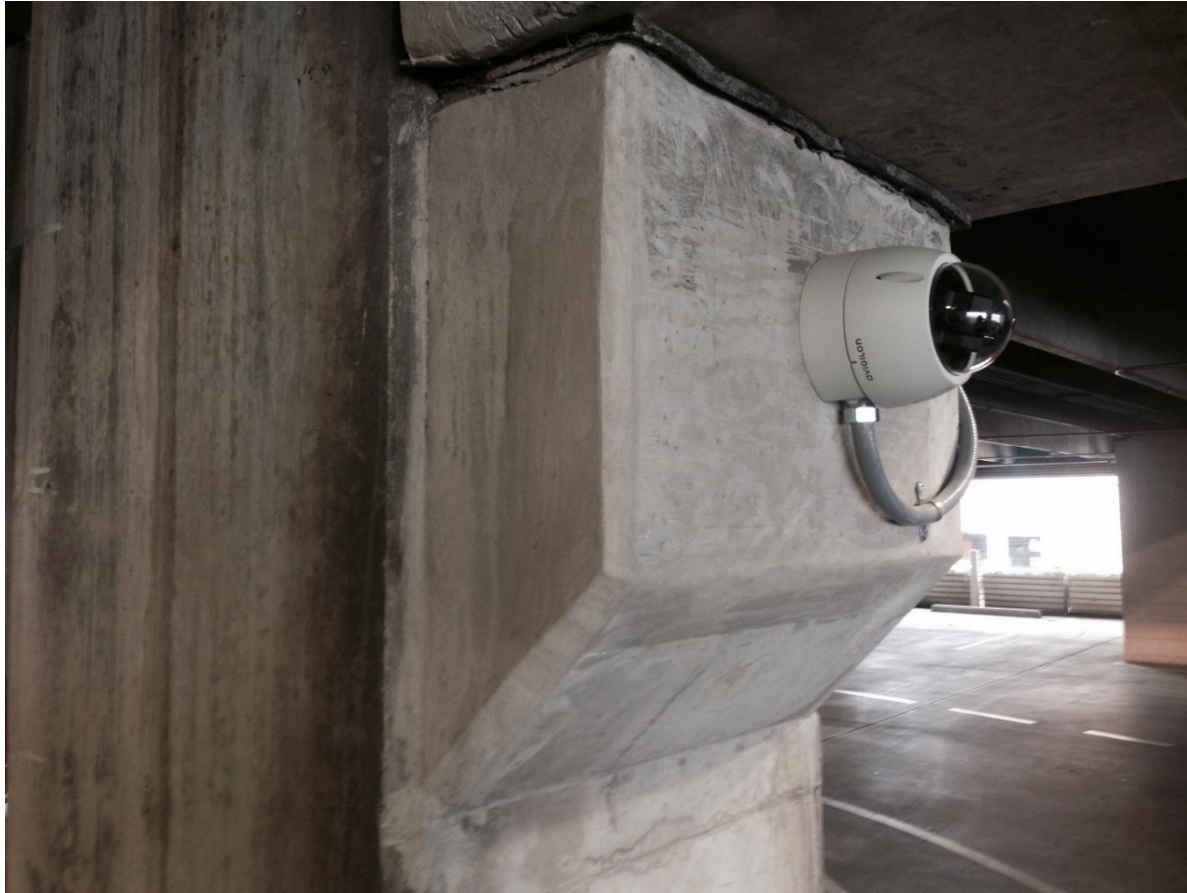
Precast Haunch Connection Finished Repair

Good as New

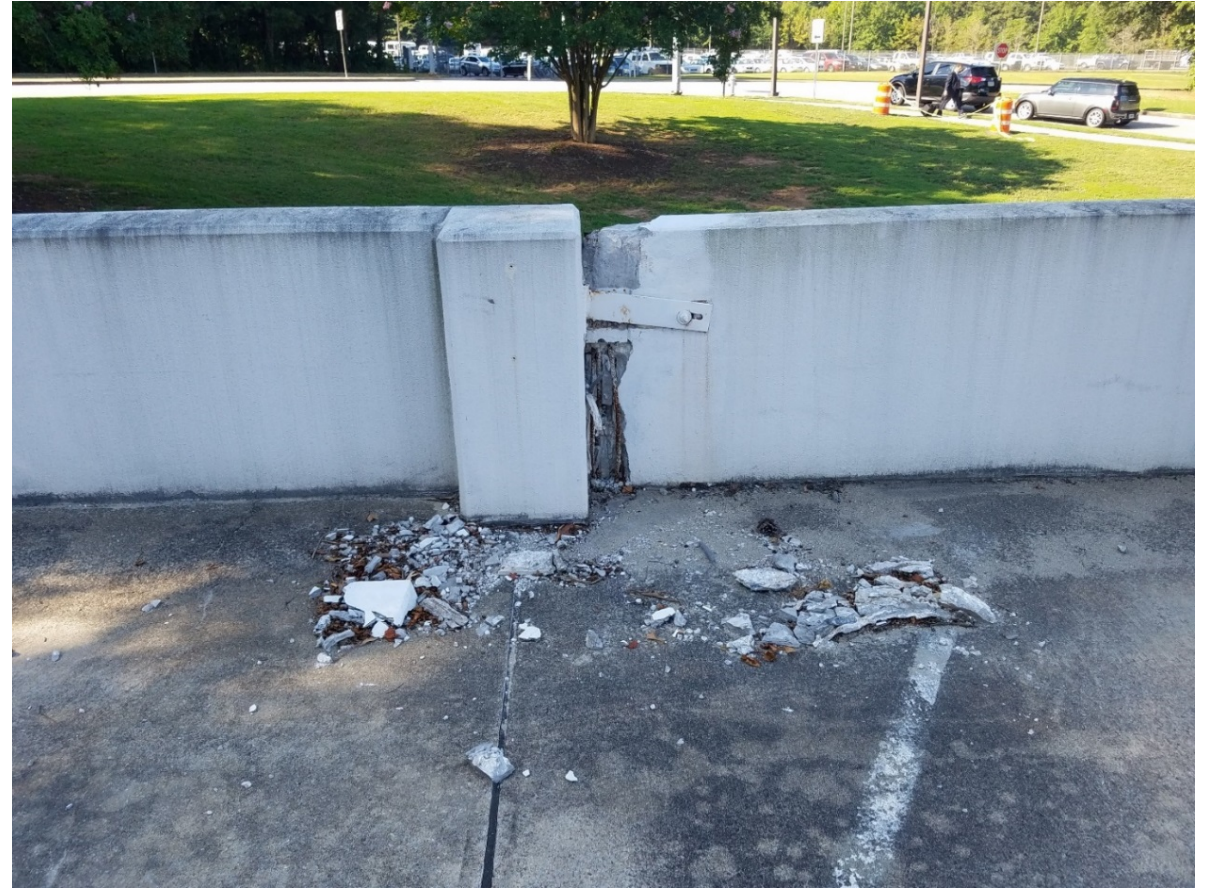
Broken Precast Spandrel Beam

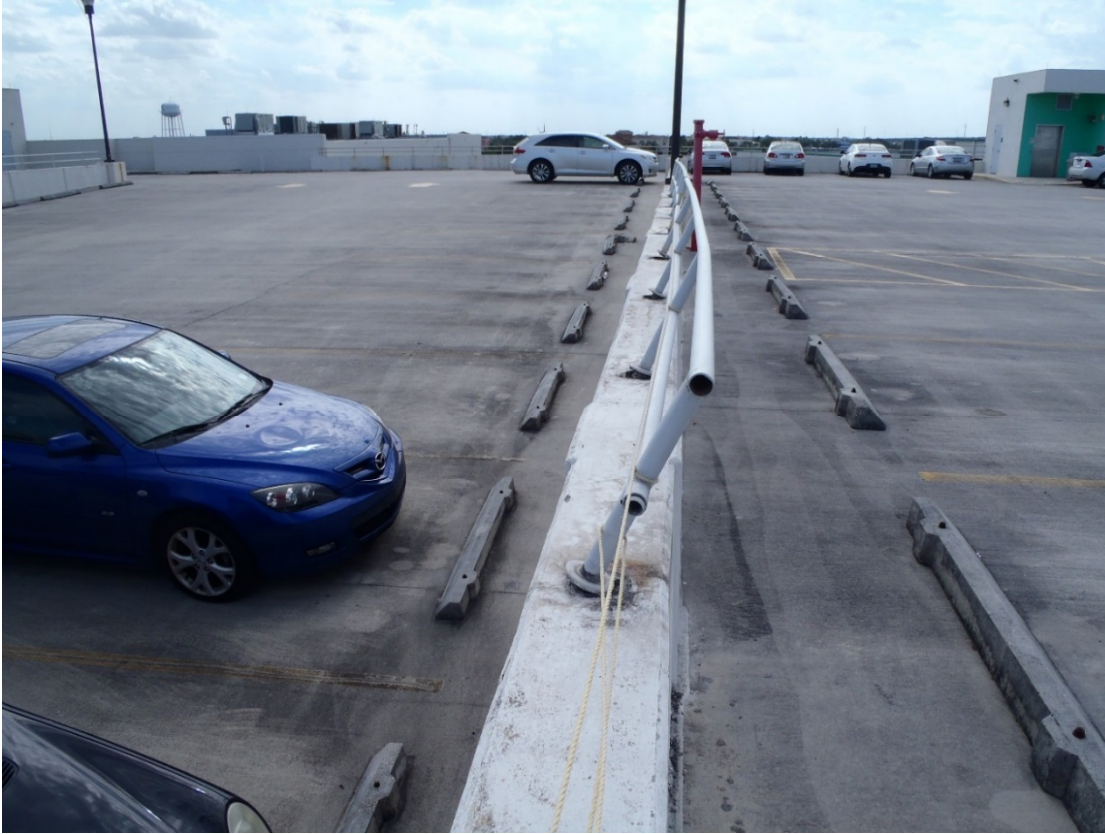
Failed Guardrail

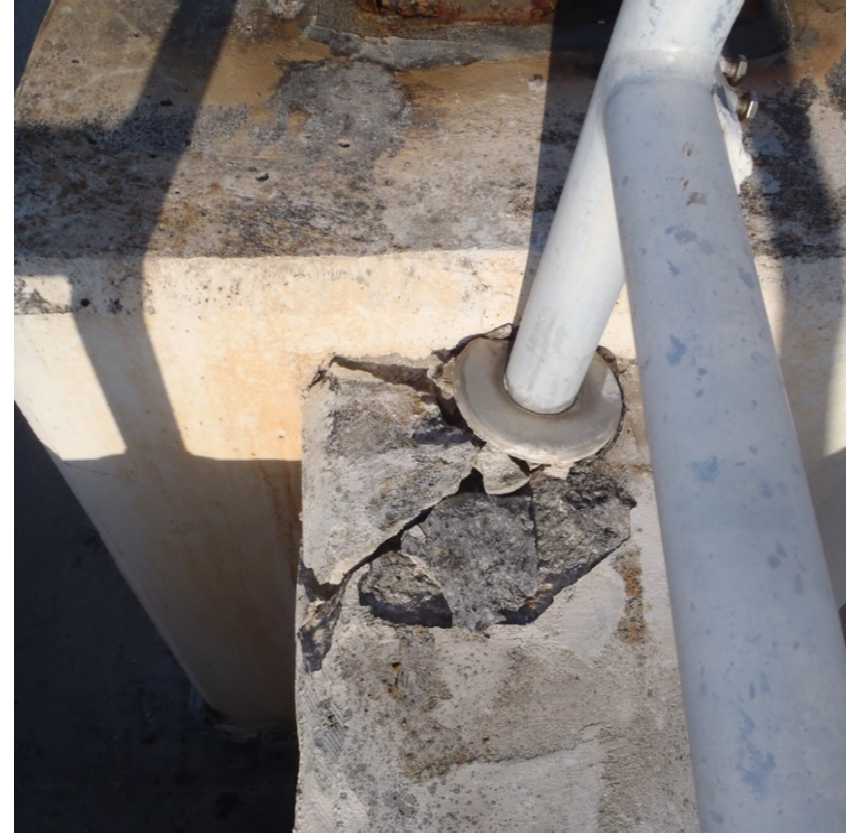
Broken End Connection

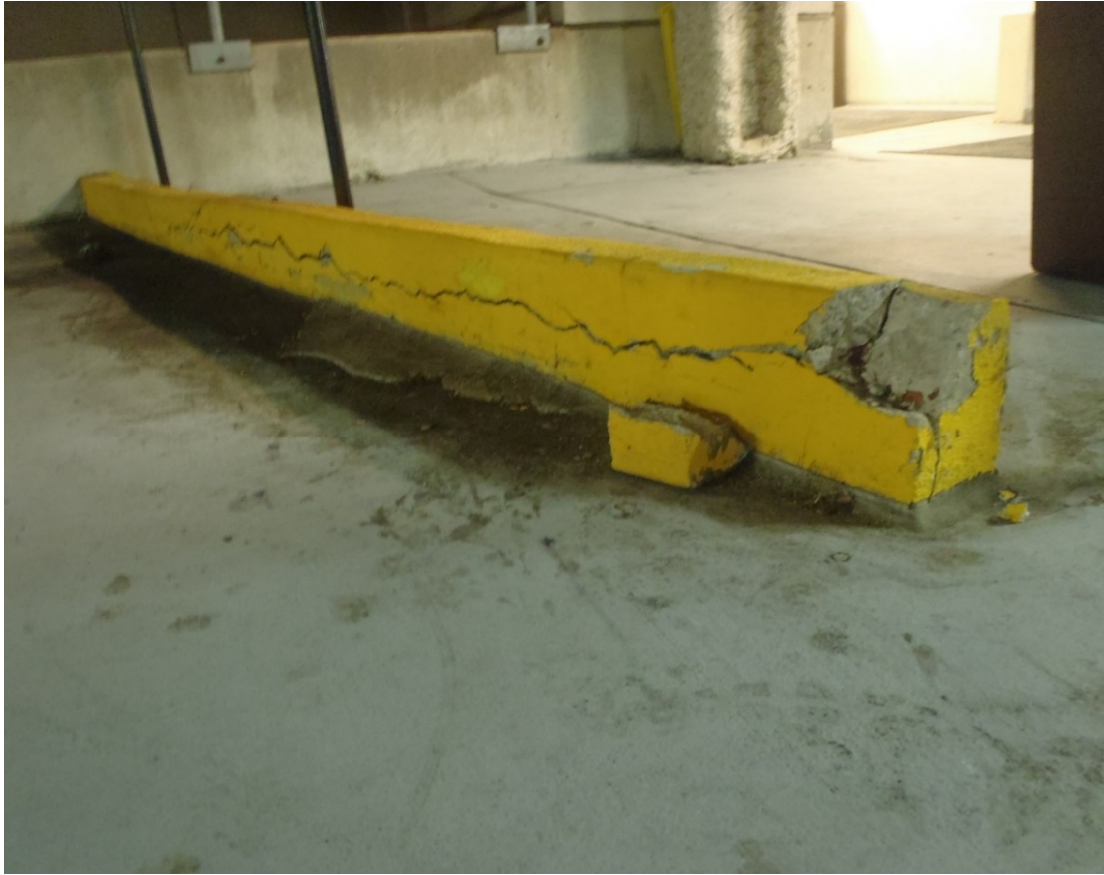
Broken Curb
