The Truth About Parking Structure Maintenance: How to Protect Your Investment

**CPMA Annual Conference & Tradeshow
Harrah's Cherokee Casino
Wednesday October 6, 2021**

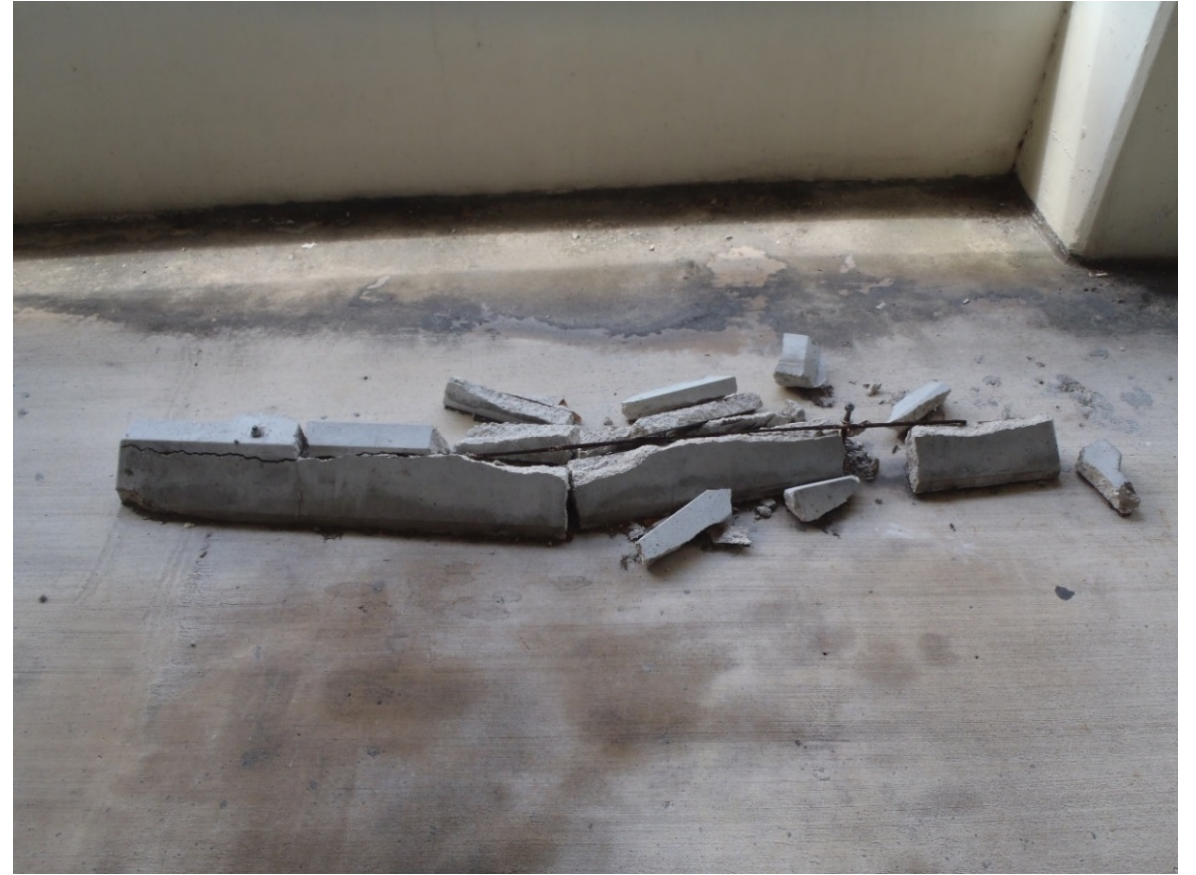
Broken Wheel Stop

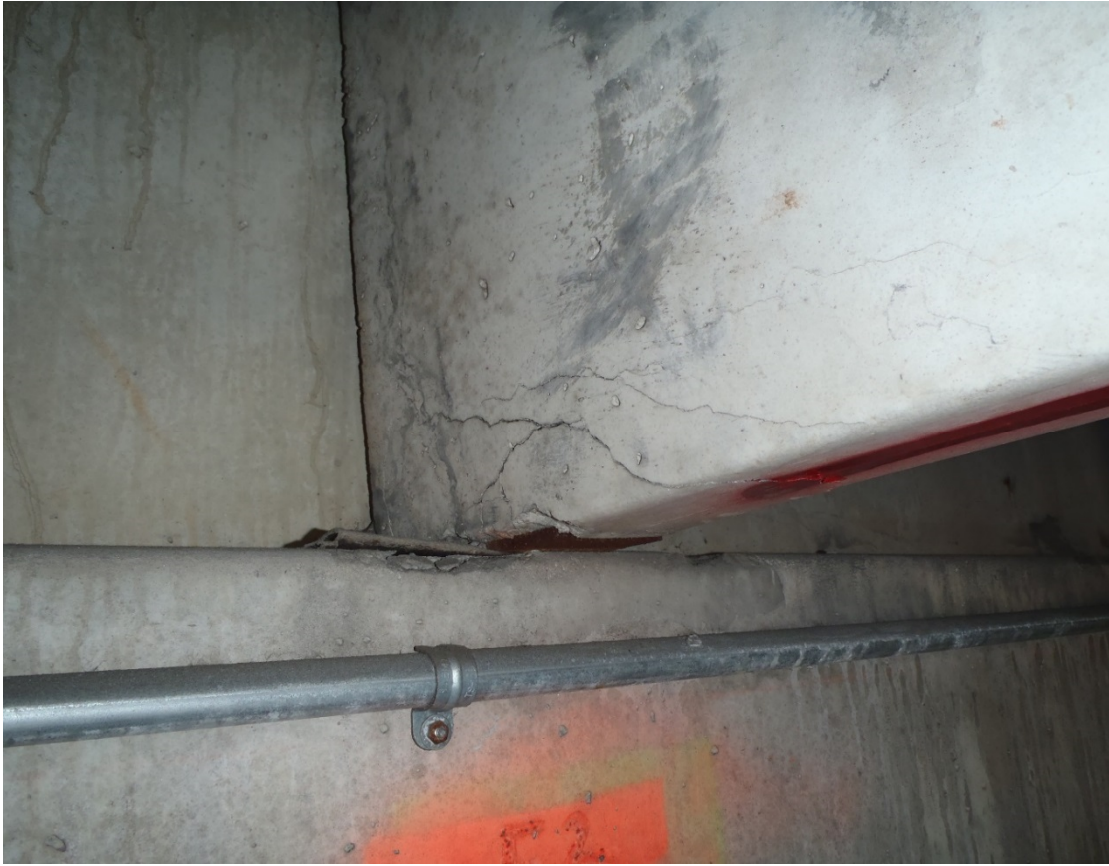
Precast Double Tee Seat

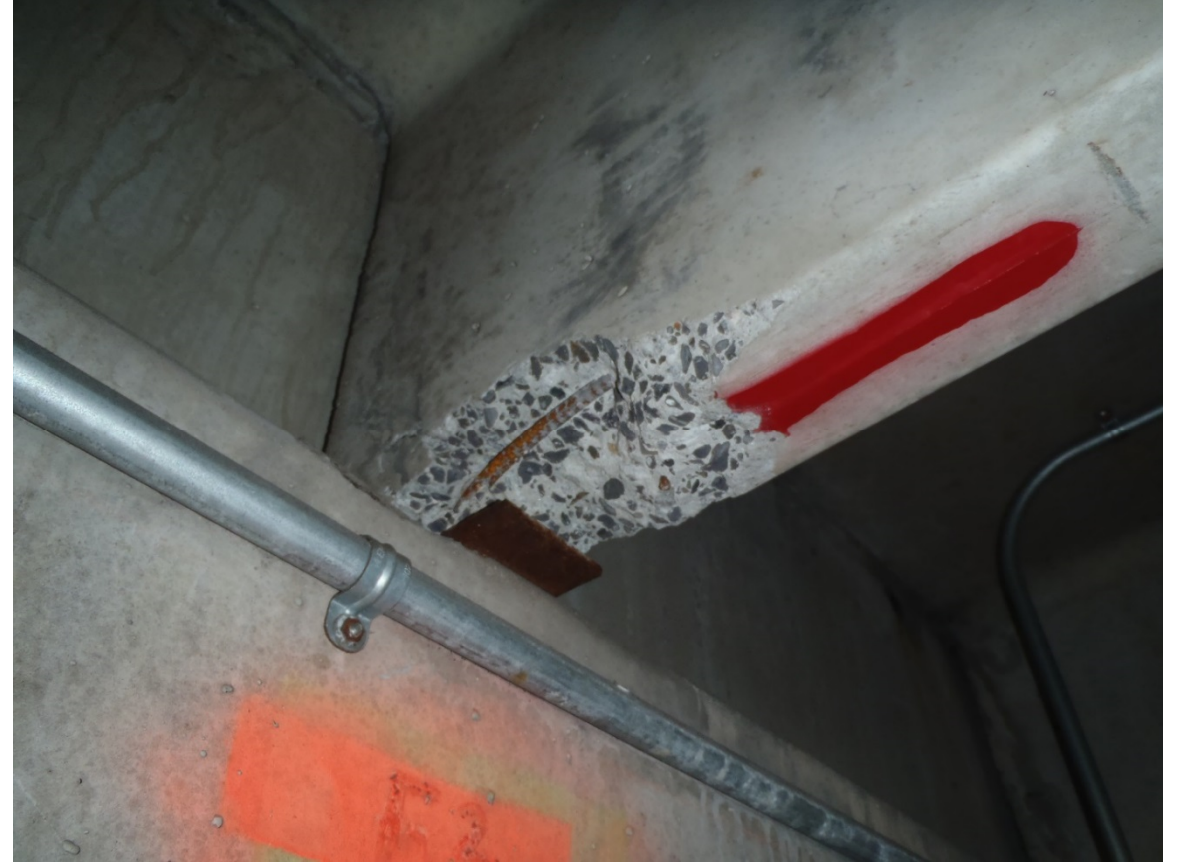
9 Months Later

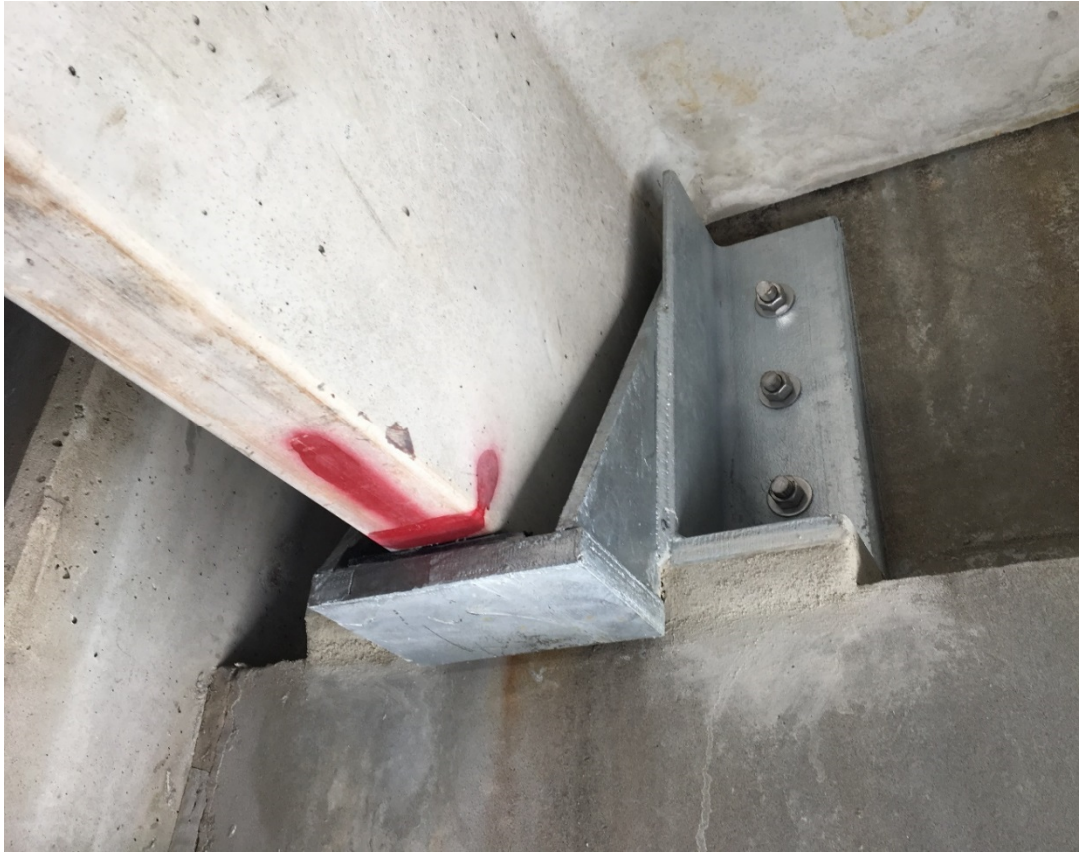
Steel Seat Repair

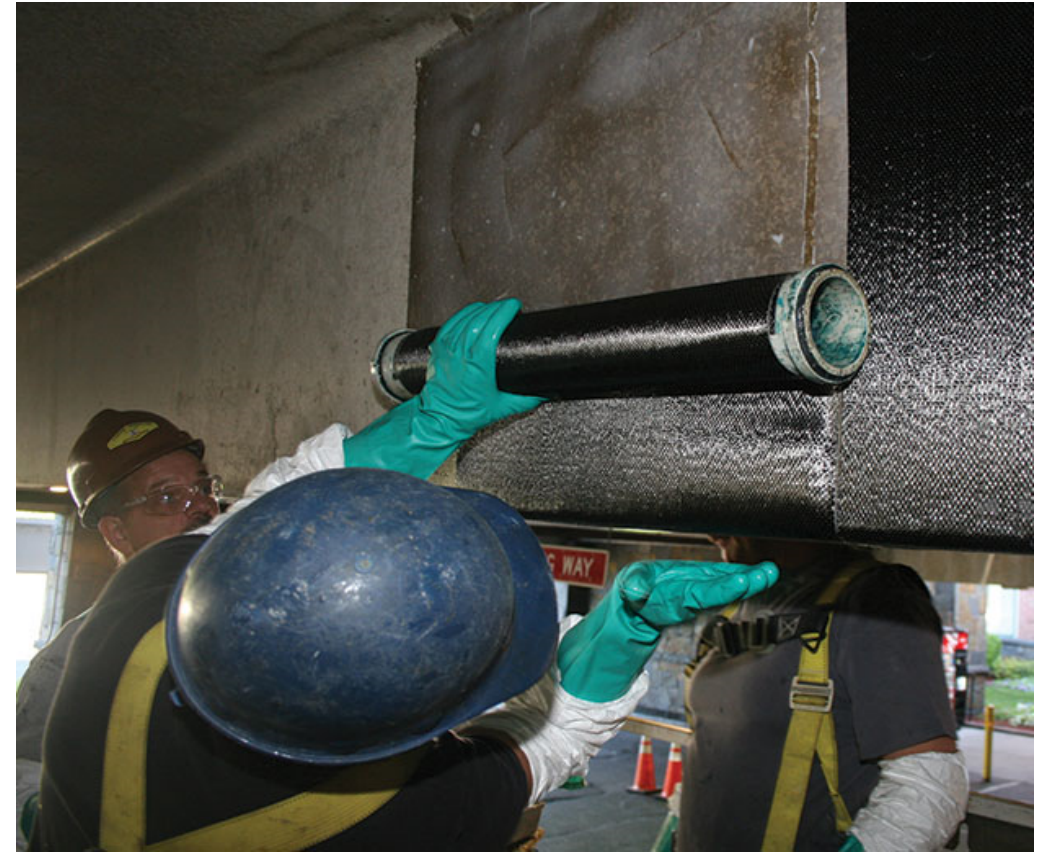
CFRP Repair

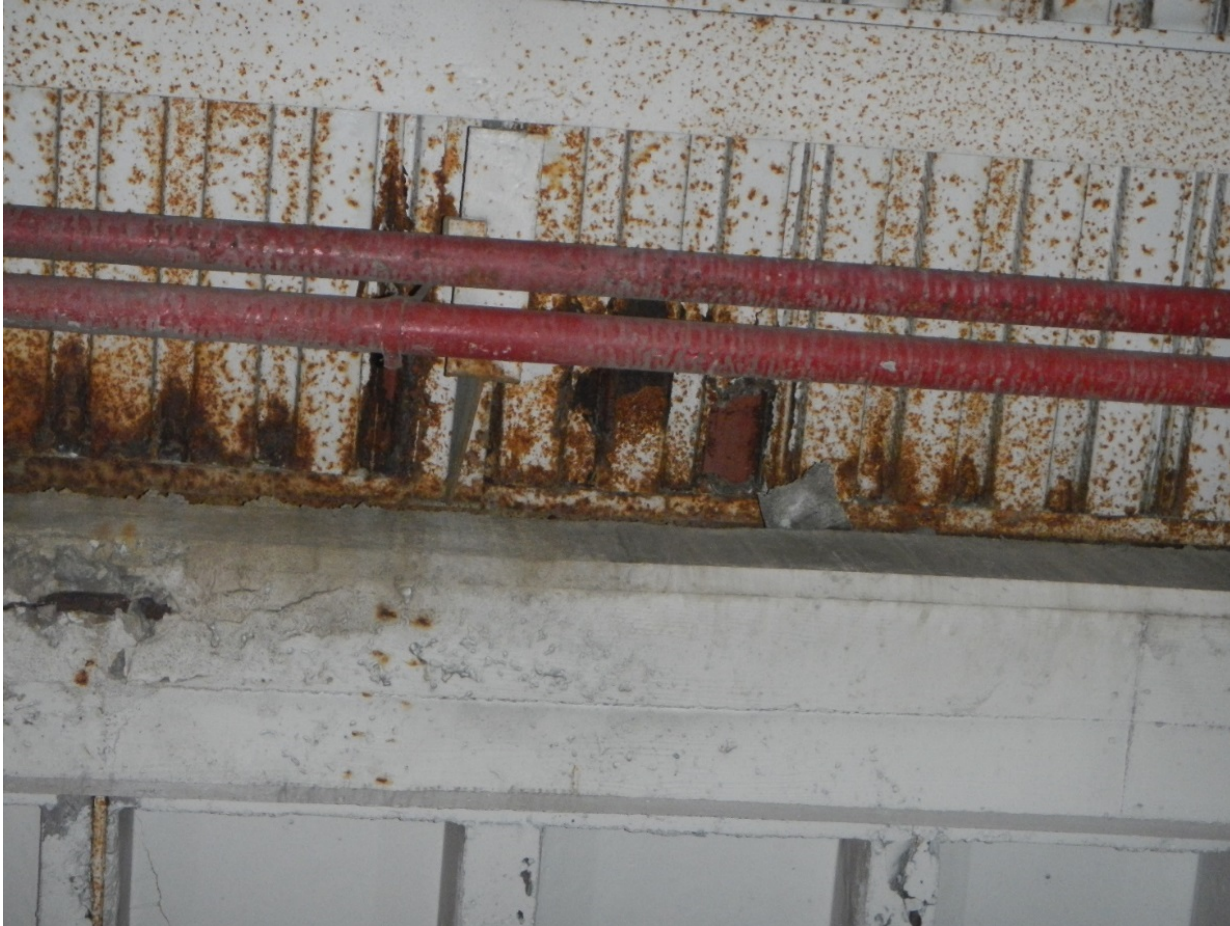
Structural Steel Corrosion

- **Steel Protection & Corrosion Issues**
- **Steel Deck Traps Moisture, Hides Degradation.**
