Building Structure Condition Assessment

How to Avoid Catastrophe

IFMA World Workplace 2022

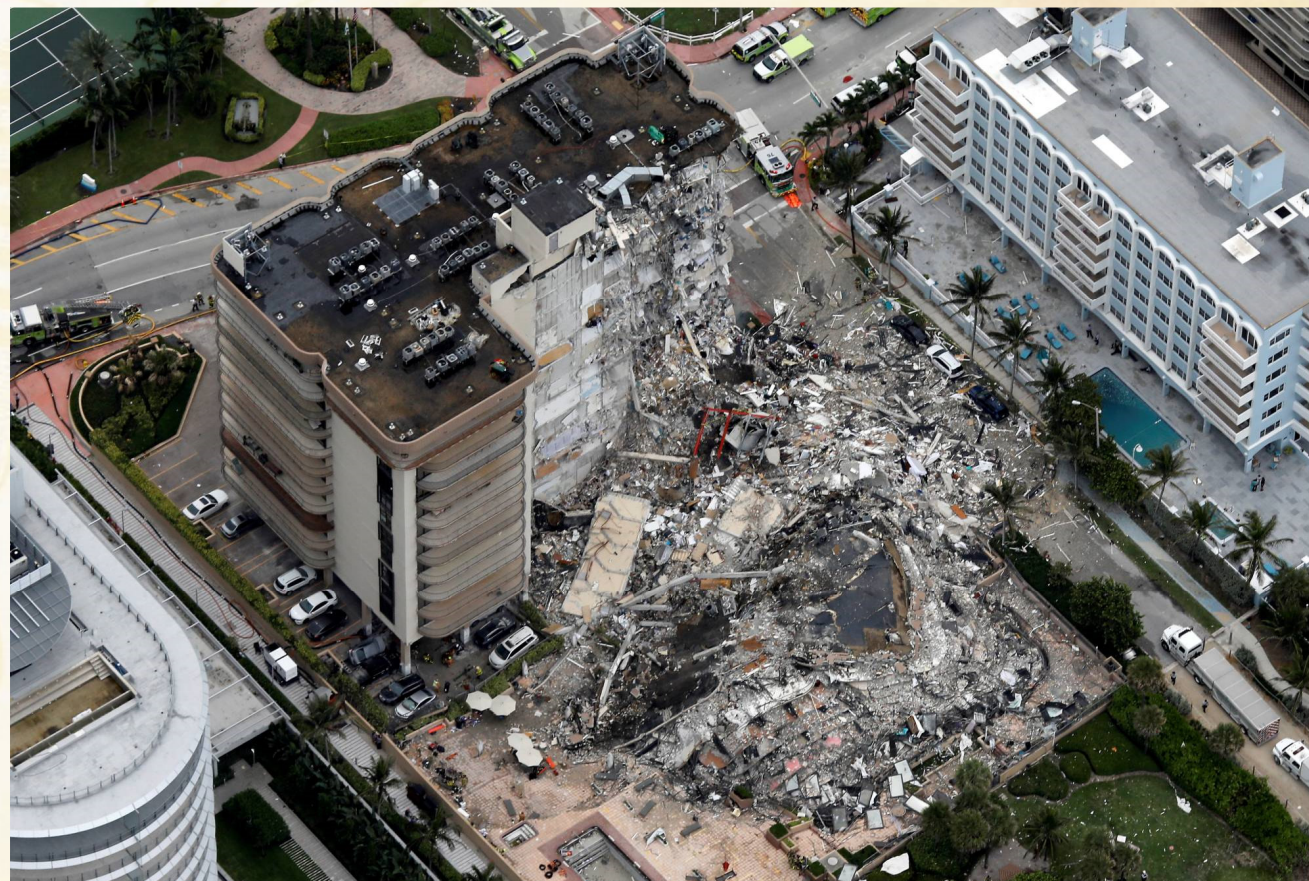
Champlain Towers Collapse

- Built 1981
- 12 Story, 136 Units
- Cast-In-Place Concrete
- Plaza Slab
- Below Grade Level Parking Garage
- 2018 Report
- 40 Year Recertification Underway

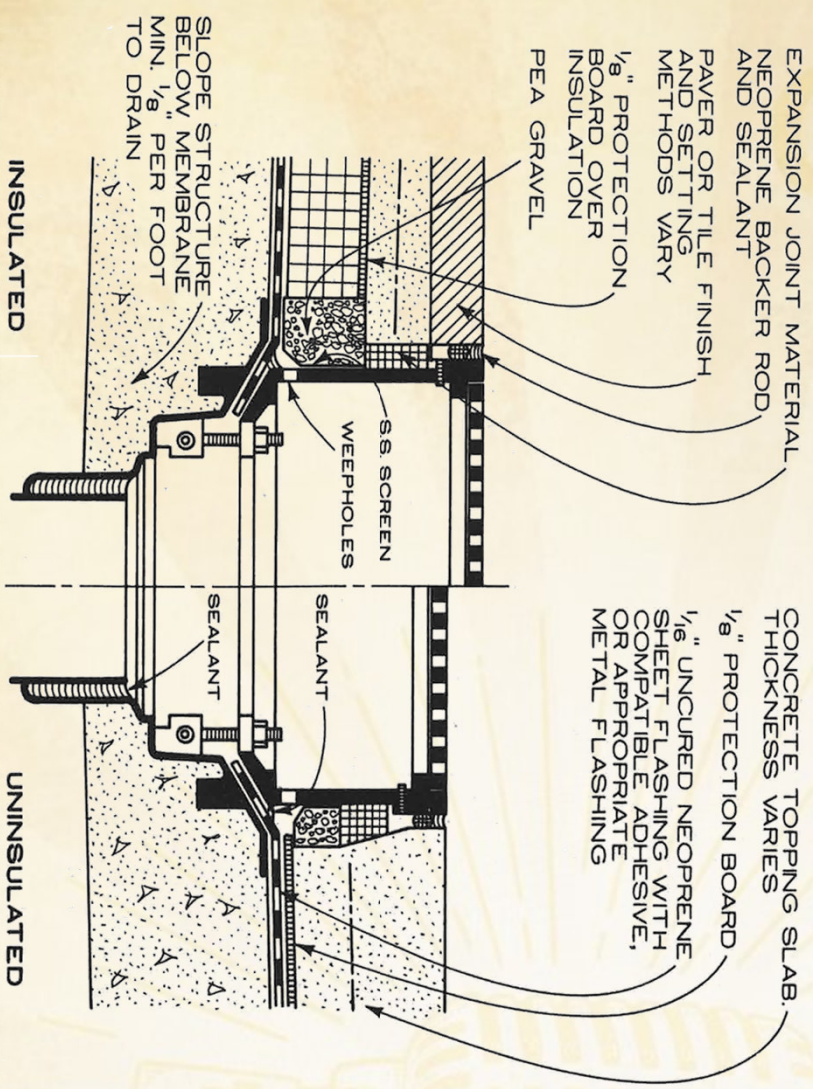
Ref.: 1981 Architectural Graphics Standards

Plaza Slabs – Protected Membranes

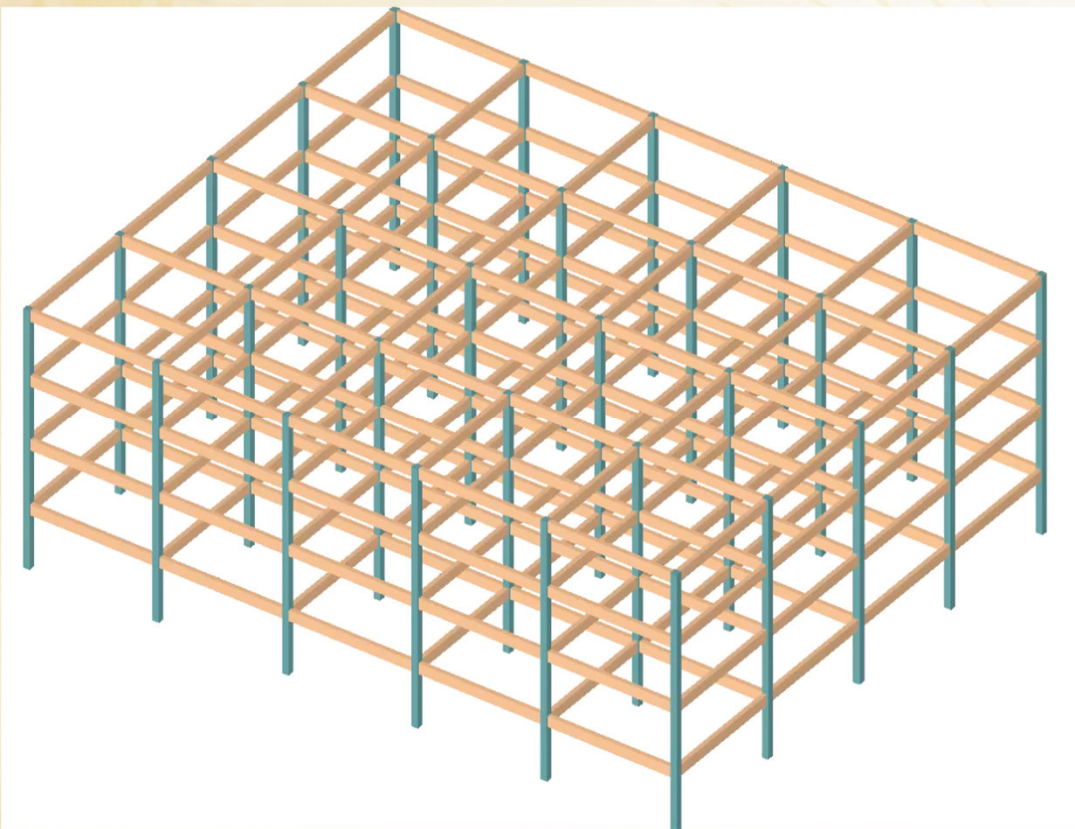
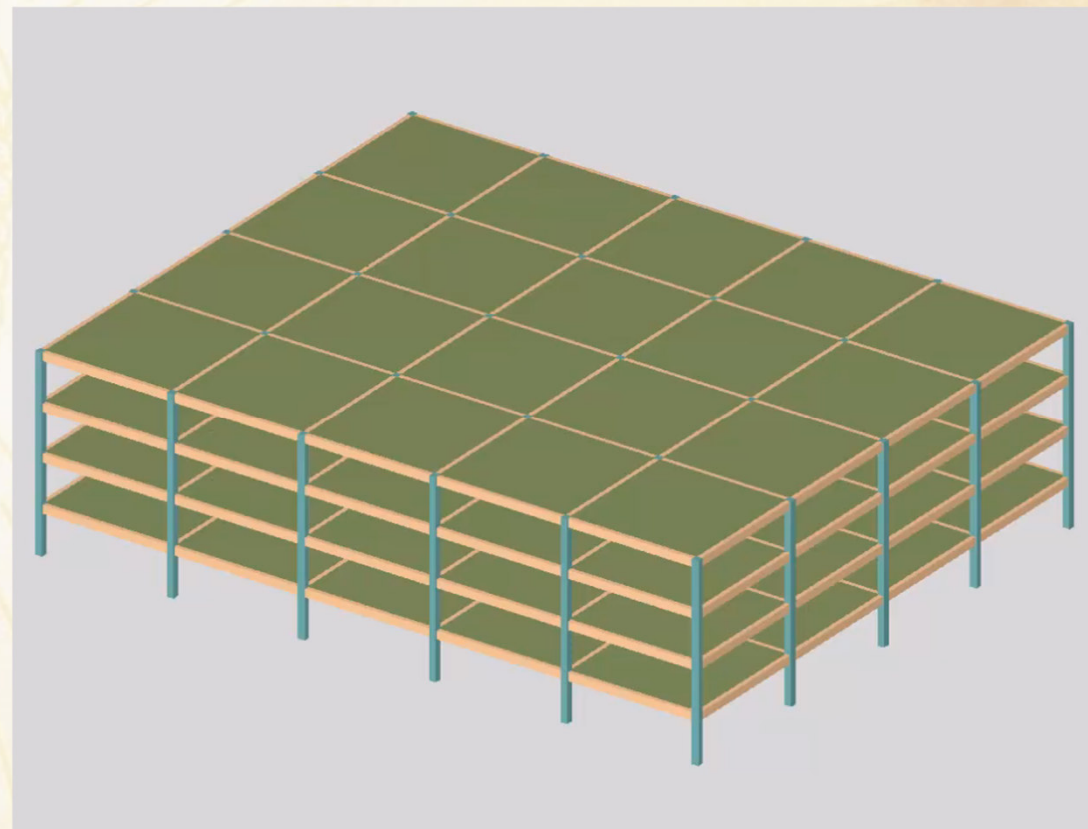
Building Structure – Progressive Collapse

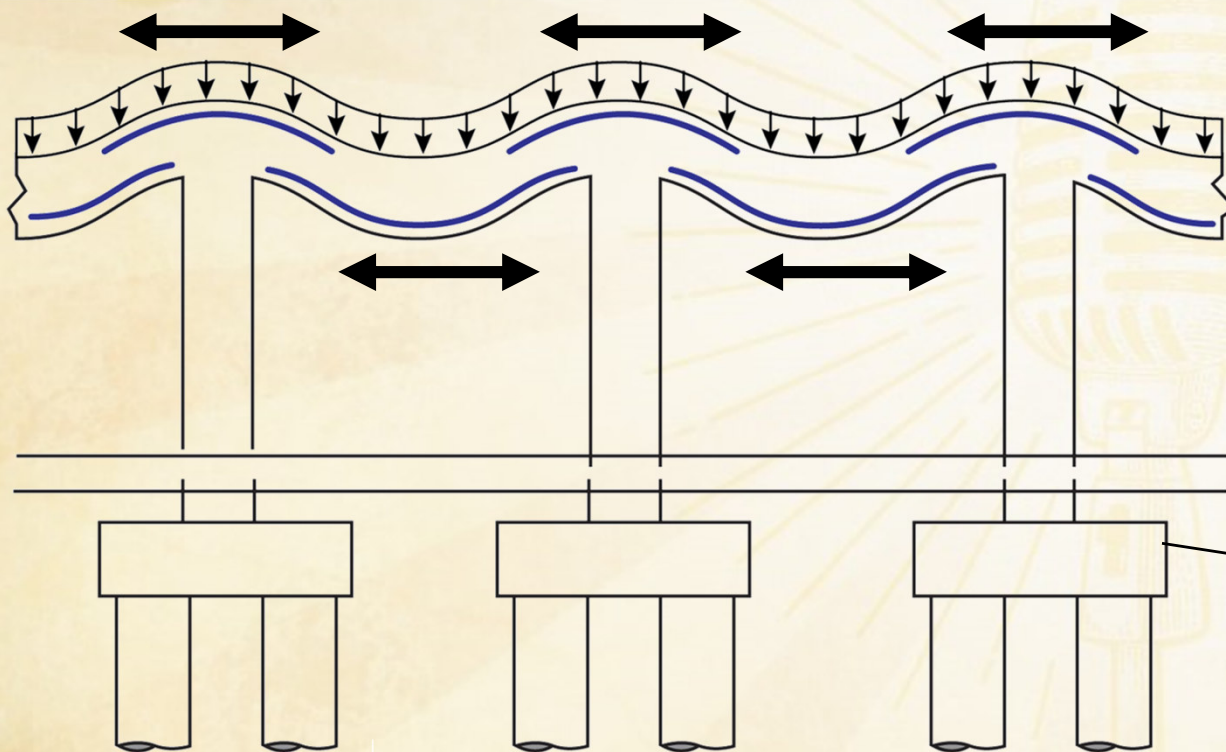
Reinforced Concrete – Multi-Span Beam/Slab

- Tension
 - Top over Columns
 - Bottom between Columns

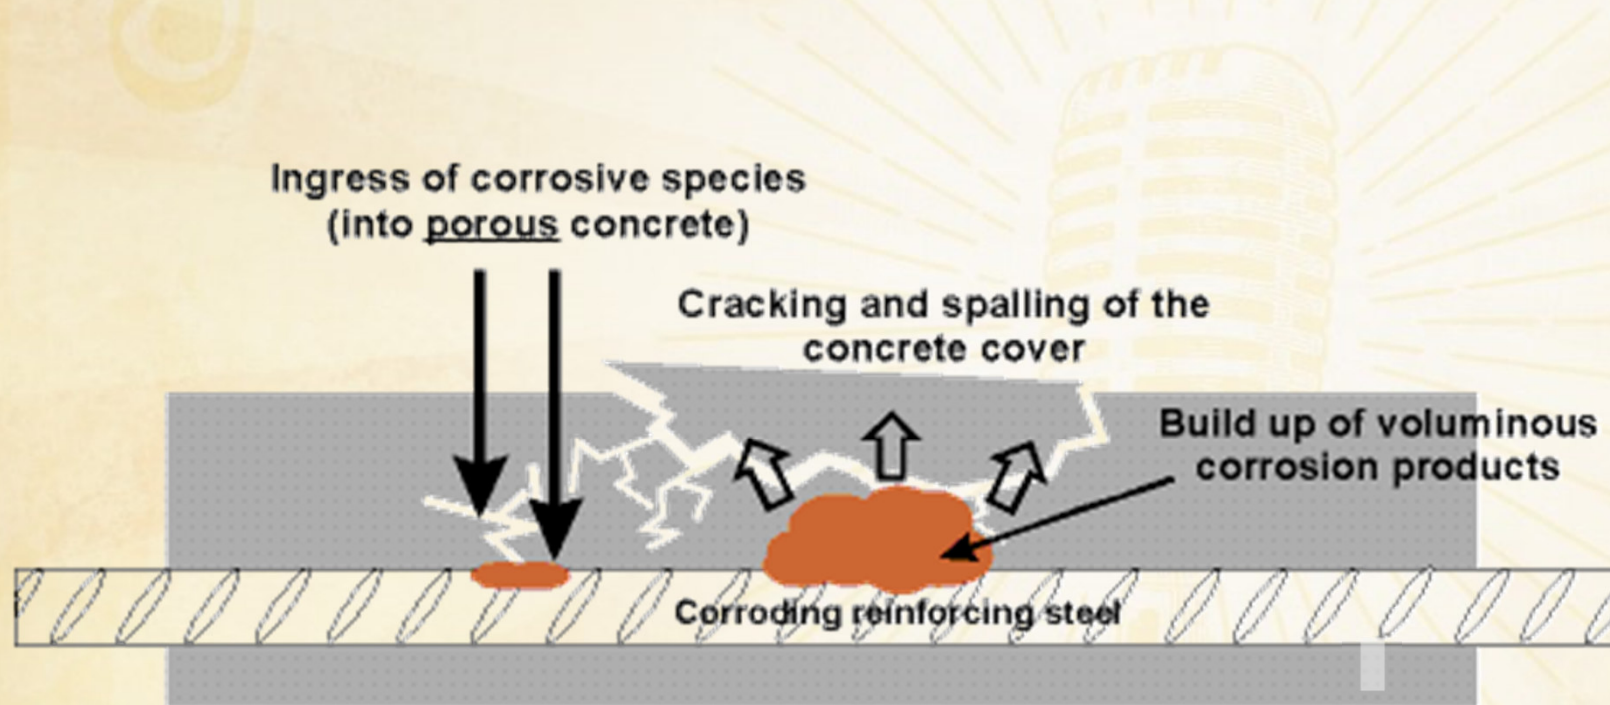
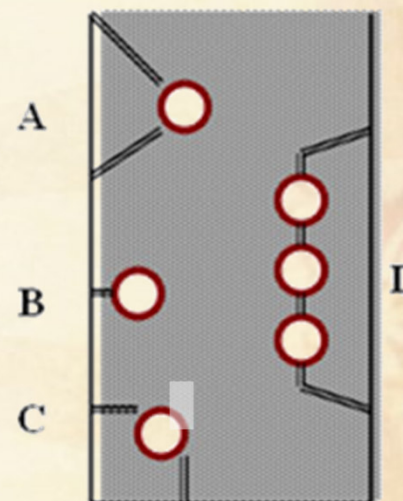
Reinforced Concrete - Corrosion

- A: Spall
- B: Crack
- C: Corner Spall
- D: Delamination

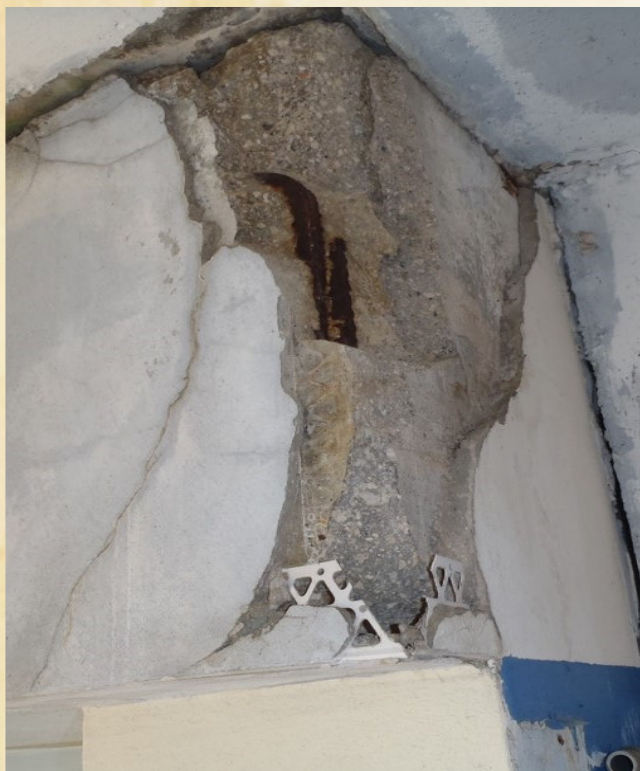
Spall

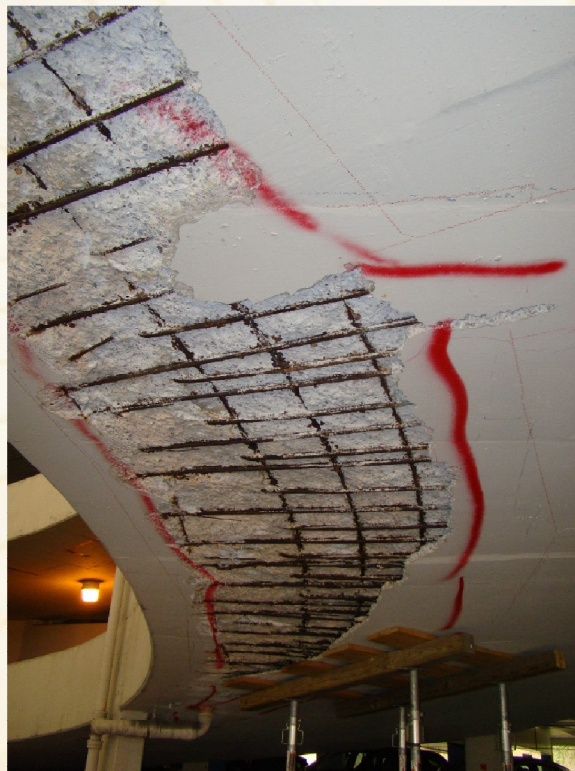
Delamination

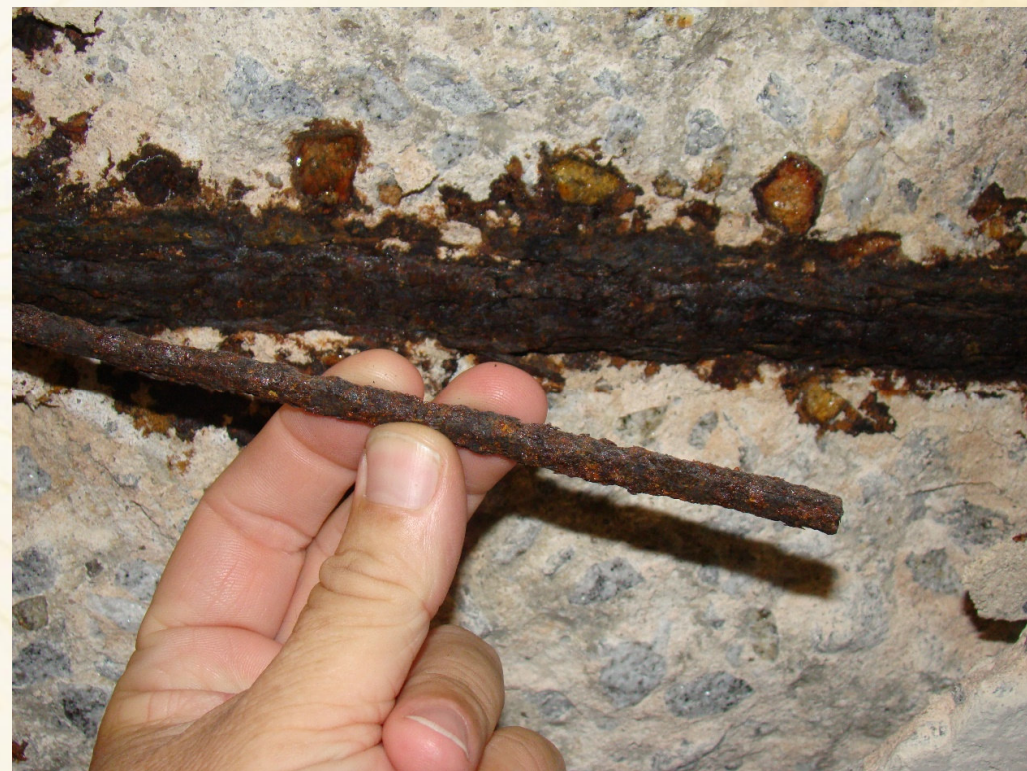
Section Loss

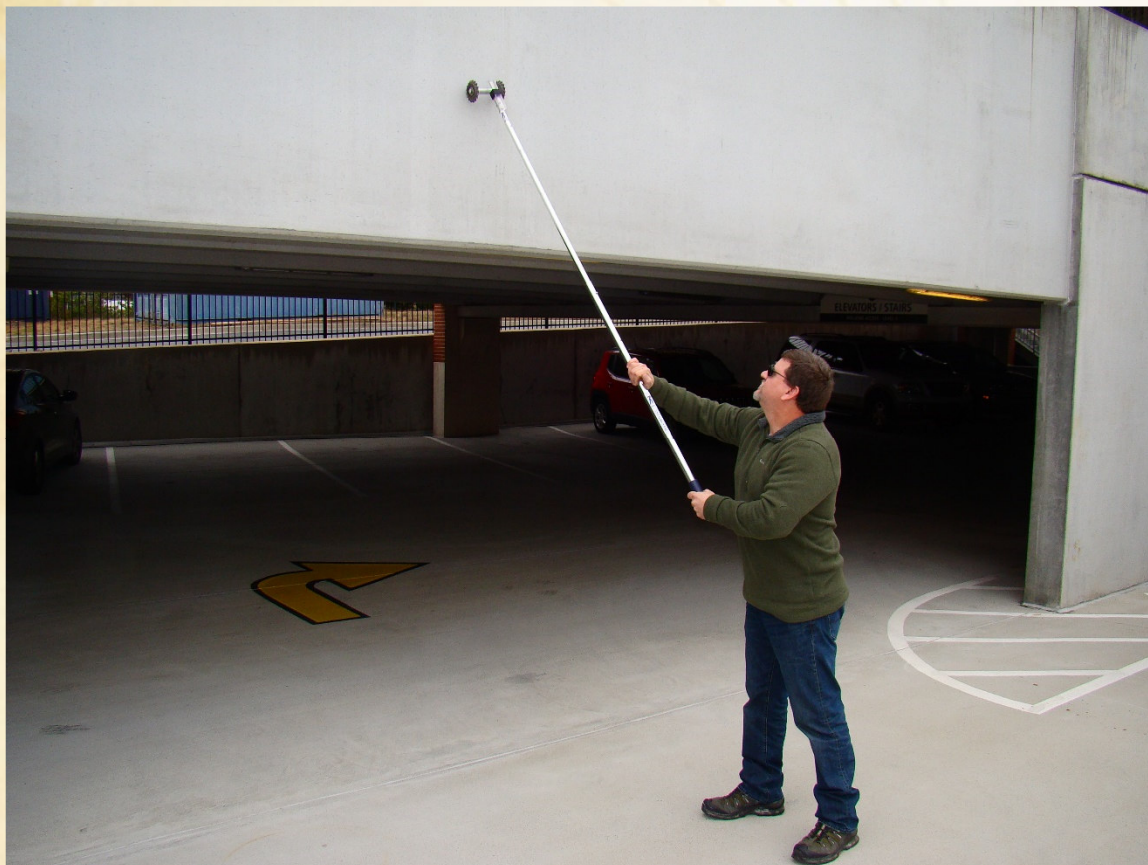
Reinforced Concrete - Sounding

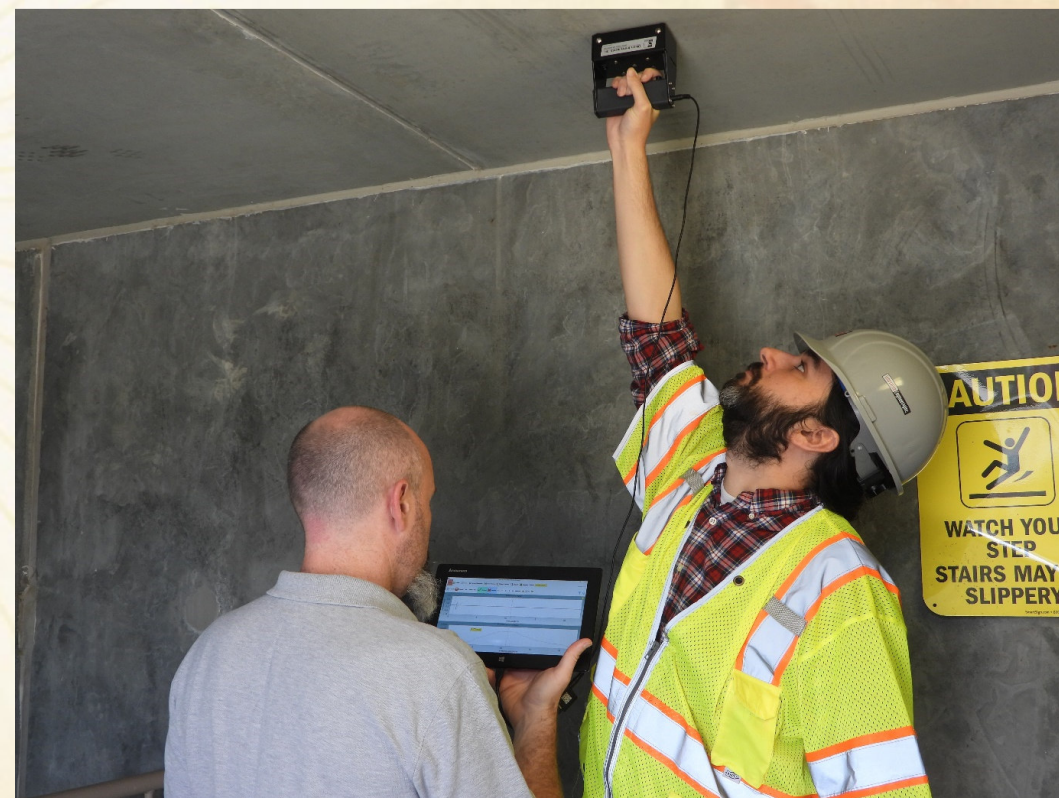
Reinforced Concrete – Impulse Echo

Plaza Slab

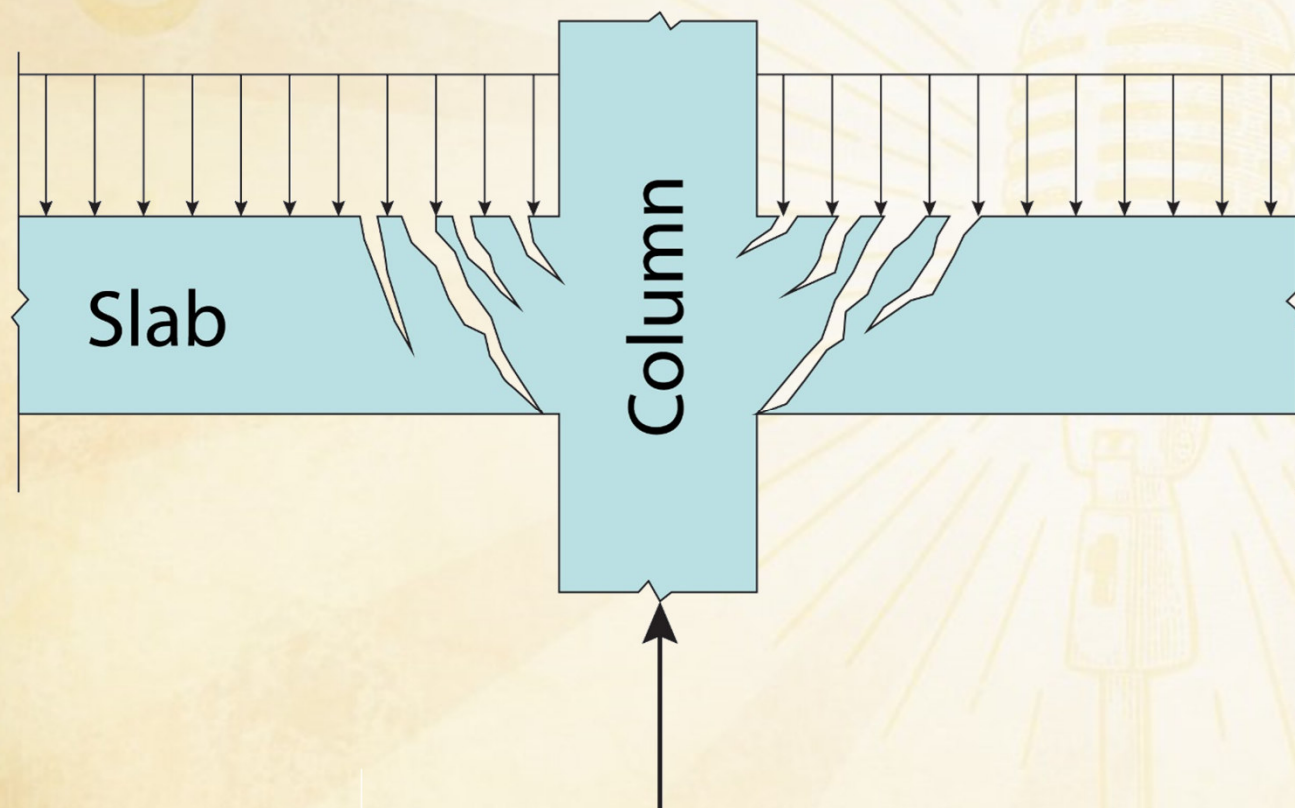
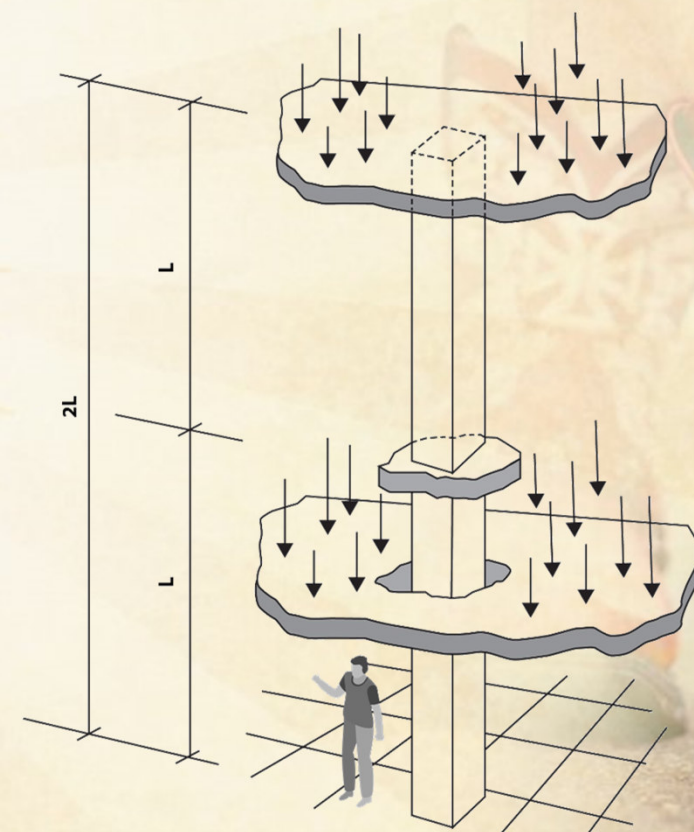
Champlain Towers Collapse – Punching Shear

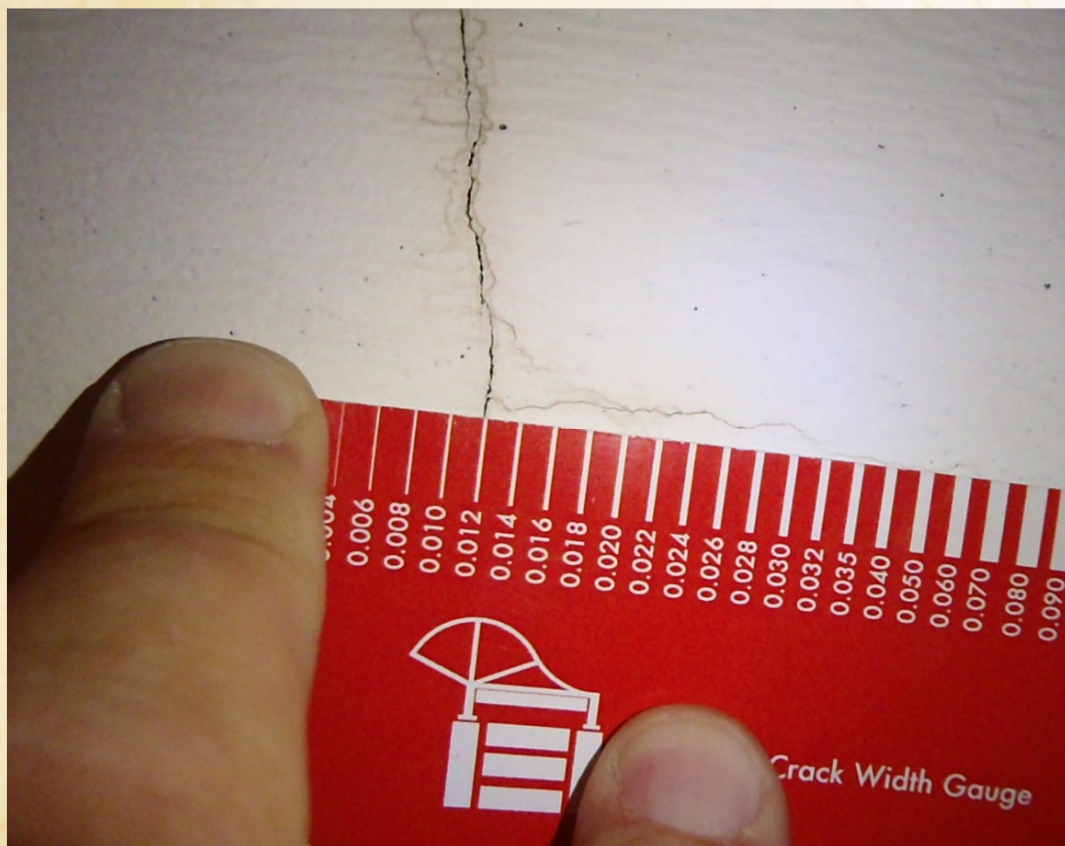
$.013'' \leq \text{Cracks} < .035''$

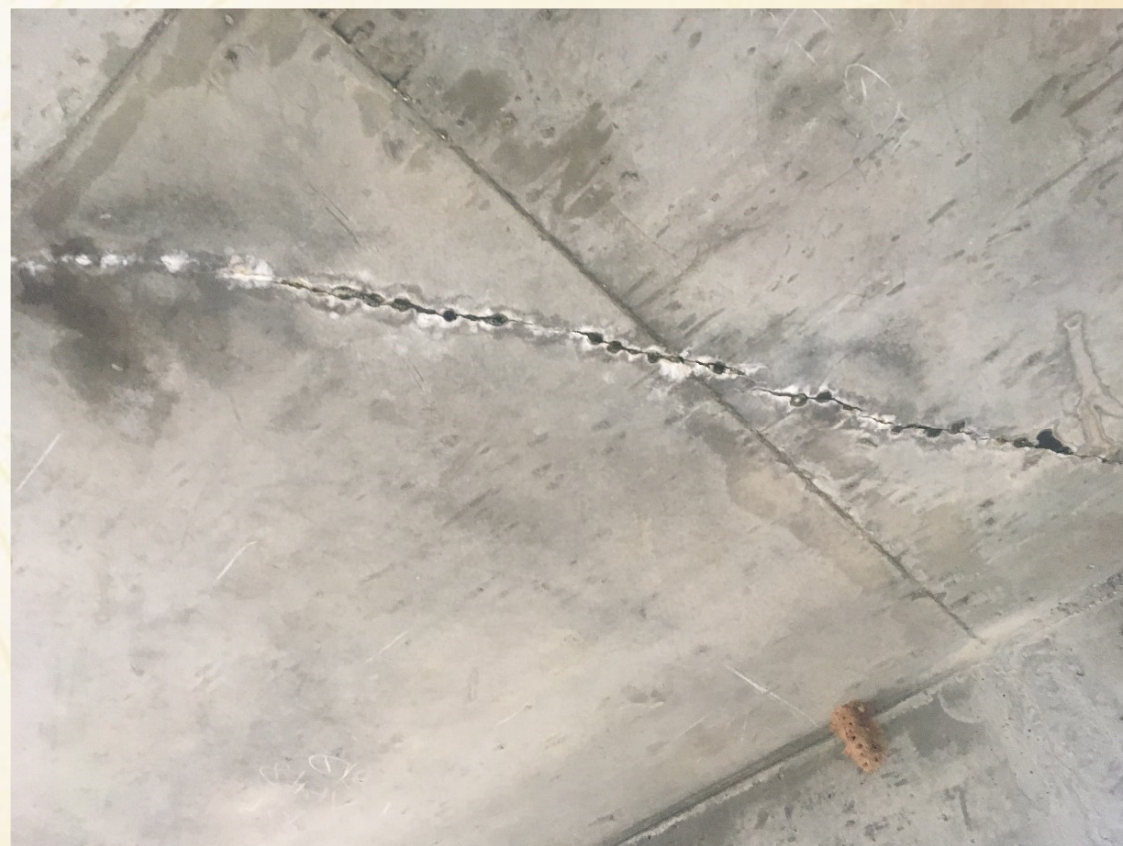
Cracks that Leak $< .035''$

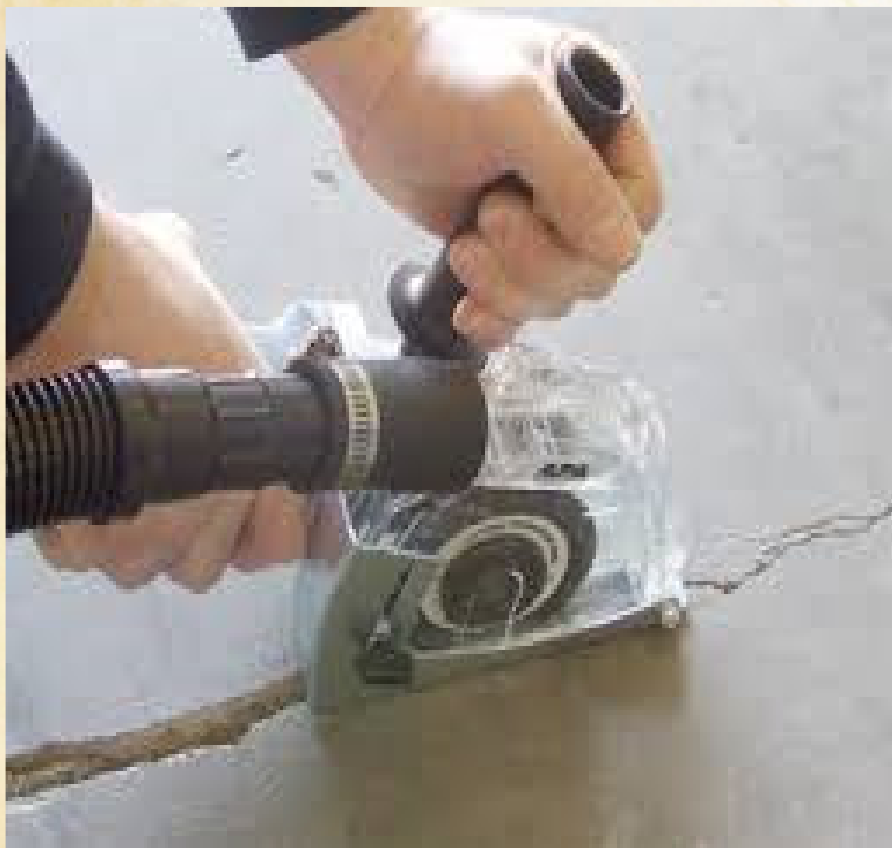
Reinforced Concrete – Crack Repair (Route & Seal)

Crack Chasing

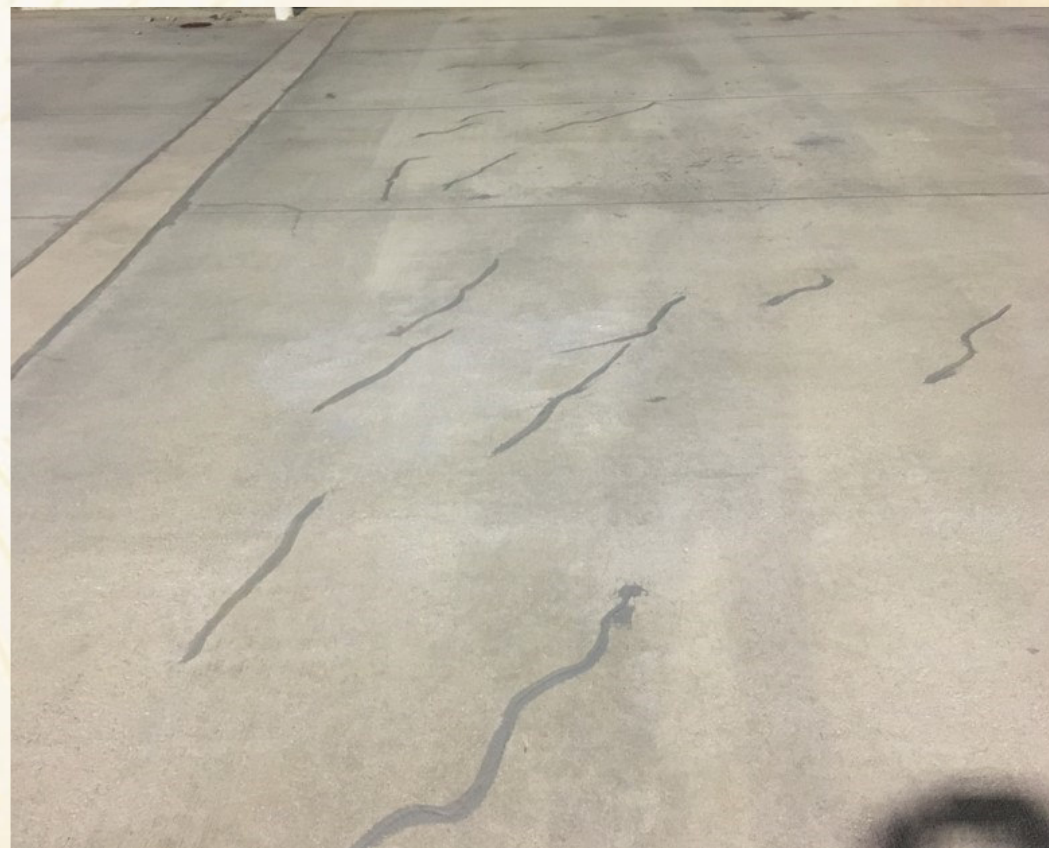
Crack Sealant

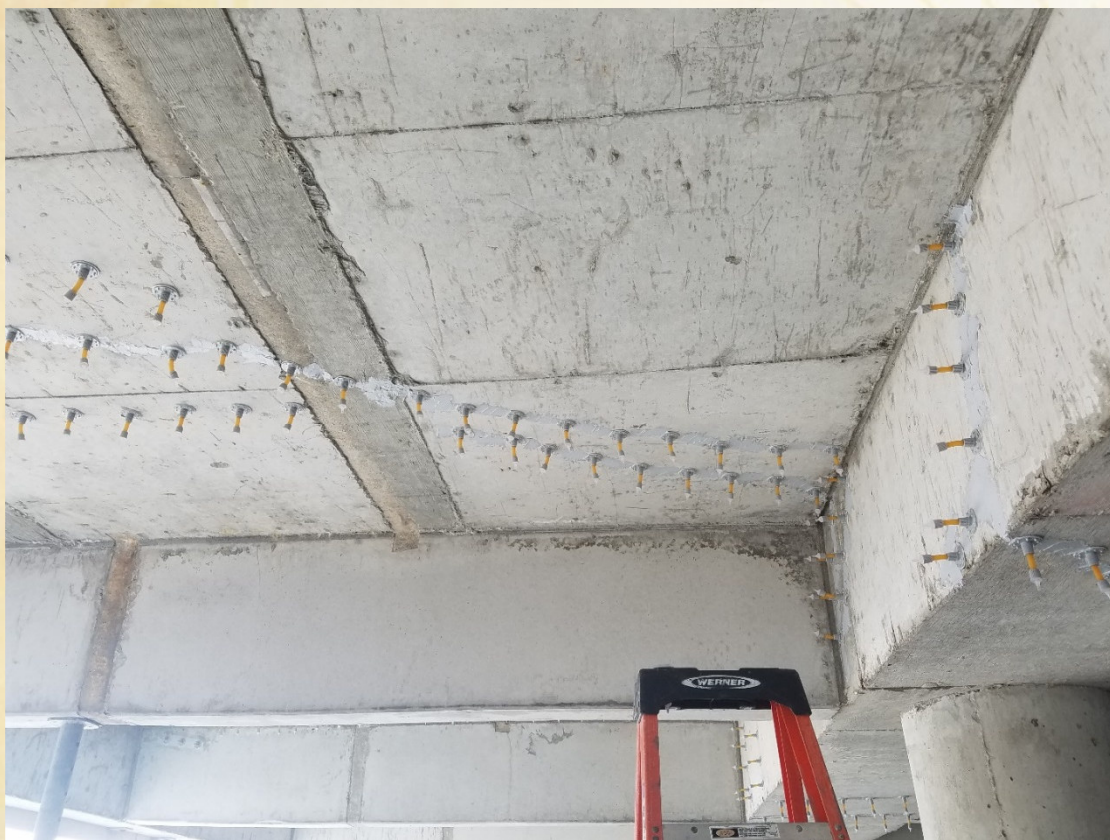
Reinforced Concrete – Crack Repair (Epoxy Injection)

Cracks \geq .035"

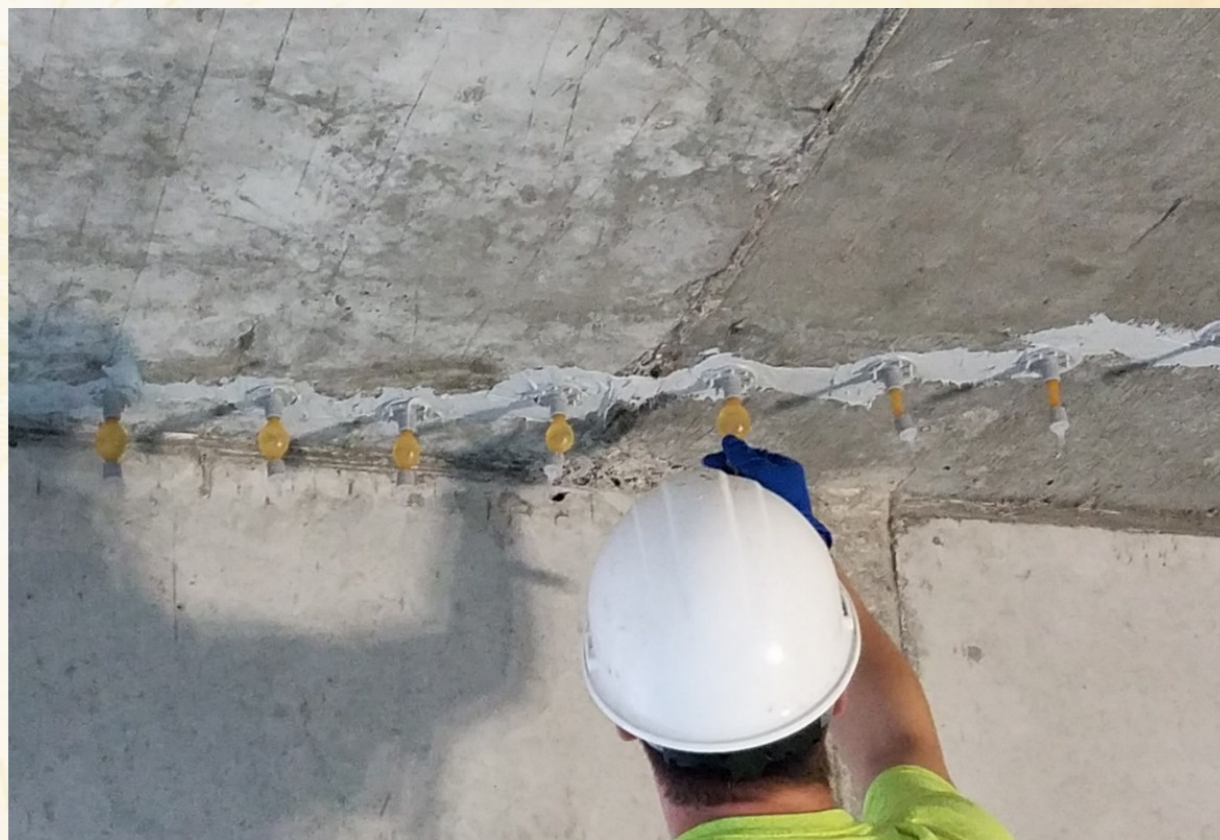
Inflatable Injection Port

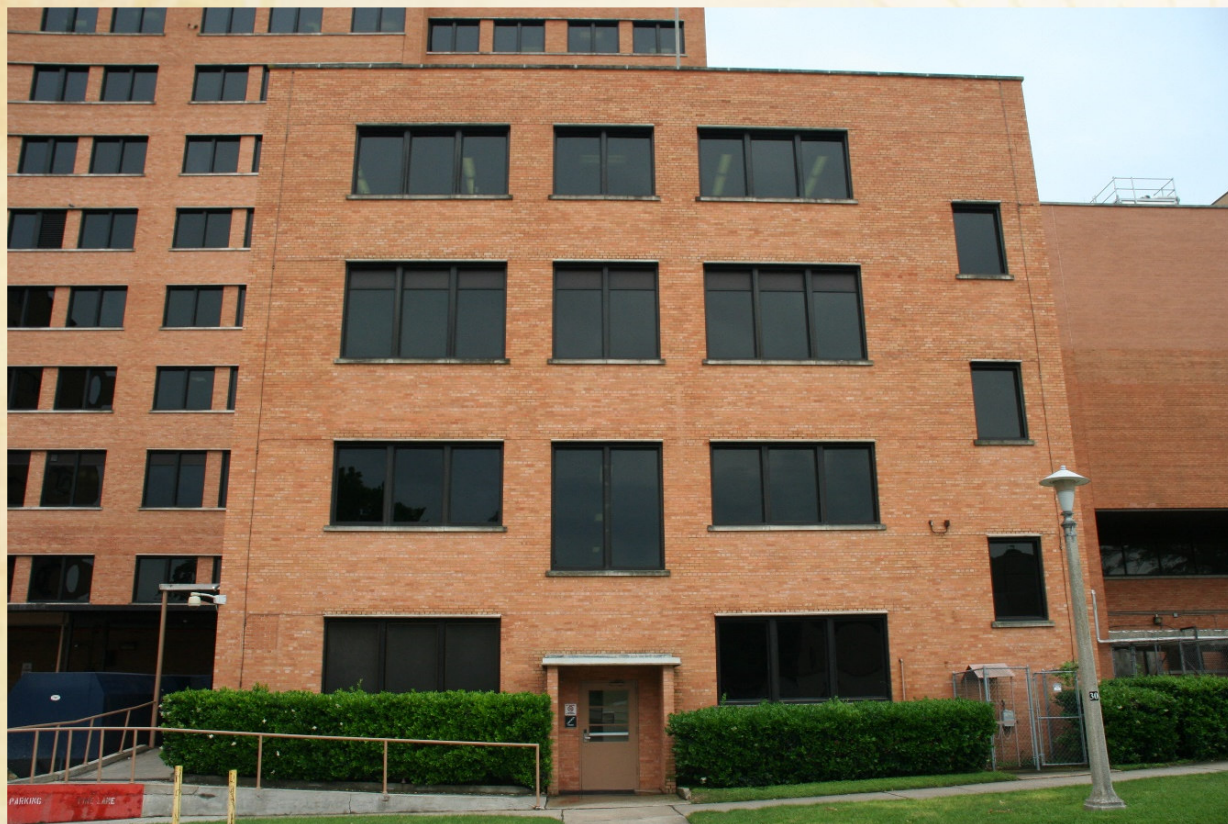
No Expansion Joints

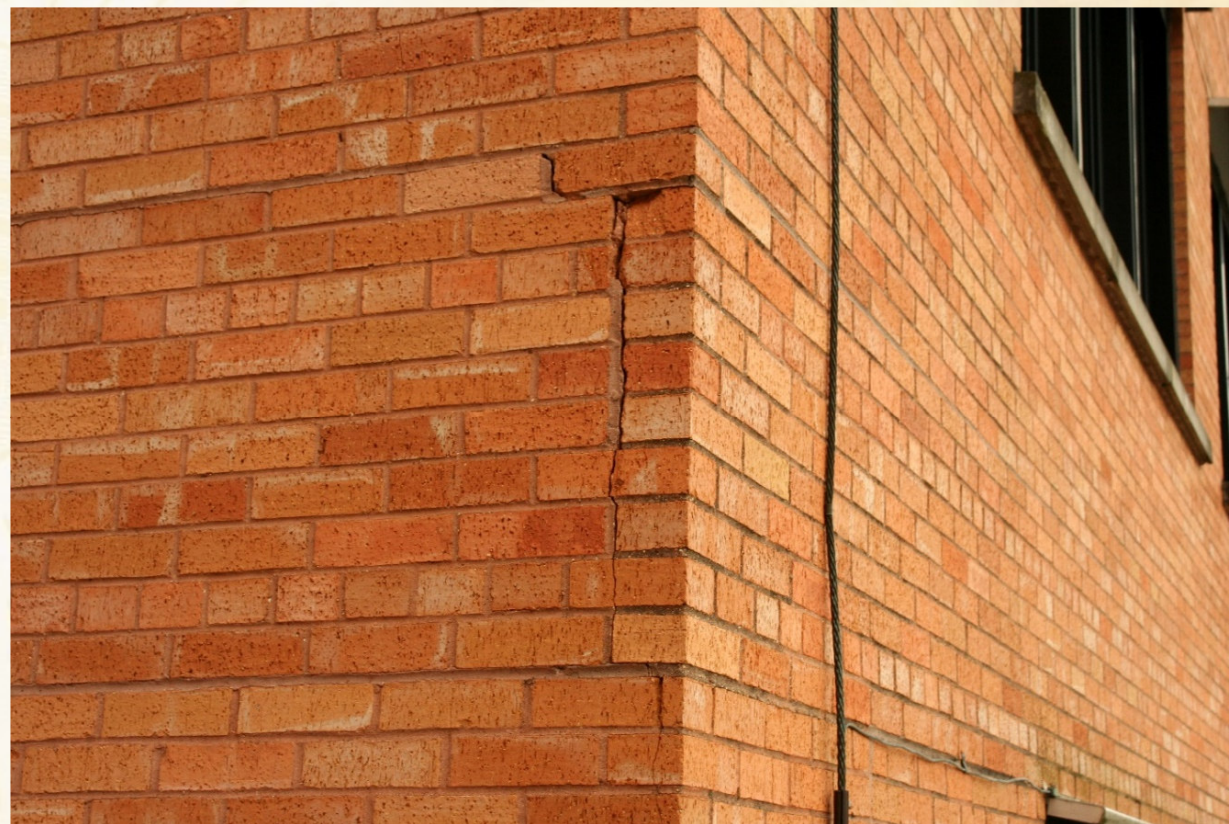
Creates Hinge at Corner

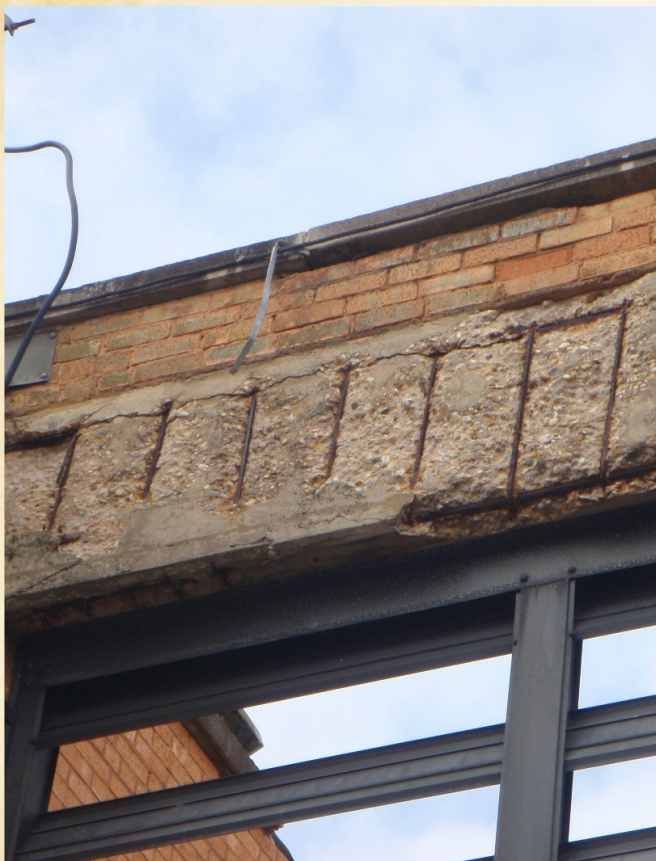
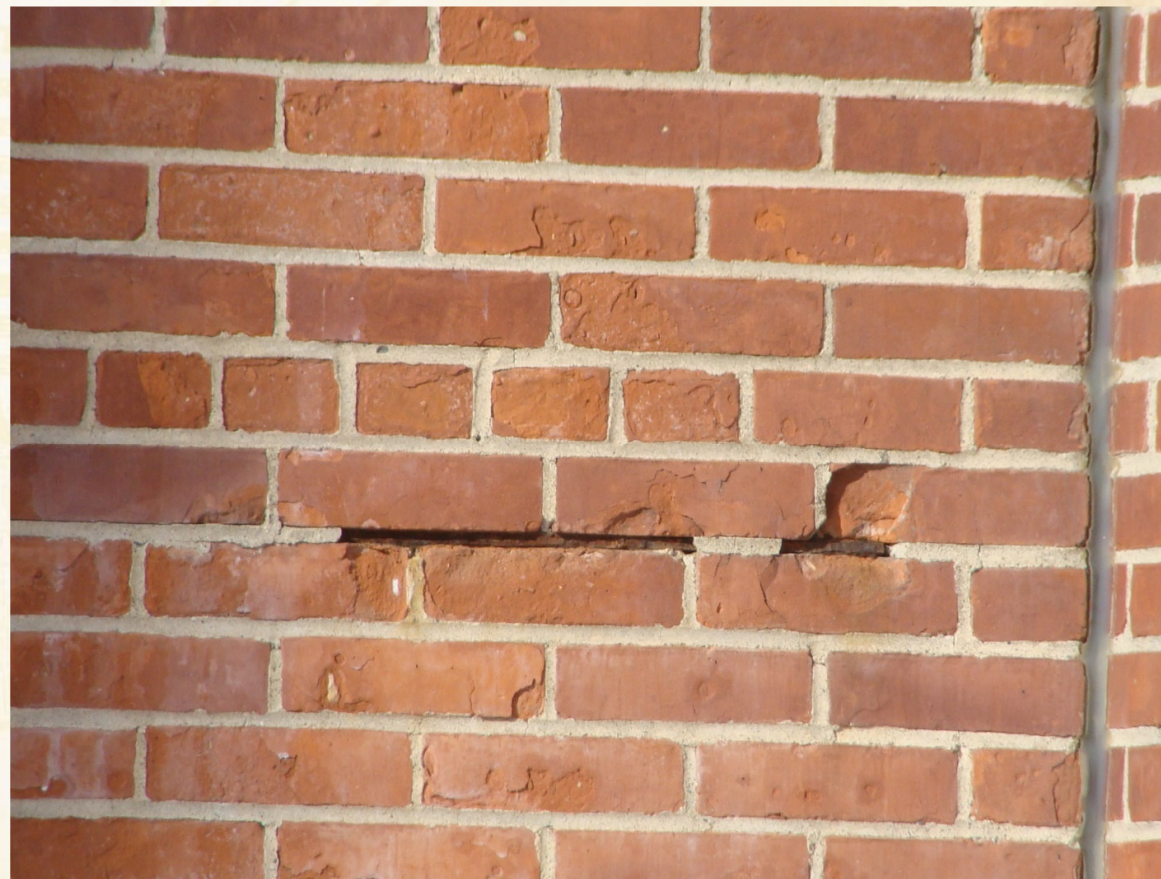
Façade – Corrosion Expansion

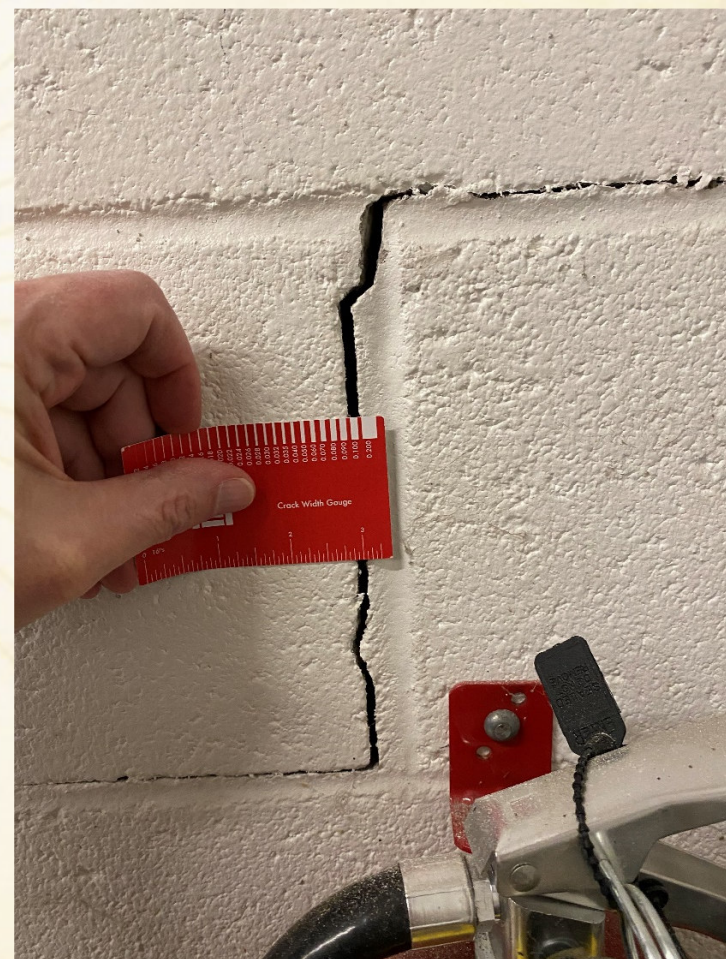
Masonry – Creep & Settlement

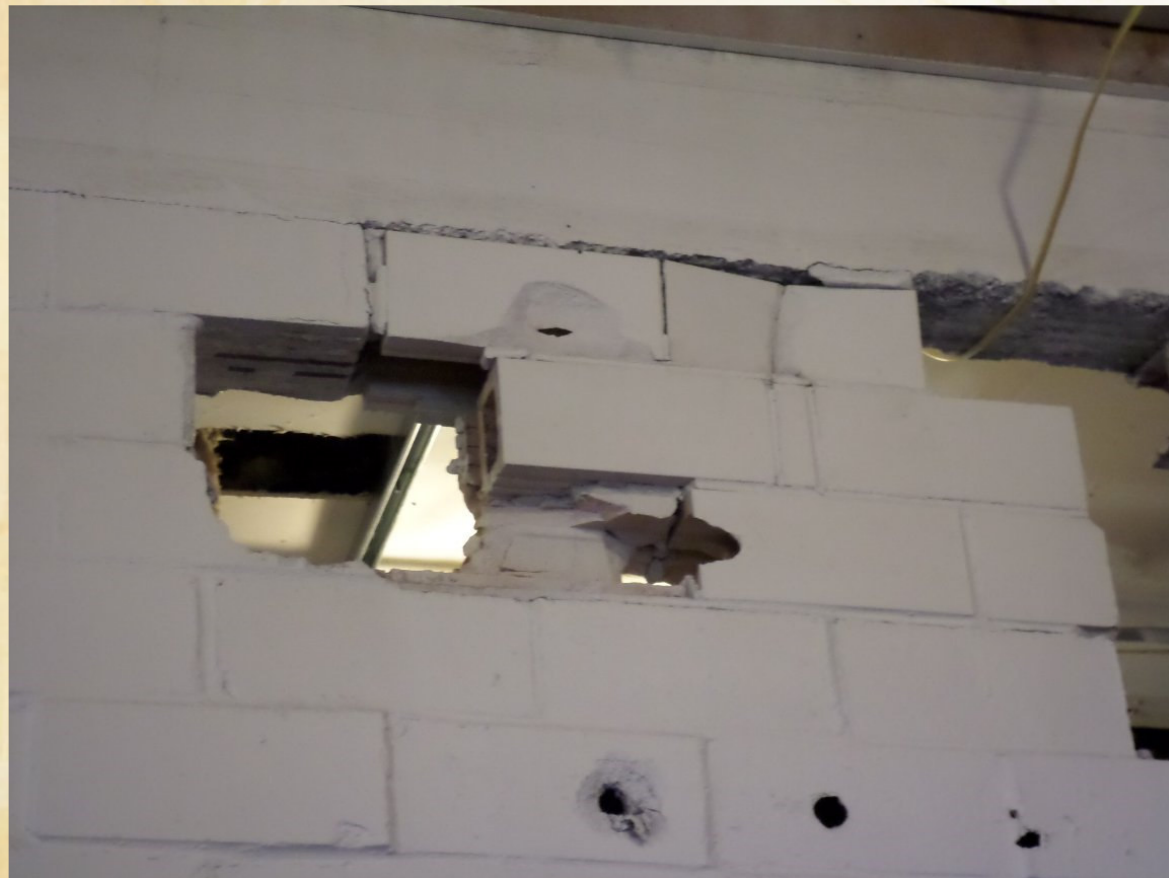
Masonry – Unauthorized Openings

- Penetrations:
 - Through Load Bearing Walls
