Building Structure Condition Assessment

How to Avoid Catastrophe

IFMA World Workplace 2022

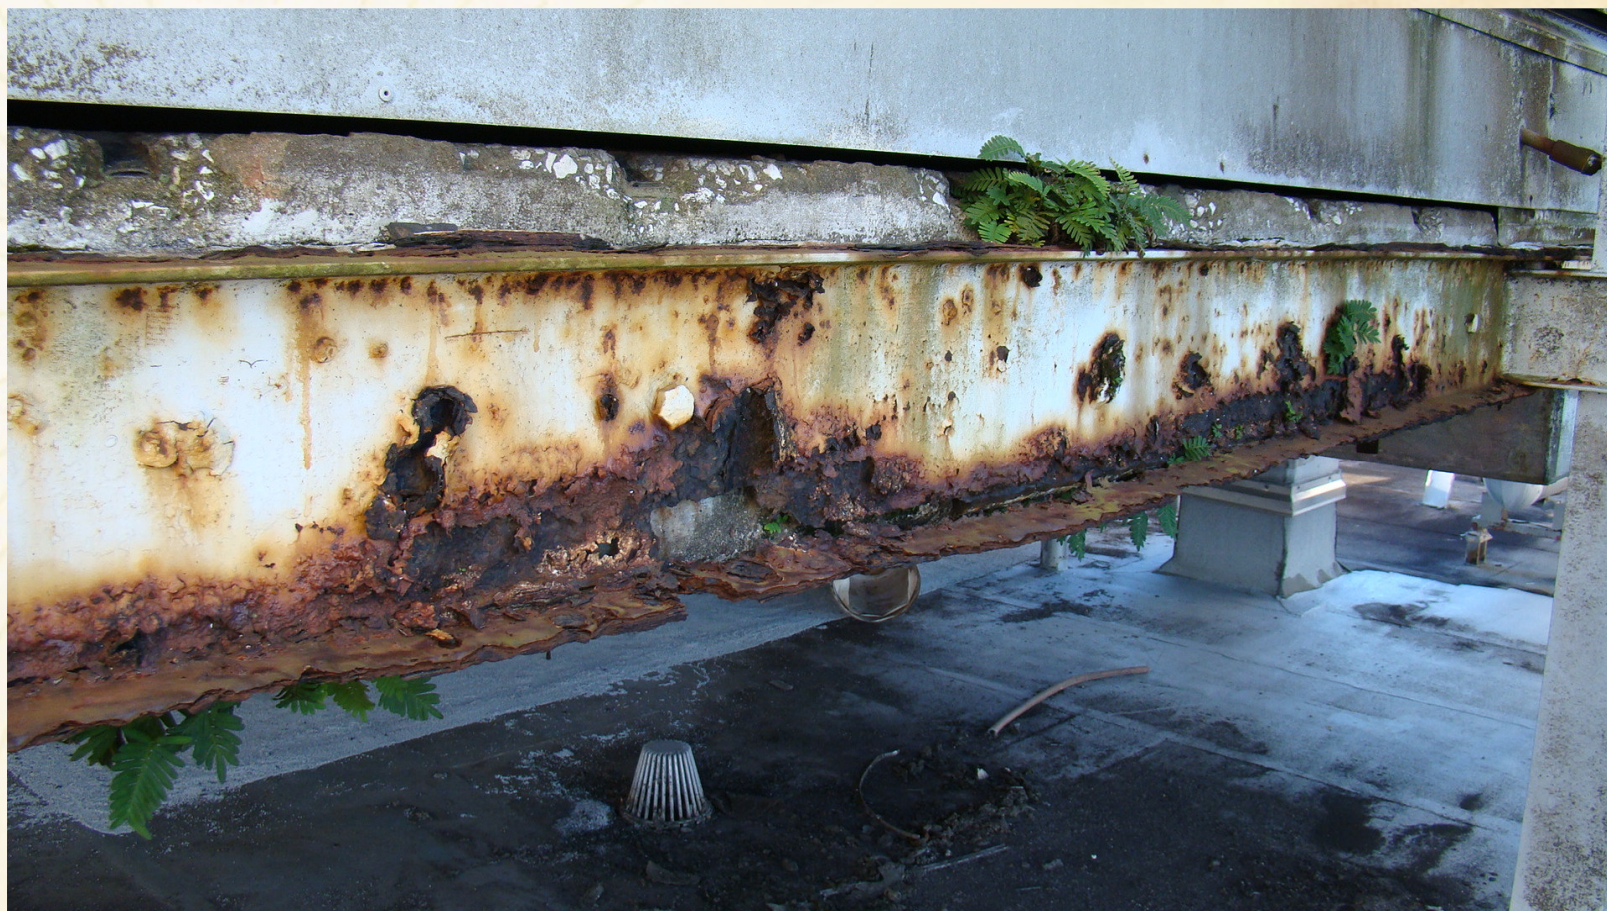
Steel Framing Corrosion

- Surface Rust
- Section Loss
 - Flange
 - Web

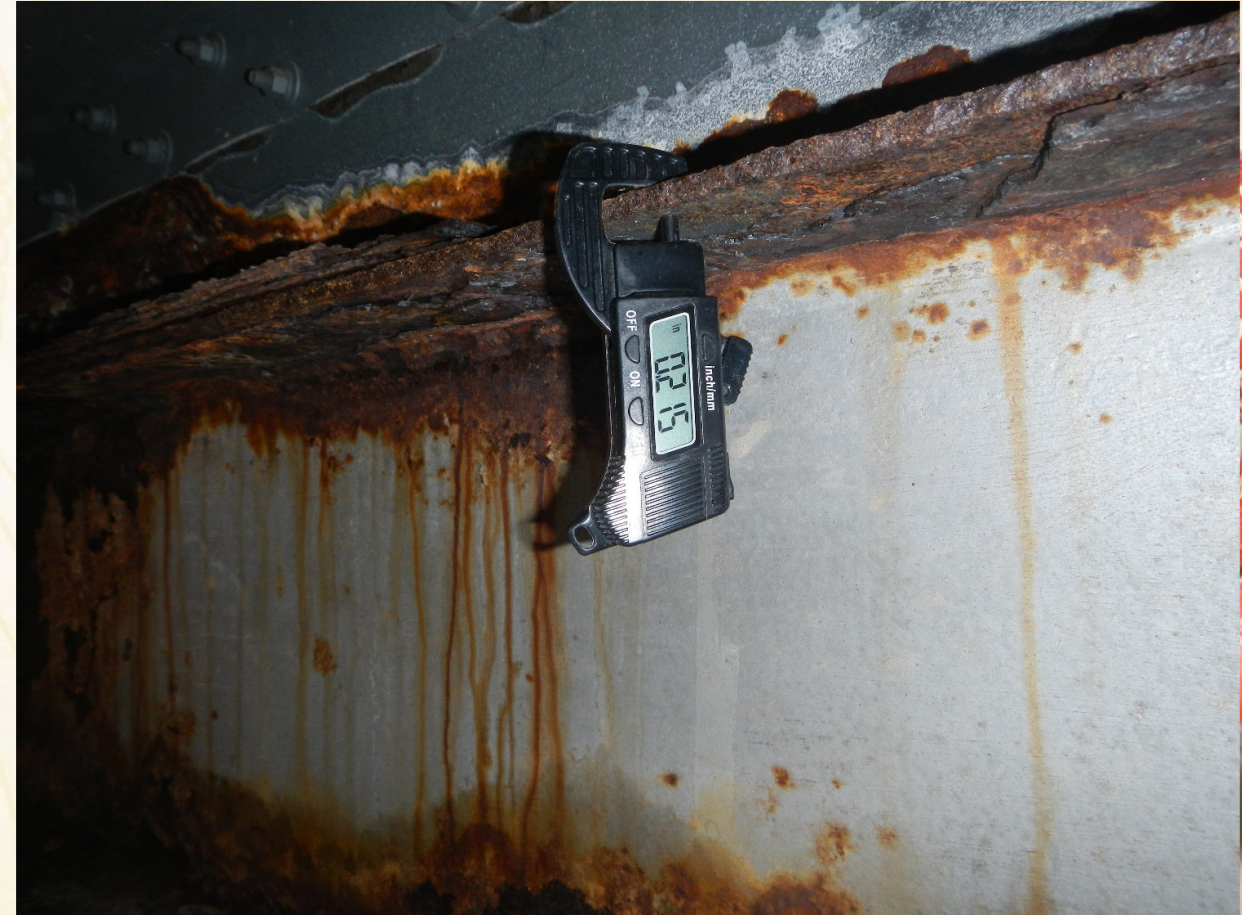
- Rust Expands:
 - 5 to 6 Times Original Volume
- Often Looks Worse Than It Is
- Scrape Rust
- Measure with Caliper

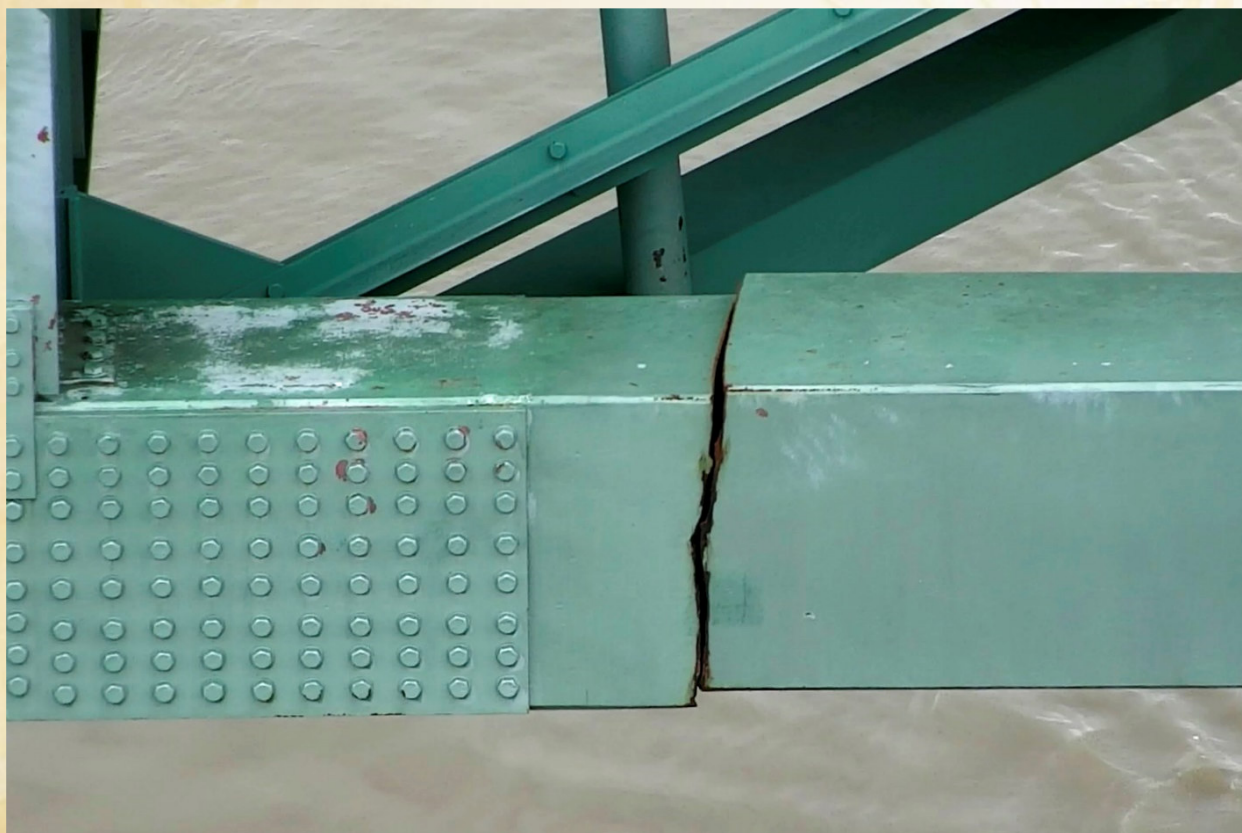
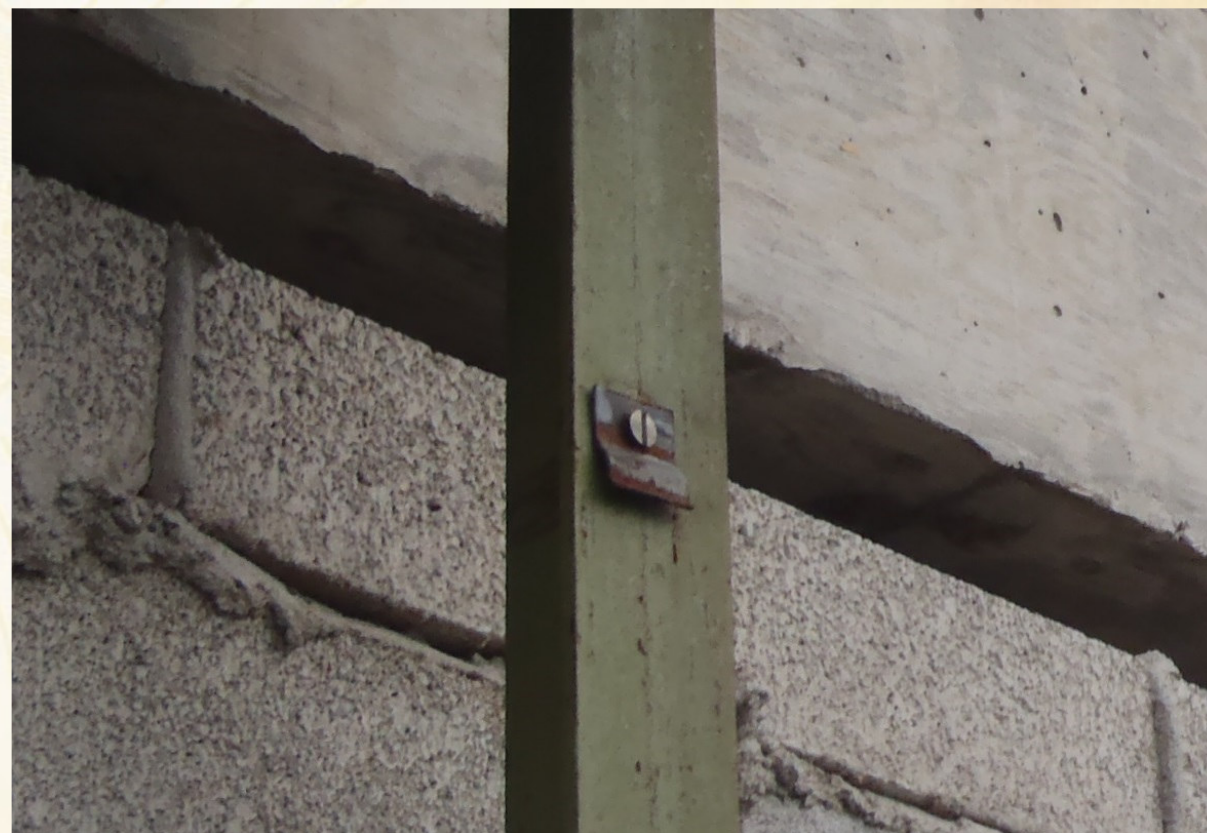
Steel Framing - Fatigue

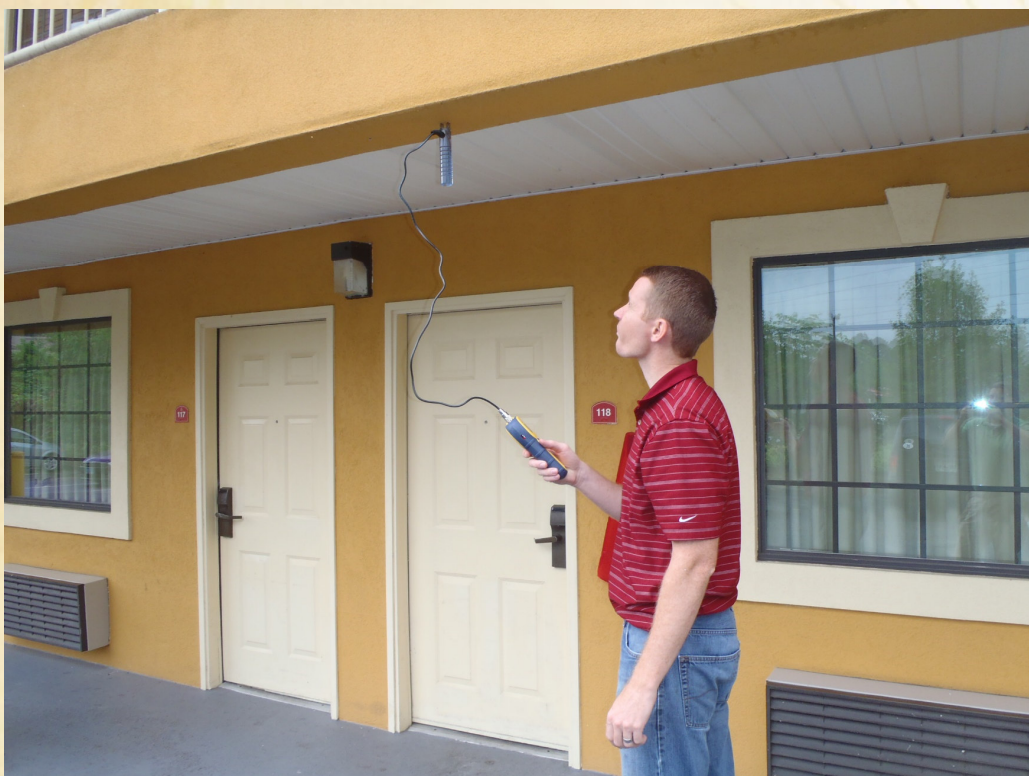
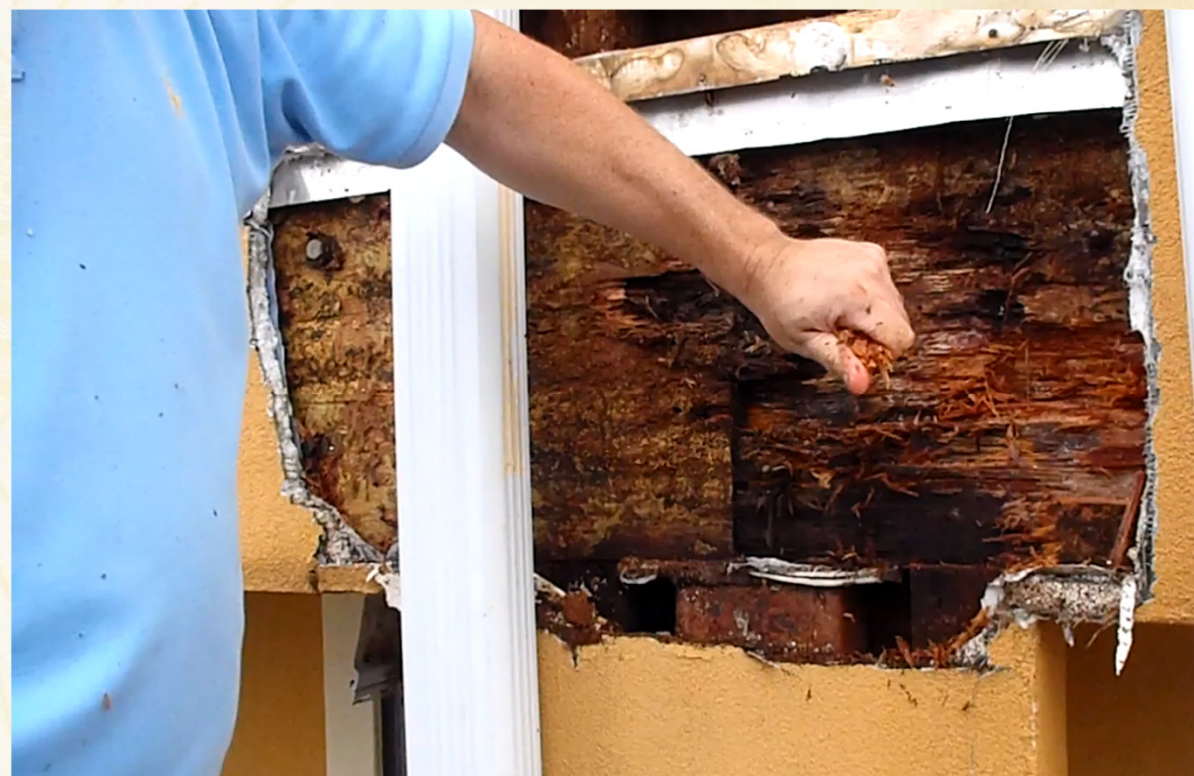
Wood Framing – Moisture Meter

Moisture Content > 30% =
Serious Decay

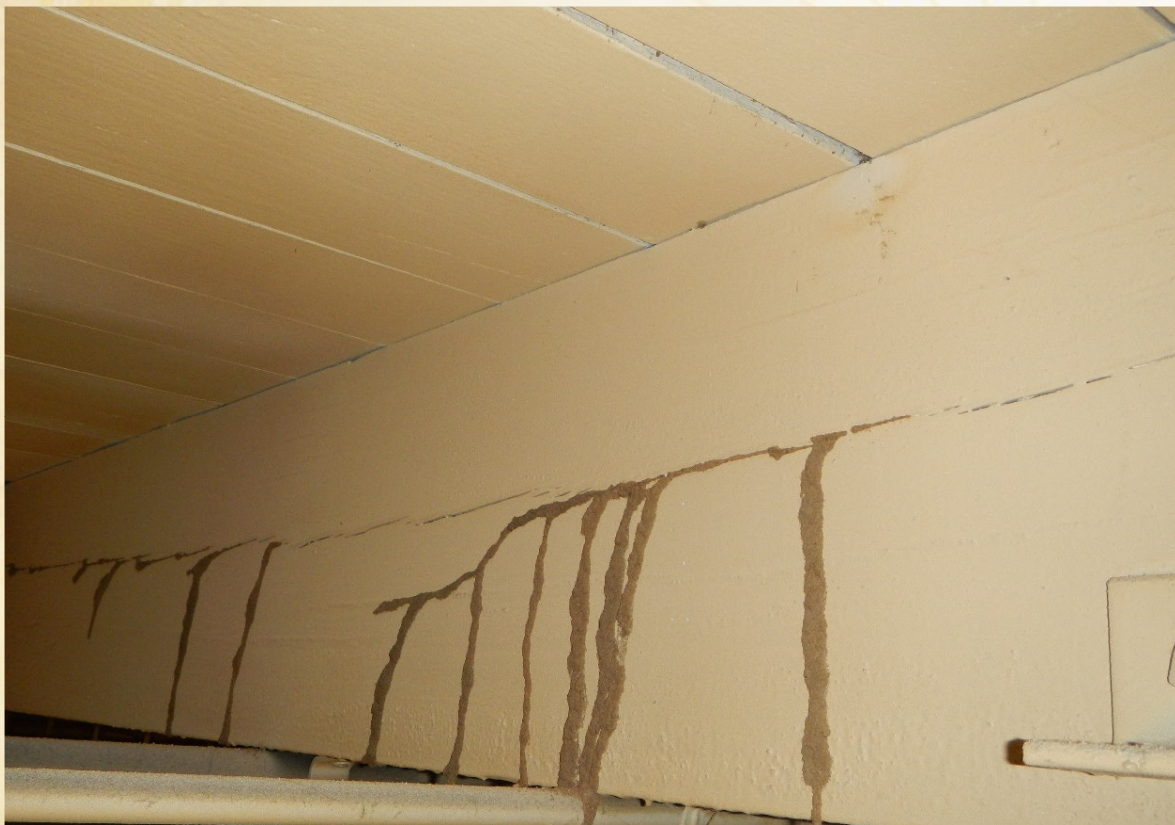
Mud Tubes
