The Truth About Parking Structure Maintenance How to Protect Your Investment

Parking Industry Expo 2021
Gaylord Texan Resort & Convention Center
Monday July 19, 2021

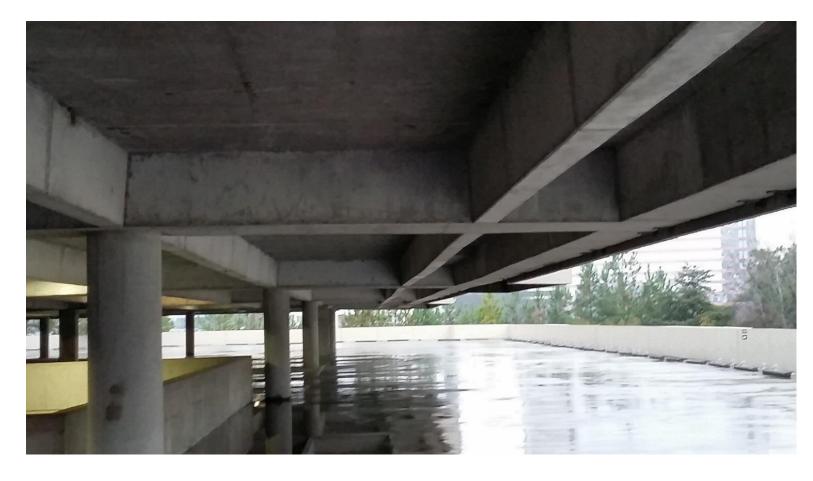
Cast-in-Place

- Flexible Geometry
- Monolithic, Fewer Joints
- Reduced Maintenance Costs
- Longer Life Expectancy
- Higher Durability

- Higher Initial Investment
- Longer Schedule
- More Labor Intensive
- Difficult Quality Control
- Weather Dependent

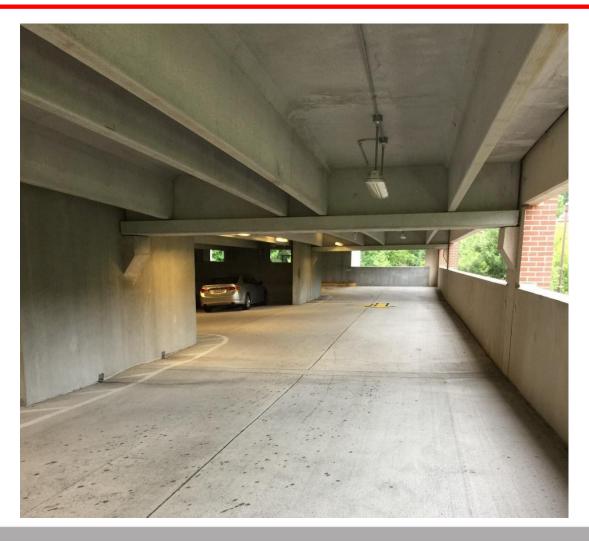
Precast Concrete - Advantages

- Lower Initial Investment than CIP
- Fabricated in Controlled Plant Environment
- Not Weather Dependent
- Accelerated Construction Schedule

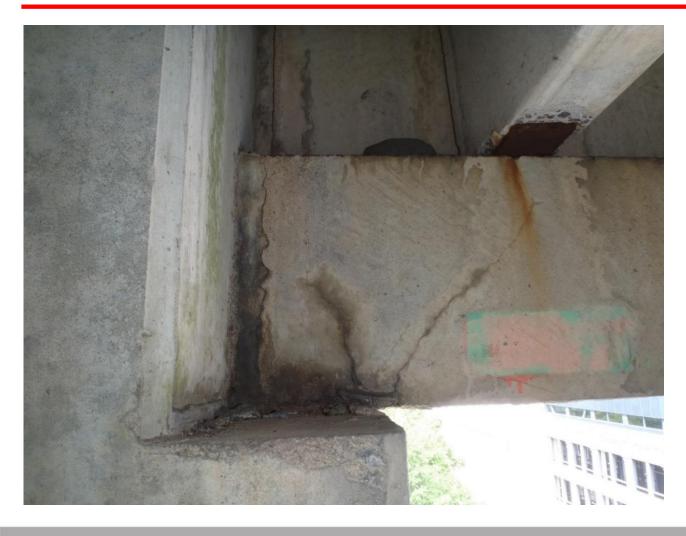
Precast Concrete - Disadvantages

- May be no local plant
- Geometry not Flexible
- Lower Perceived Ceiling heights
- Shearwalls (Closed In)
- More Joints
- Prone to Thermal Expansion & Contraction Damage
- Corrosion of Steel Embedments
- Higher Maintenance Costs

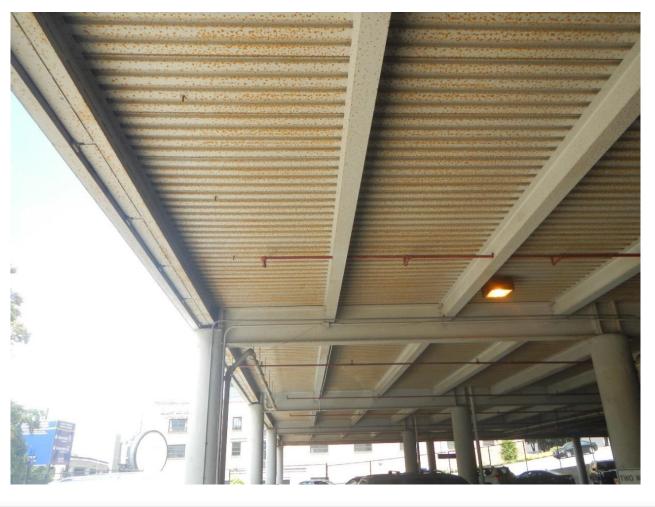
Structural Steel

- Lower Initial Cost than Precast
- Accelerated Construction Schedule
- Fabricated in Controlled Environment
- No Shearwalls (Open)

- Corrosion Issues
- Higher Maintenance Costs
- Not Suitable for Fire Protection

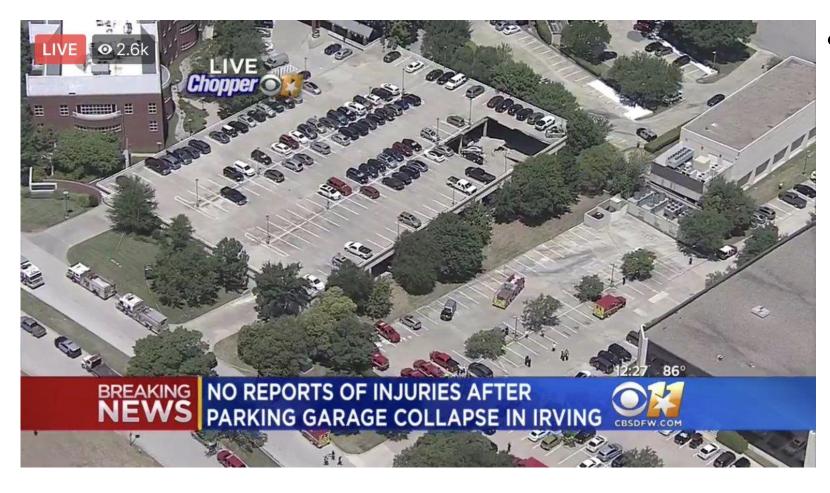
Irving Texas, O'Conner Ridge Blvd. Collapse

- What we know
 - Old Parking Structure
 - Expansive Soils in TX
 - Exterior Columns Leaning
 - Cracks Sealed with Sealant
 - No OSHA Report
 - Demolished

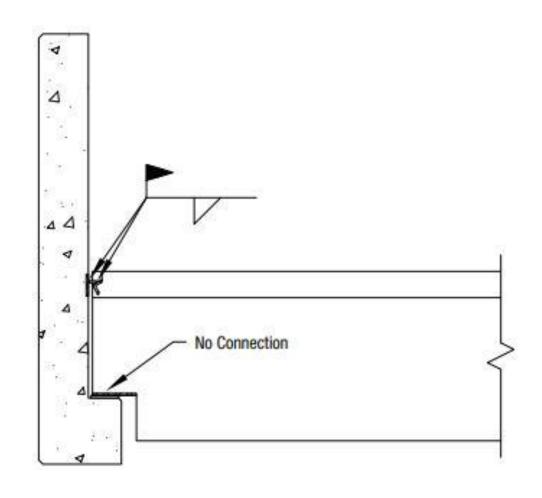
Typical Precast Double Tee
 Joist Seat

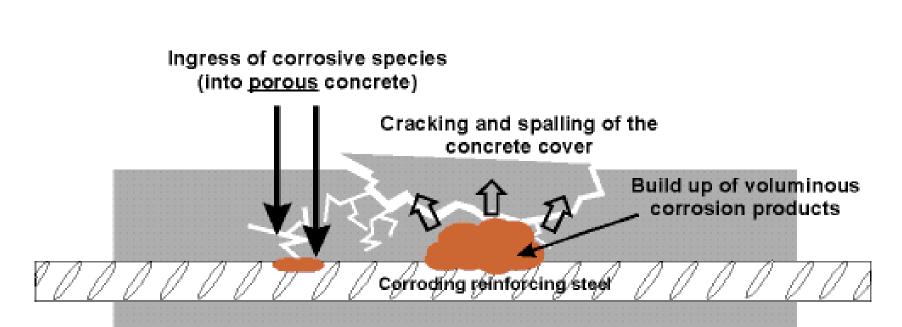
Common Deficiency: Corrosion

A: Spall

B: Crack

C: Corner Spall

D:Delamination

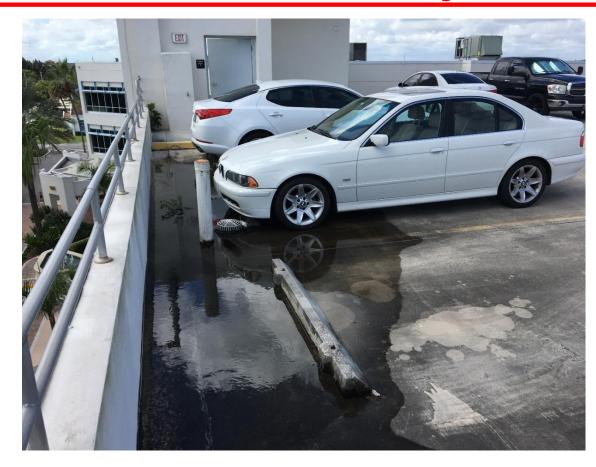
Ponding

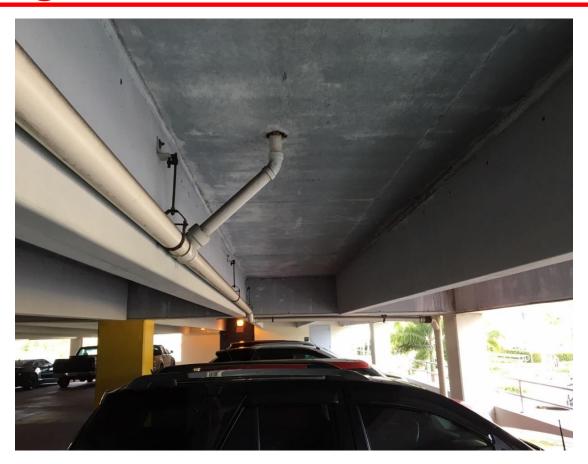
Supplemental Drain

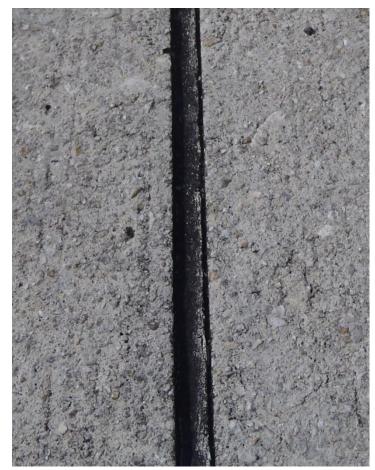
Sealant Failure

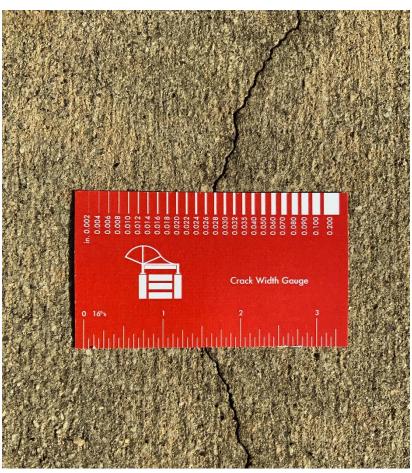
Cracks

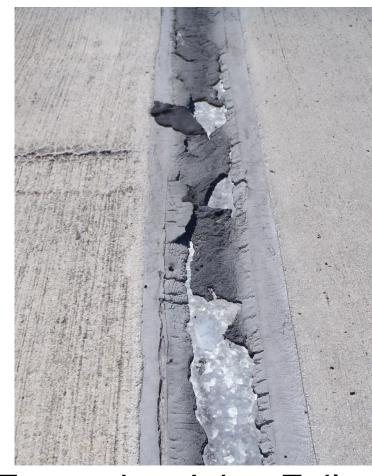
Expansion Joint Failure

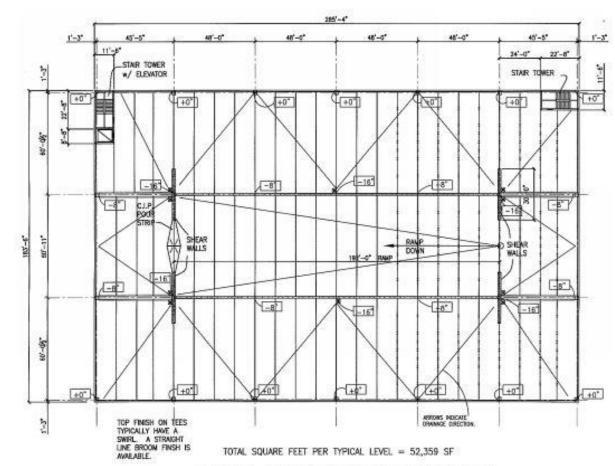
Drainage & Joint Plan

- All orthogonal lines are sealant Joints
- Diagonal lines are slope lines

- Expansion joint in middle
- Joint sealant at perimeter and at stair towers

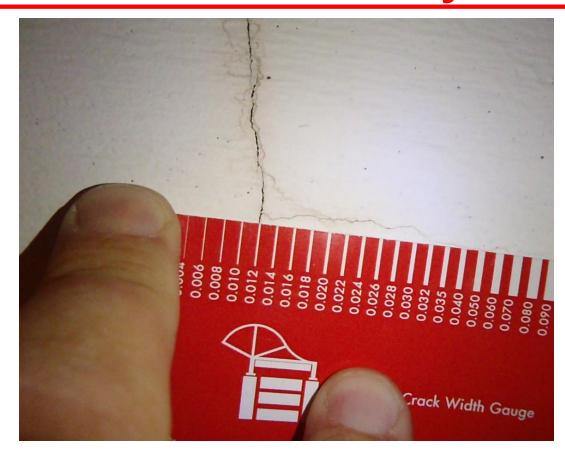
.013" < Cracks < .035"

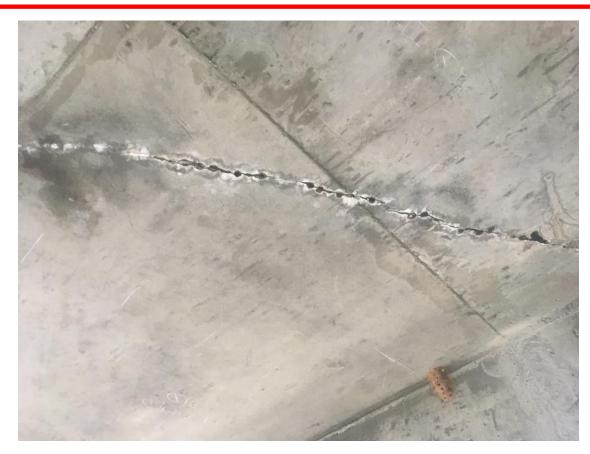
Cracks that Leak < .035"

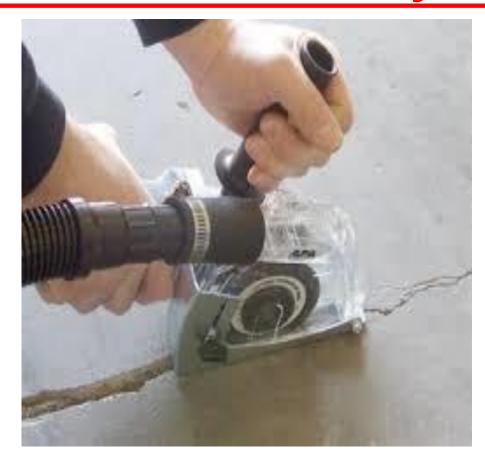
Crack Chasing

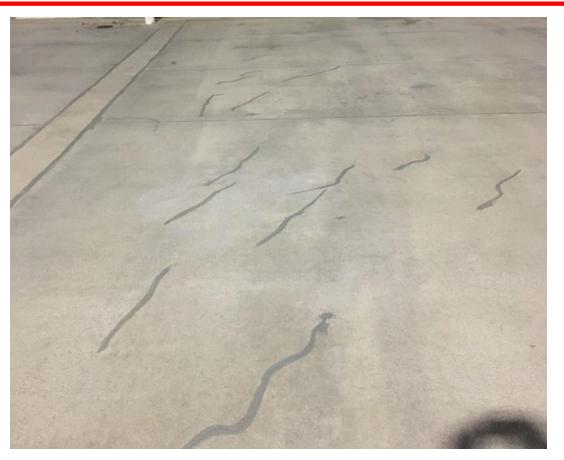
Crack Sealant

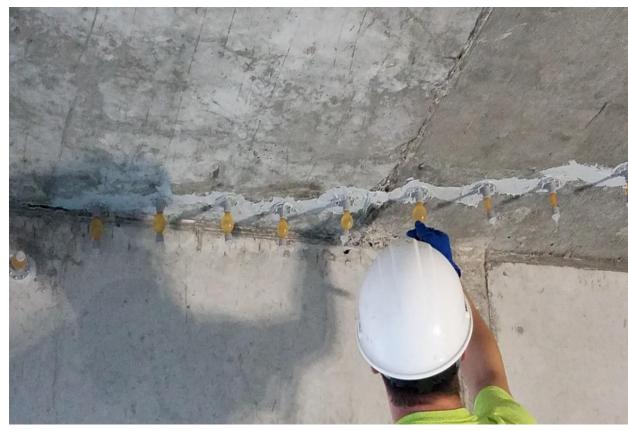
Cracks \geq .035"

Inflatable Injection Port

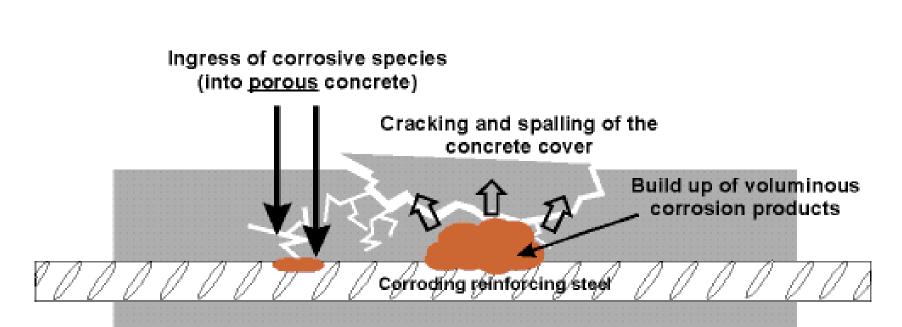
Common Deficiency: Corrosion

A: Spall

B: Crack

C: Corner Spall

D:Delamination

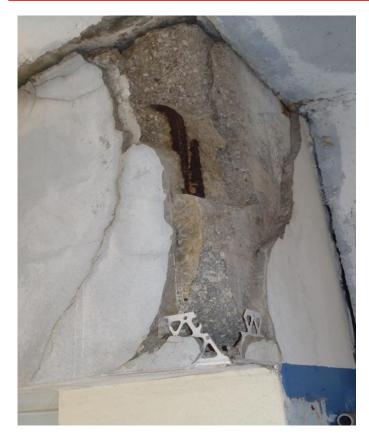
Spall

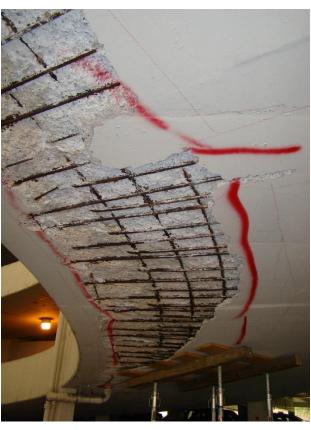
Delamination

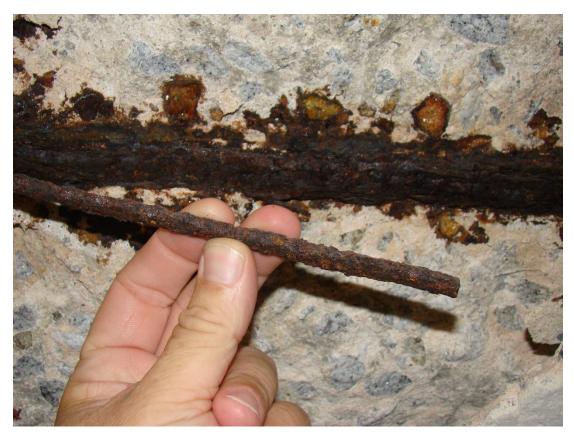
Section Loss

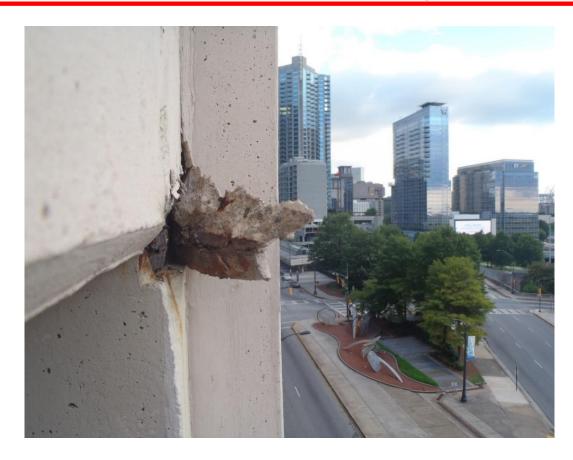
Spall Over Sidewalk

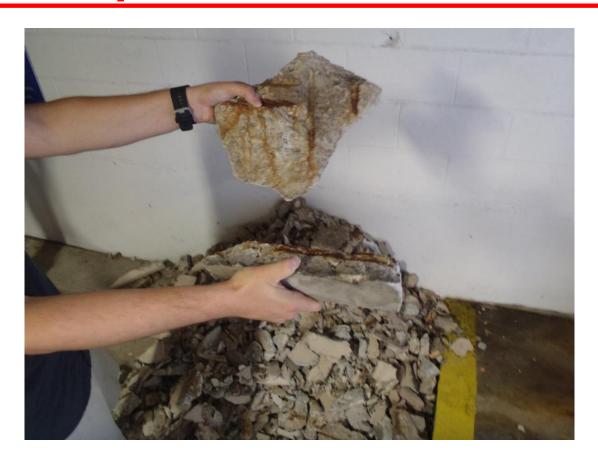
Spall Size

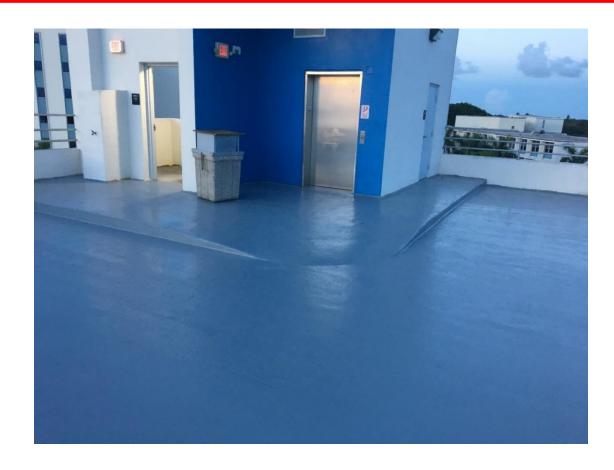
Traffic Bearing Membrane

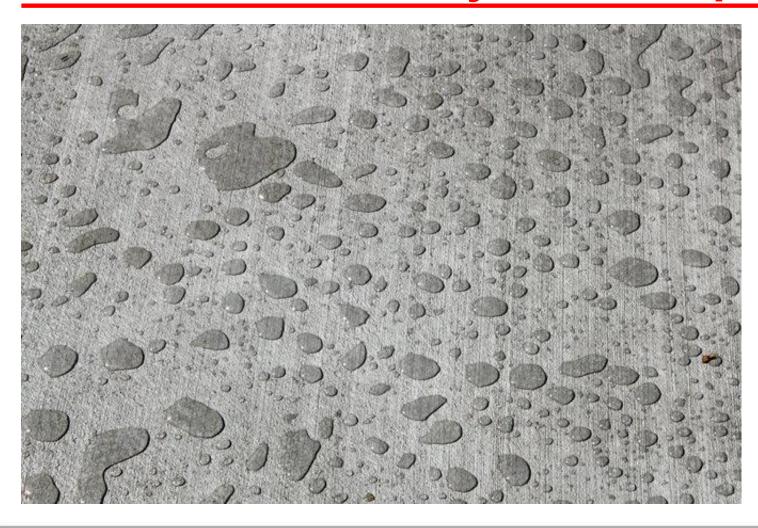
Silane Sealer

- Water Retardant
- Breathable
- Fills Pores of Dense Concrete
- Minimizes penetration of water and chemicals
- Reapply 5 to 10 years

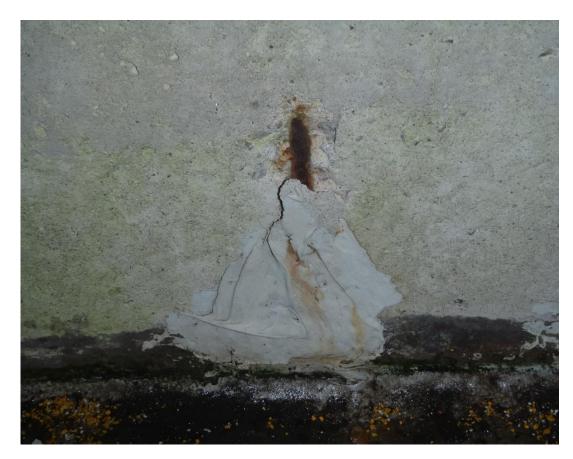
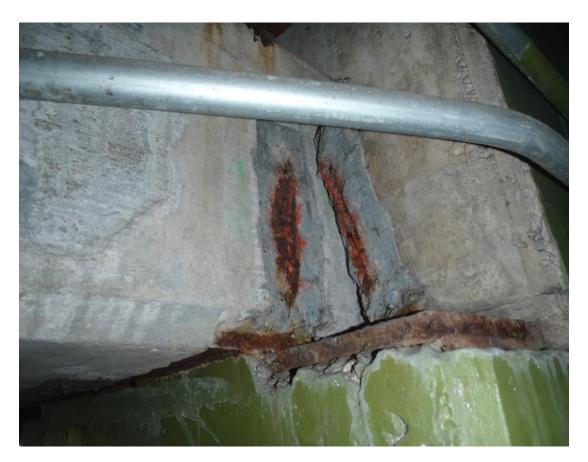
Improper Surface Preparation

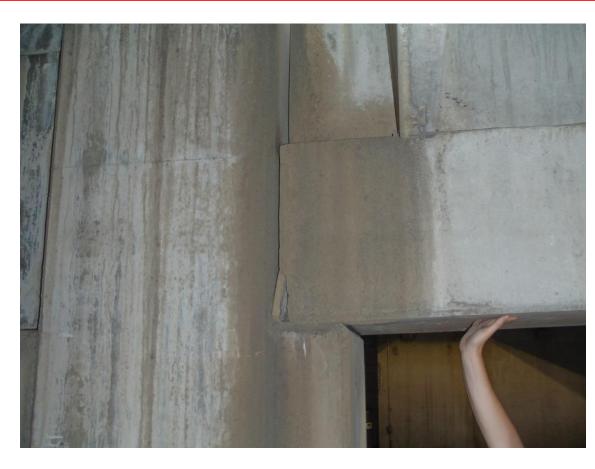
Precast Beam Haunch

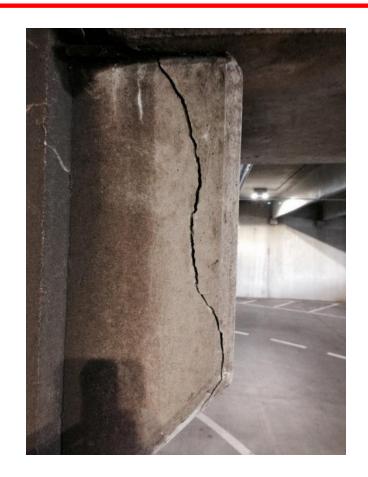
4 Months Later

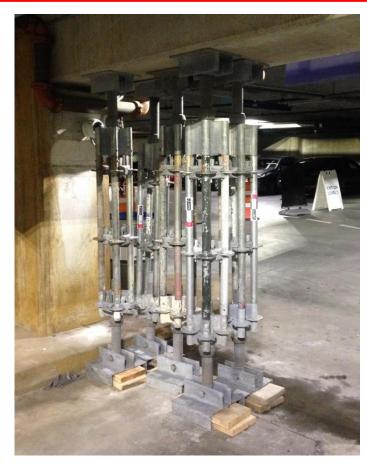
Shoring to Remove Load

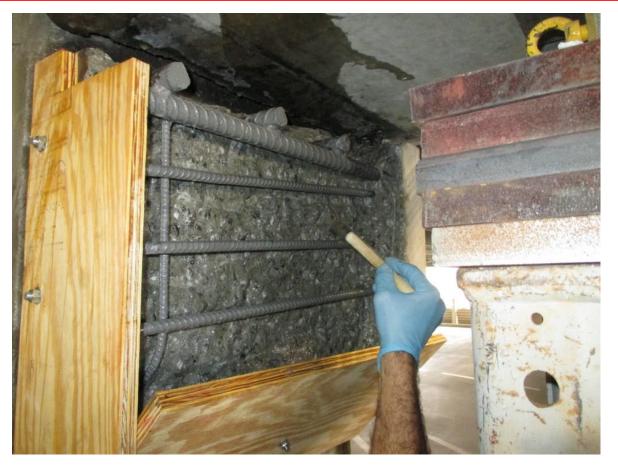
Applying Epoxy Bonding Agent

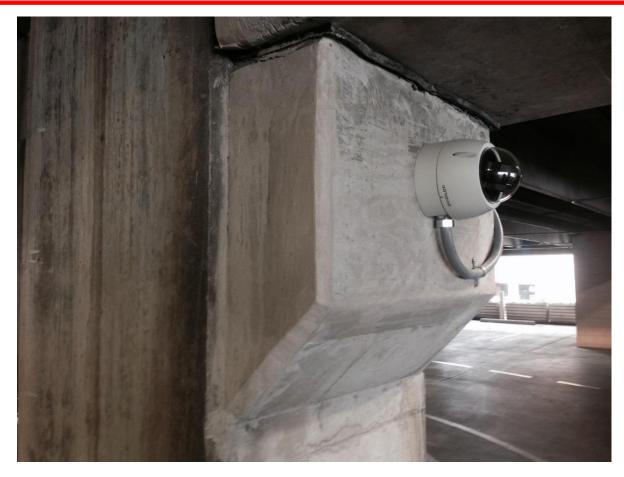
Precast Haunch Connection Finished Repair

Good as New

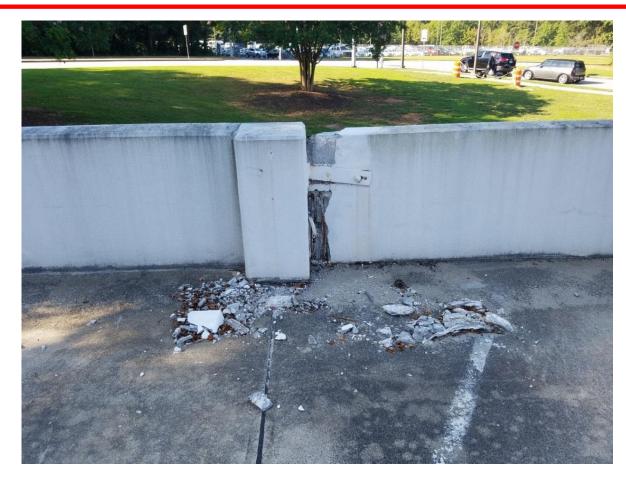
Broken Precast Spandrel Beam

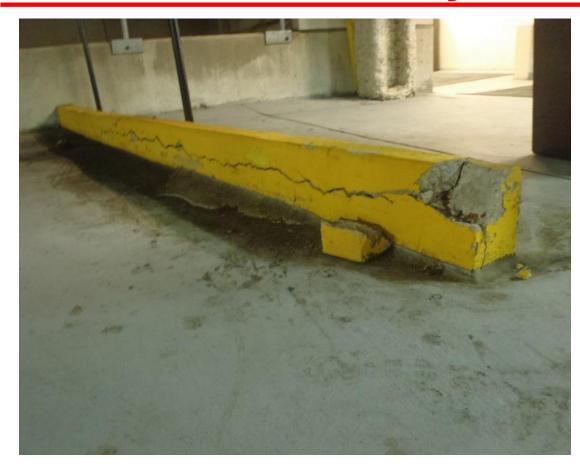
Broken Curb

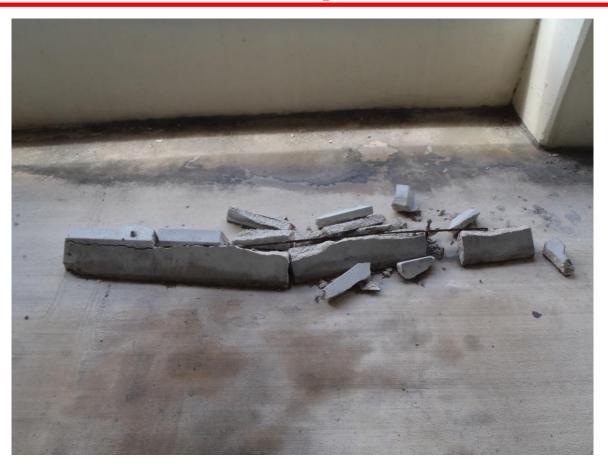
Broken Wheel Stop

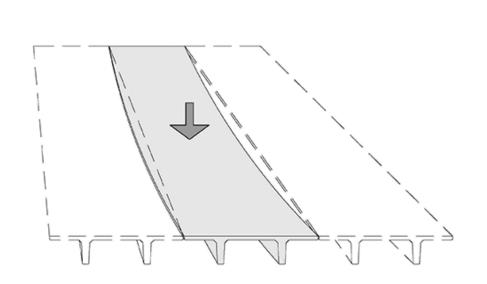
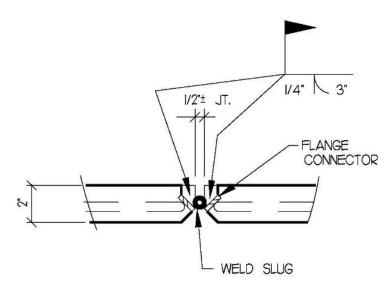
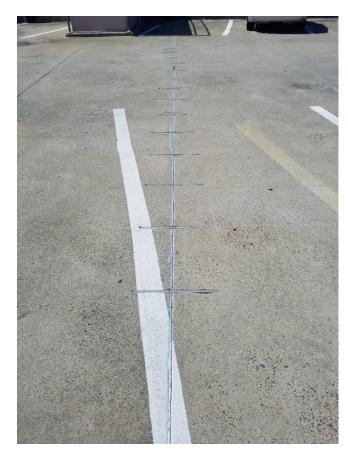
Precast Shear Transfer Repair

Precast Double Tees

Shear Transfer

Repair

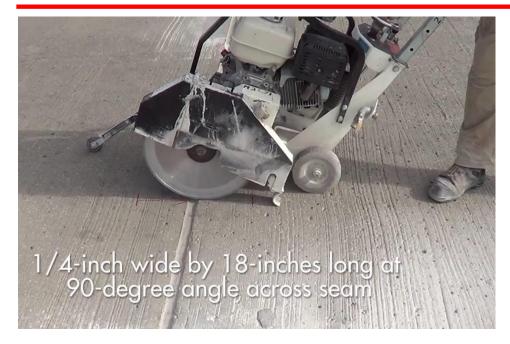
Saw Cut Slab

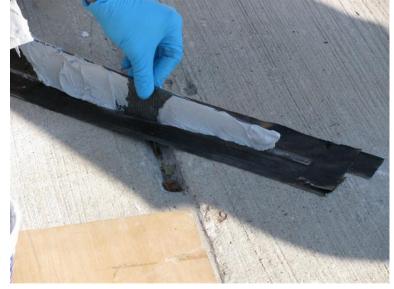
Prepared Joint & Biscuit

Repair

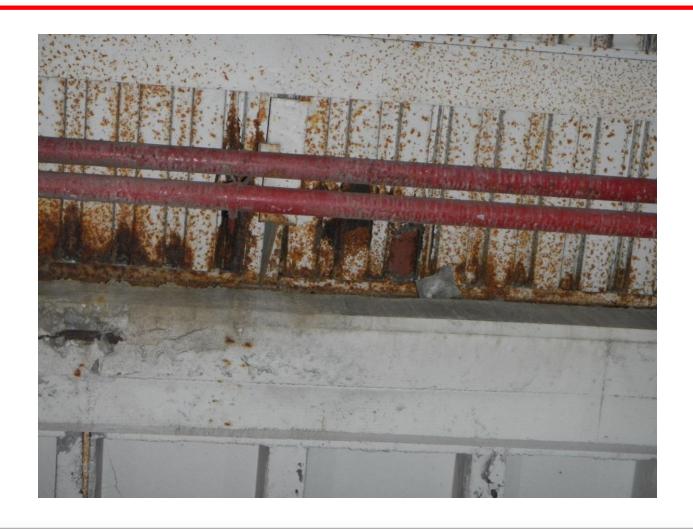
Structural Steel Corrosion

- Steel Protection & Corrosion Issues
- Steel Deck Traps Moisture, Hides Degradation.

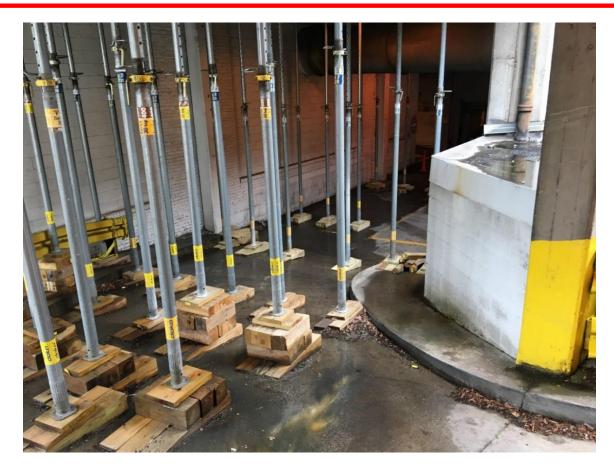
Now Demolished
