# **Structural Inspection and Repair**

## **Part I: Inspection**

**BOMA Georgia**

**Tuesday July 20, 2021**

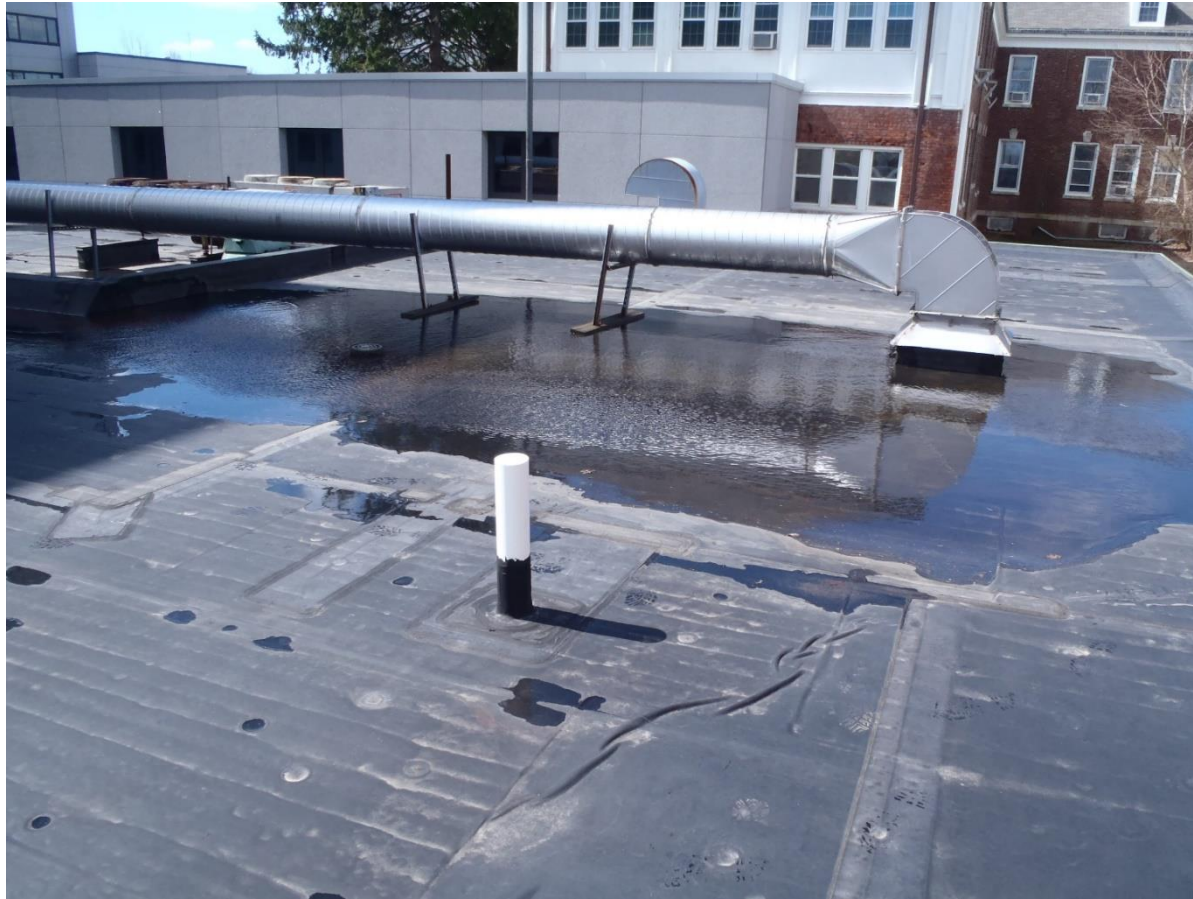
Ponding > 48 Hours

- **Ponding:** Most common factor in roofing & plaza slab failure
- **Water Shedding:** Can make up for shortcomings in design, construction, durability, & maintenance.
- **Degradation:** Asphalt & Polymeric materials
- **Freezing:** Erodes surface aggregate
- **Voids:** Manufacturer's warranty

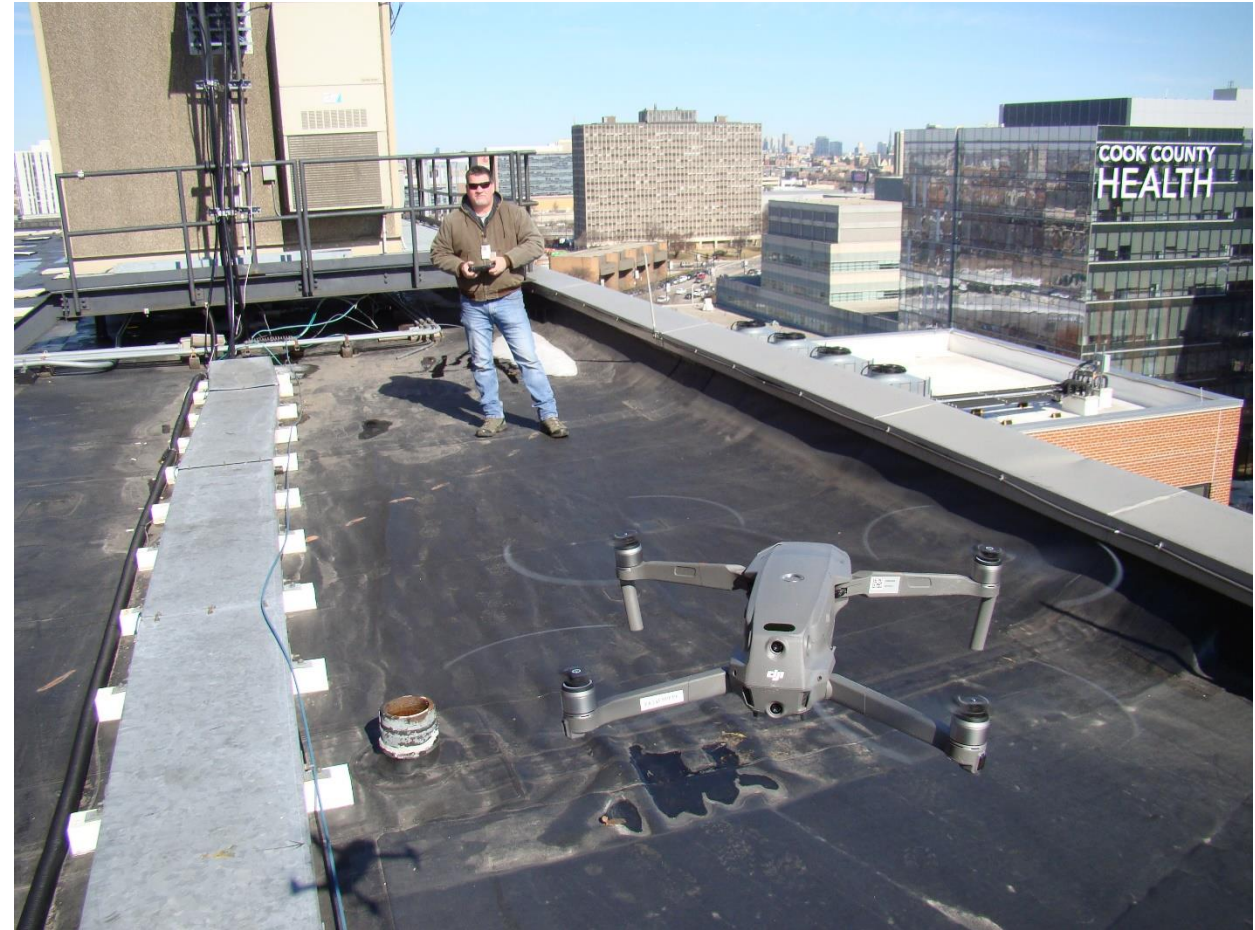
- Infrared Camera (IR)
- Best After Dusk
  - Insulation and Moisture Heats Up During the Day
  - Dry Insulation cools off faster than Wet Insulation
- Daylight Waiver Required
- Height to See Major Portions of Roof
- Safer and More Accurate than Handheld

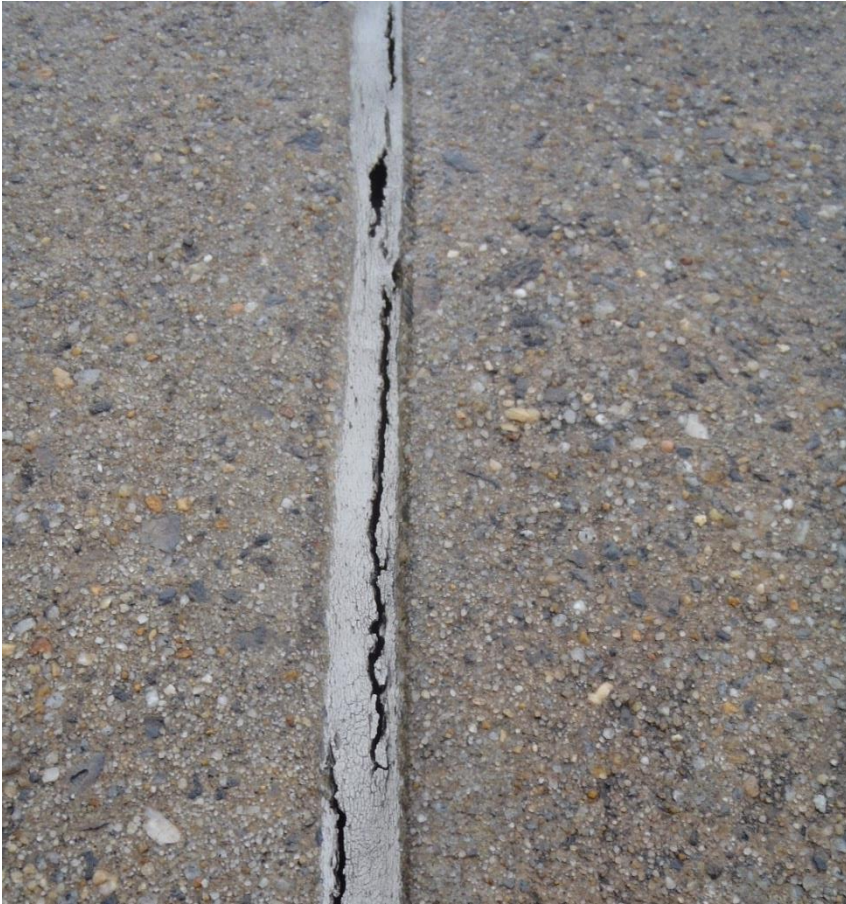
Cohesive Failure/Aged & Weathered

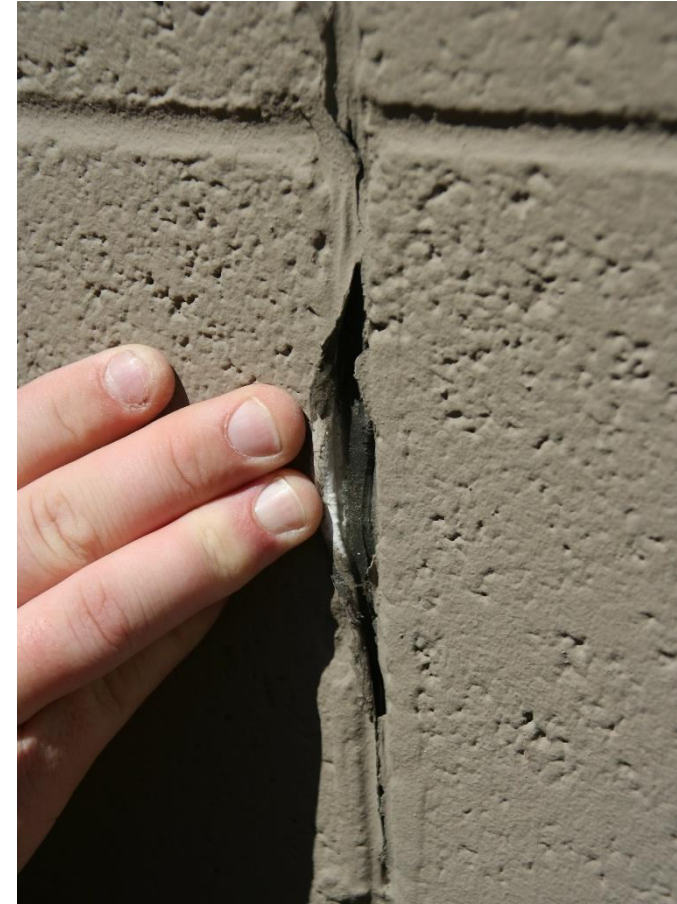
Adhesive Failure

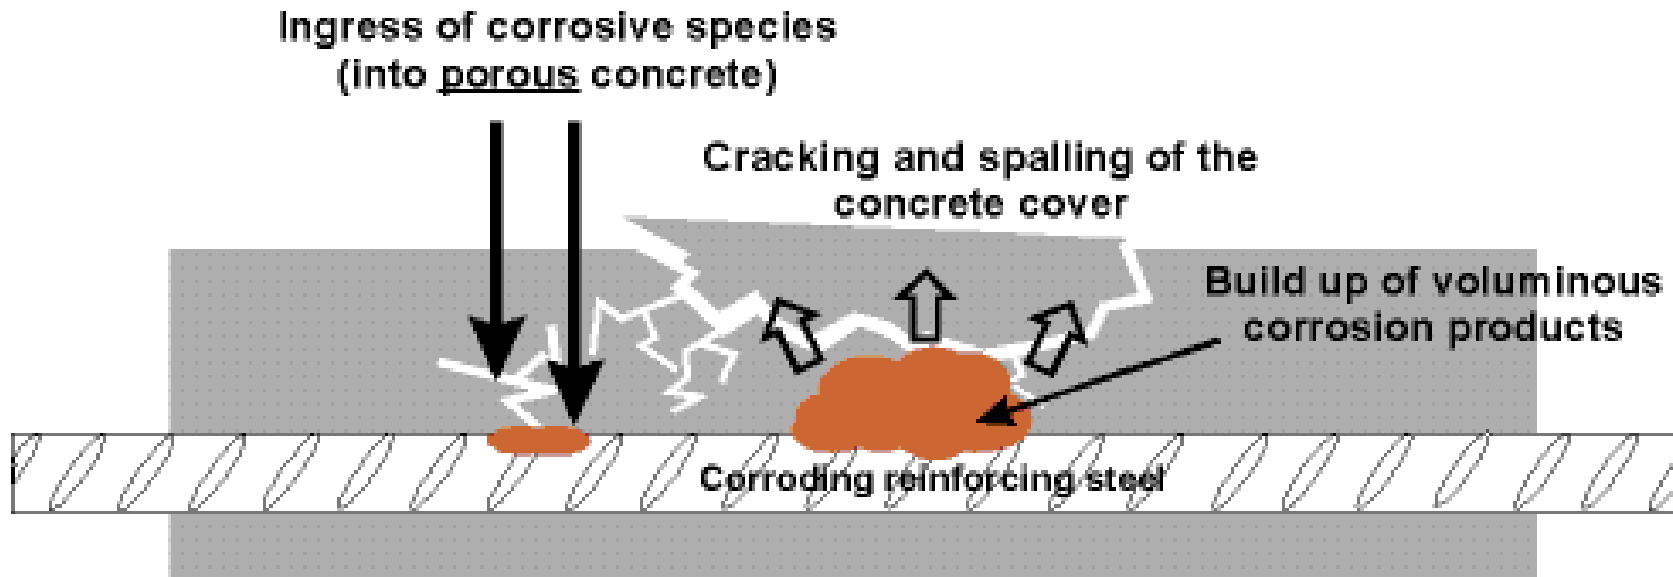
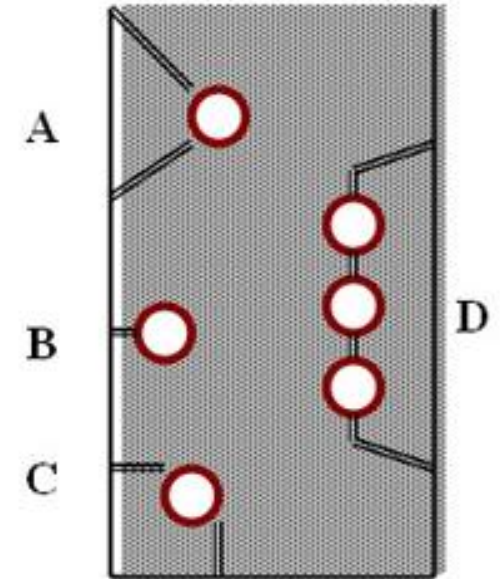
- A: Spall
- B: Crack
- C: Corner Spall
- D: Delamination

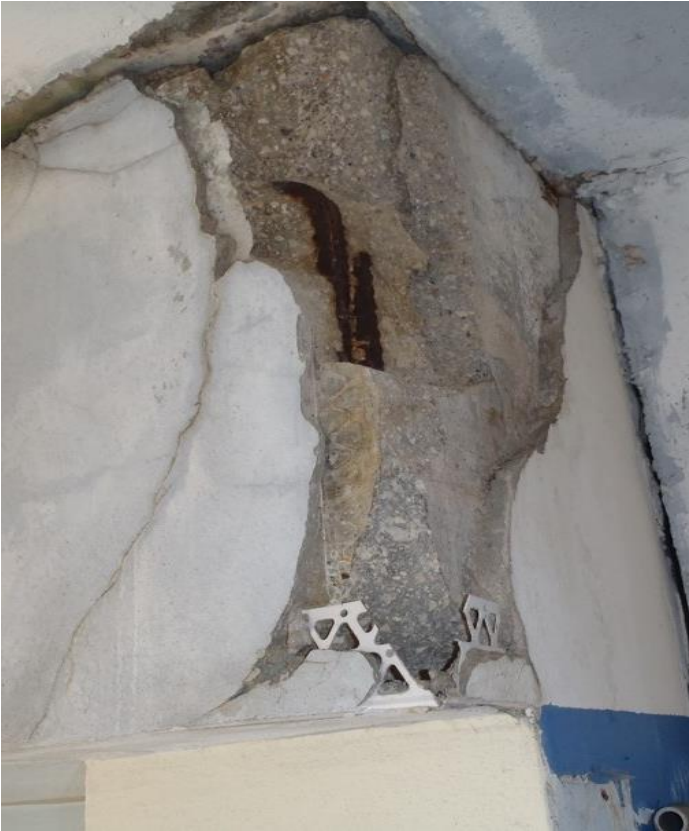
Spall

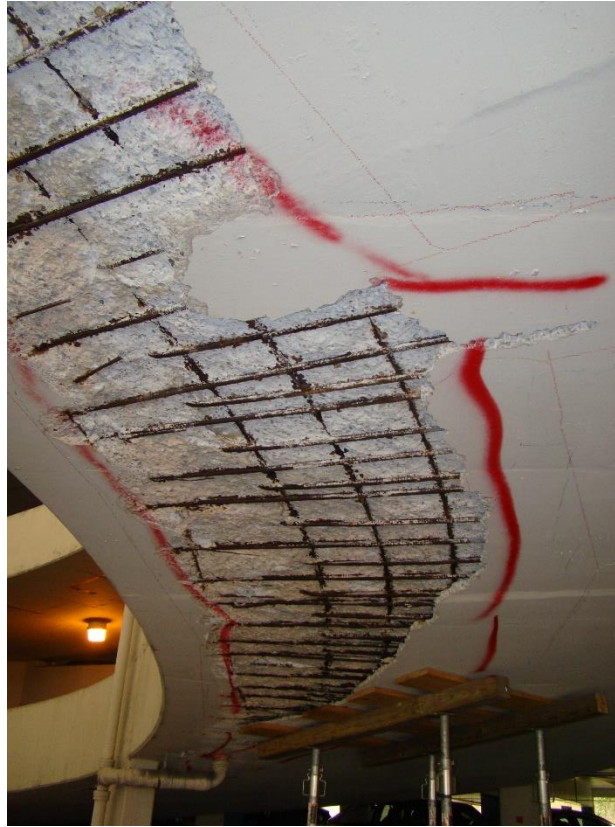
Delamination

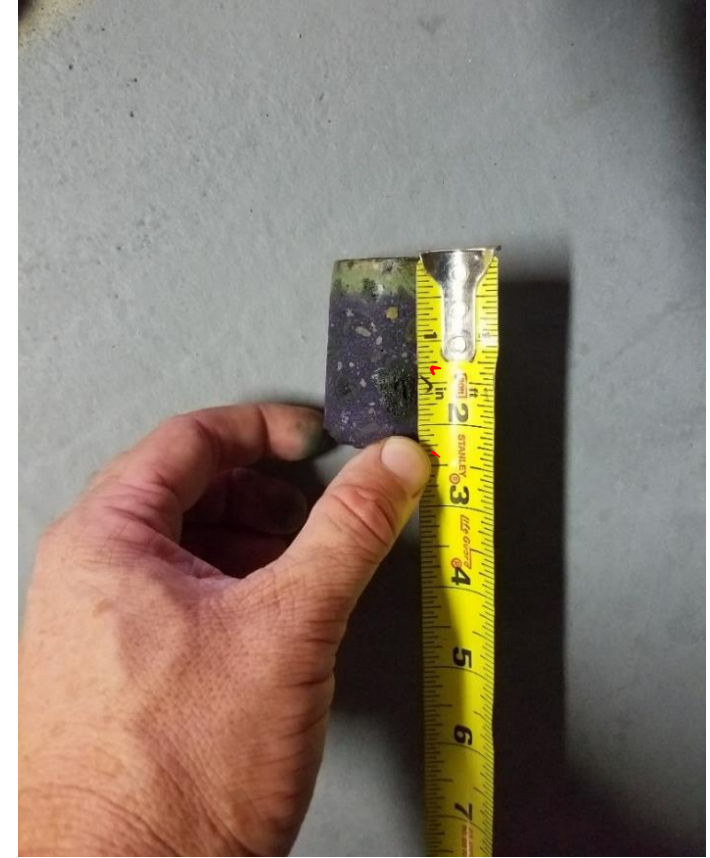
Depth of Carbonation

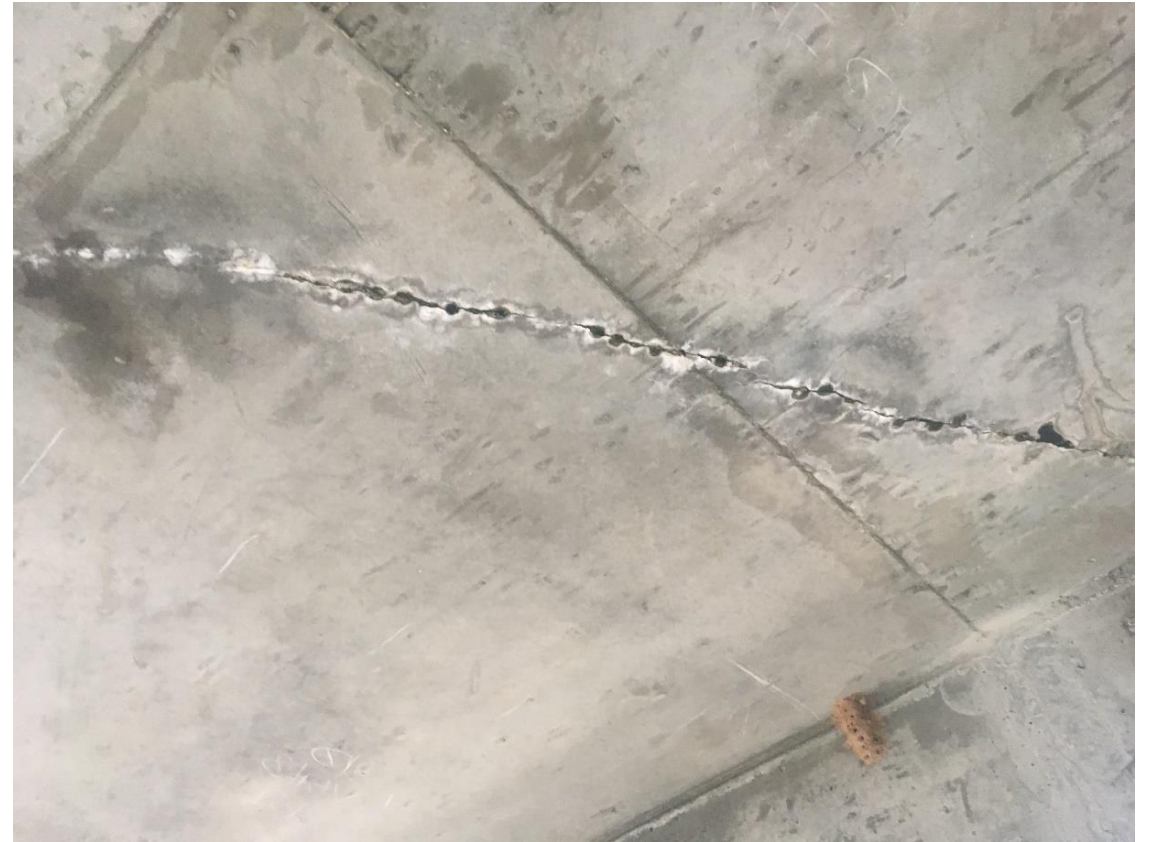
Cracks that Leak  $< .035''$

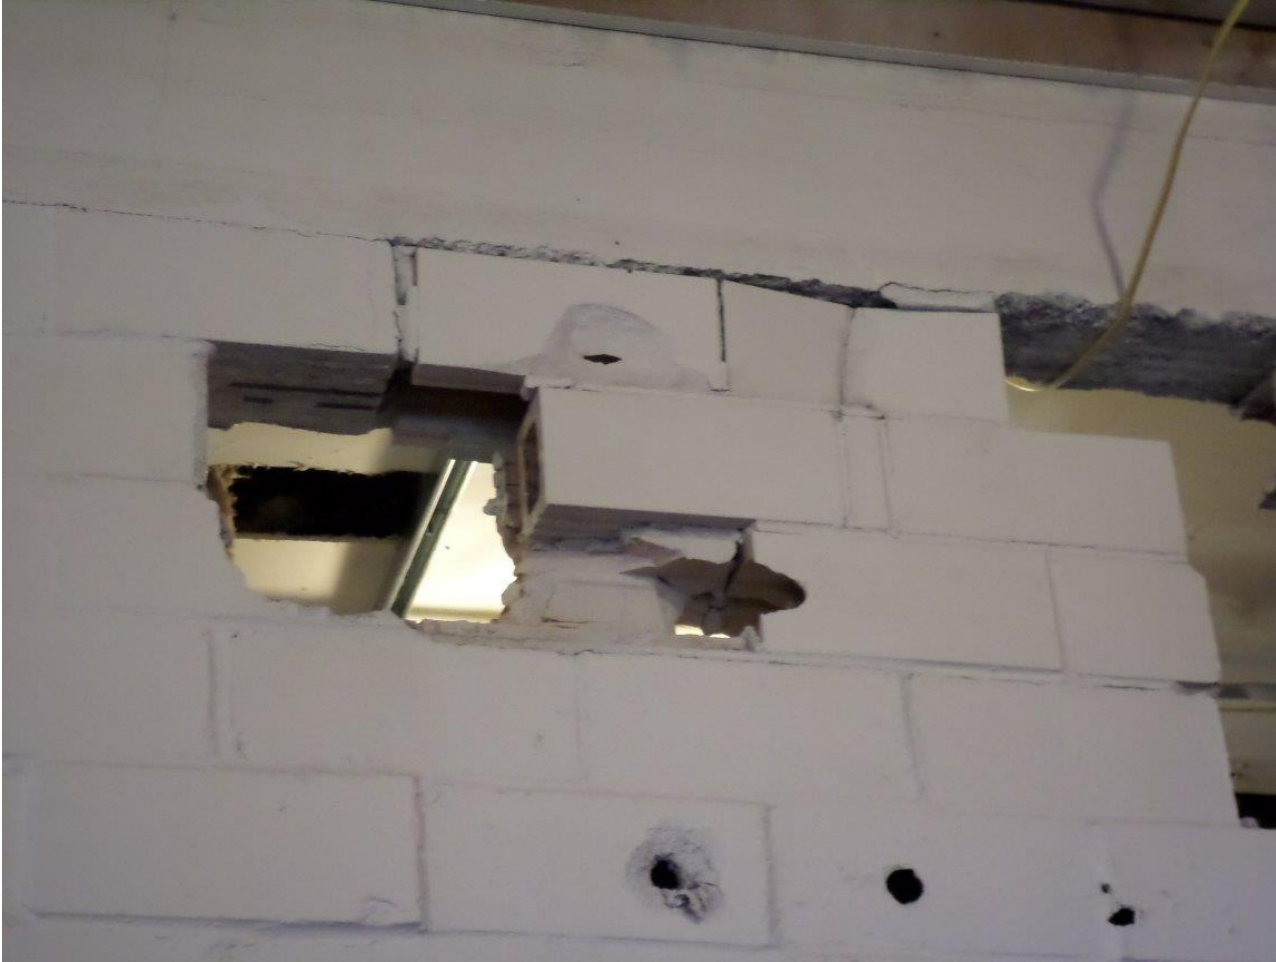
- Penetrations Through Load Bearing Walls

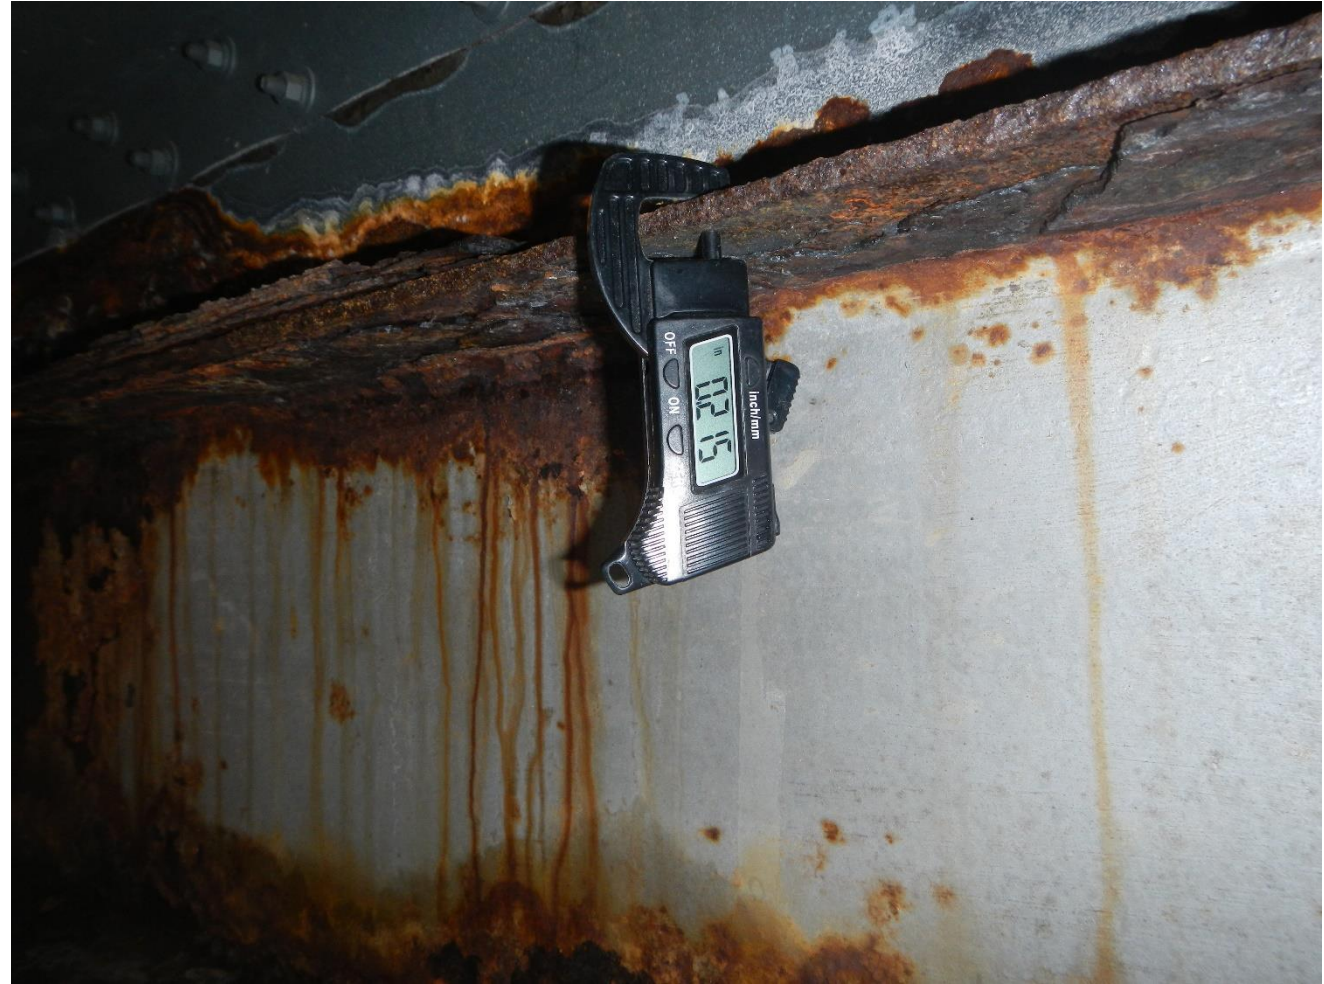
- Rust Expands 5 to 6 Times Original Volume
- Often Looks Worse Than It Is
- Scrape Rust
- Measure with Caliper

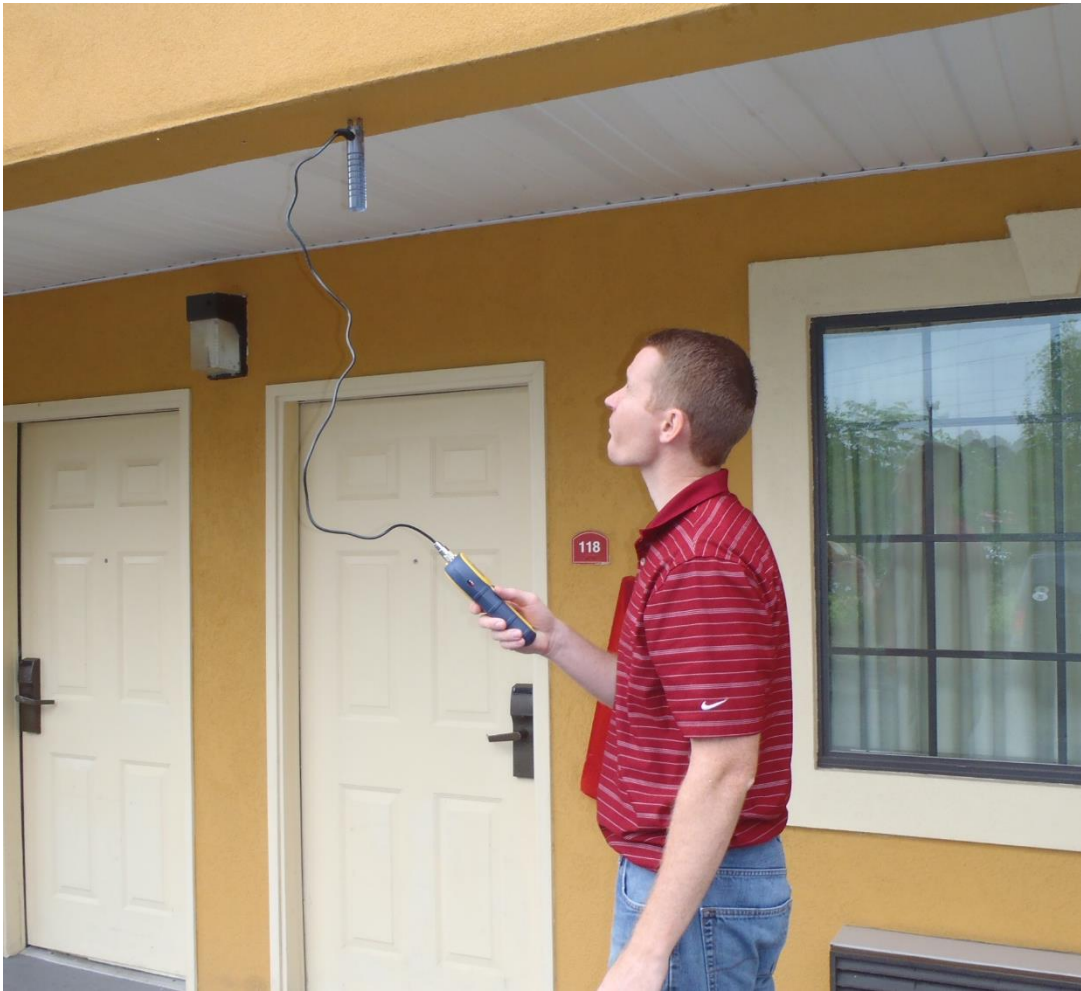
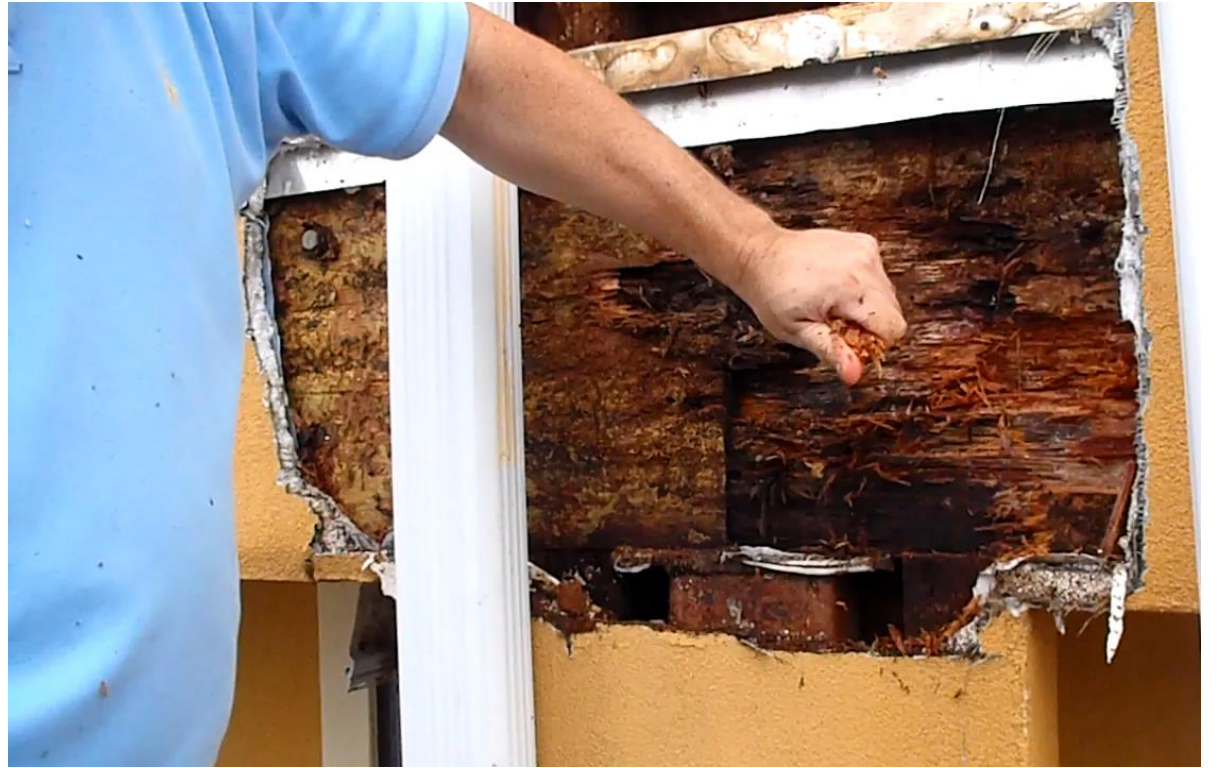
Moisture Content  $> 30\%$  =  
Serious Decay

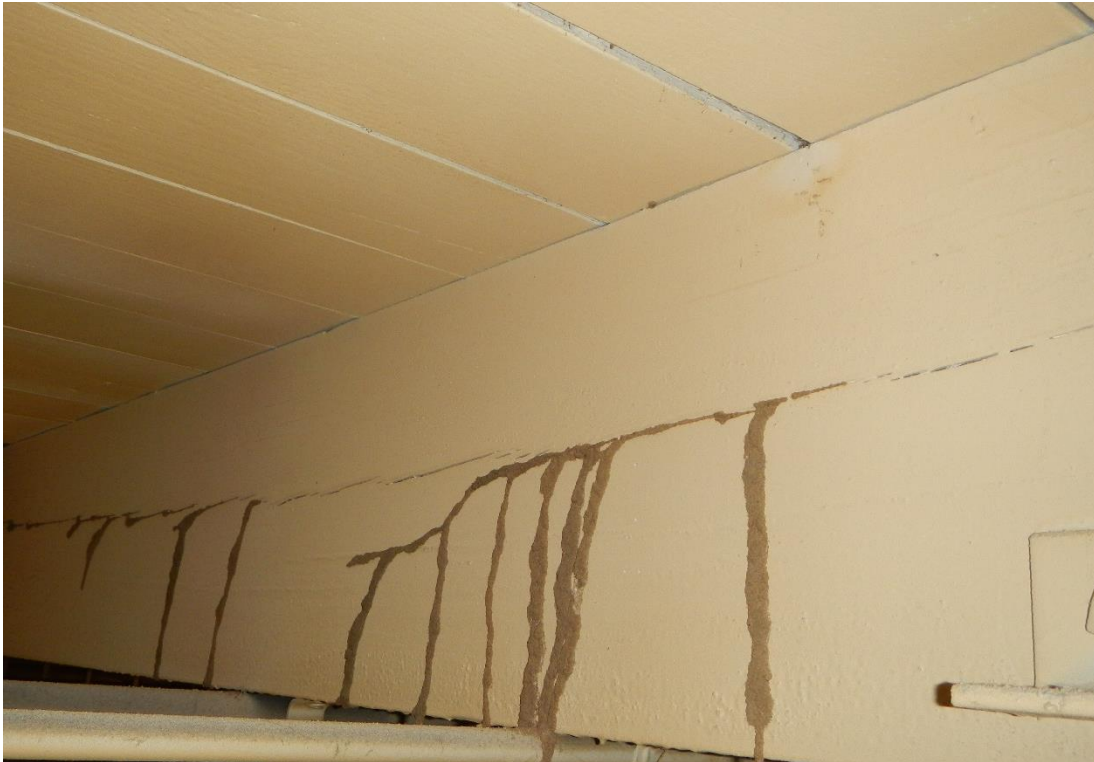
Mud Tubes
