Practical Considerations for Façade Inspections

**EVAN MOORE
with
INNOVATIVE ENGINEERING**

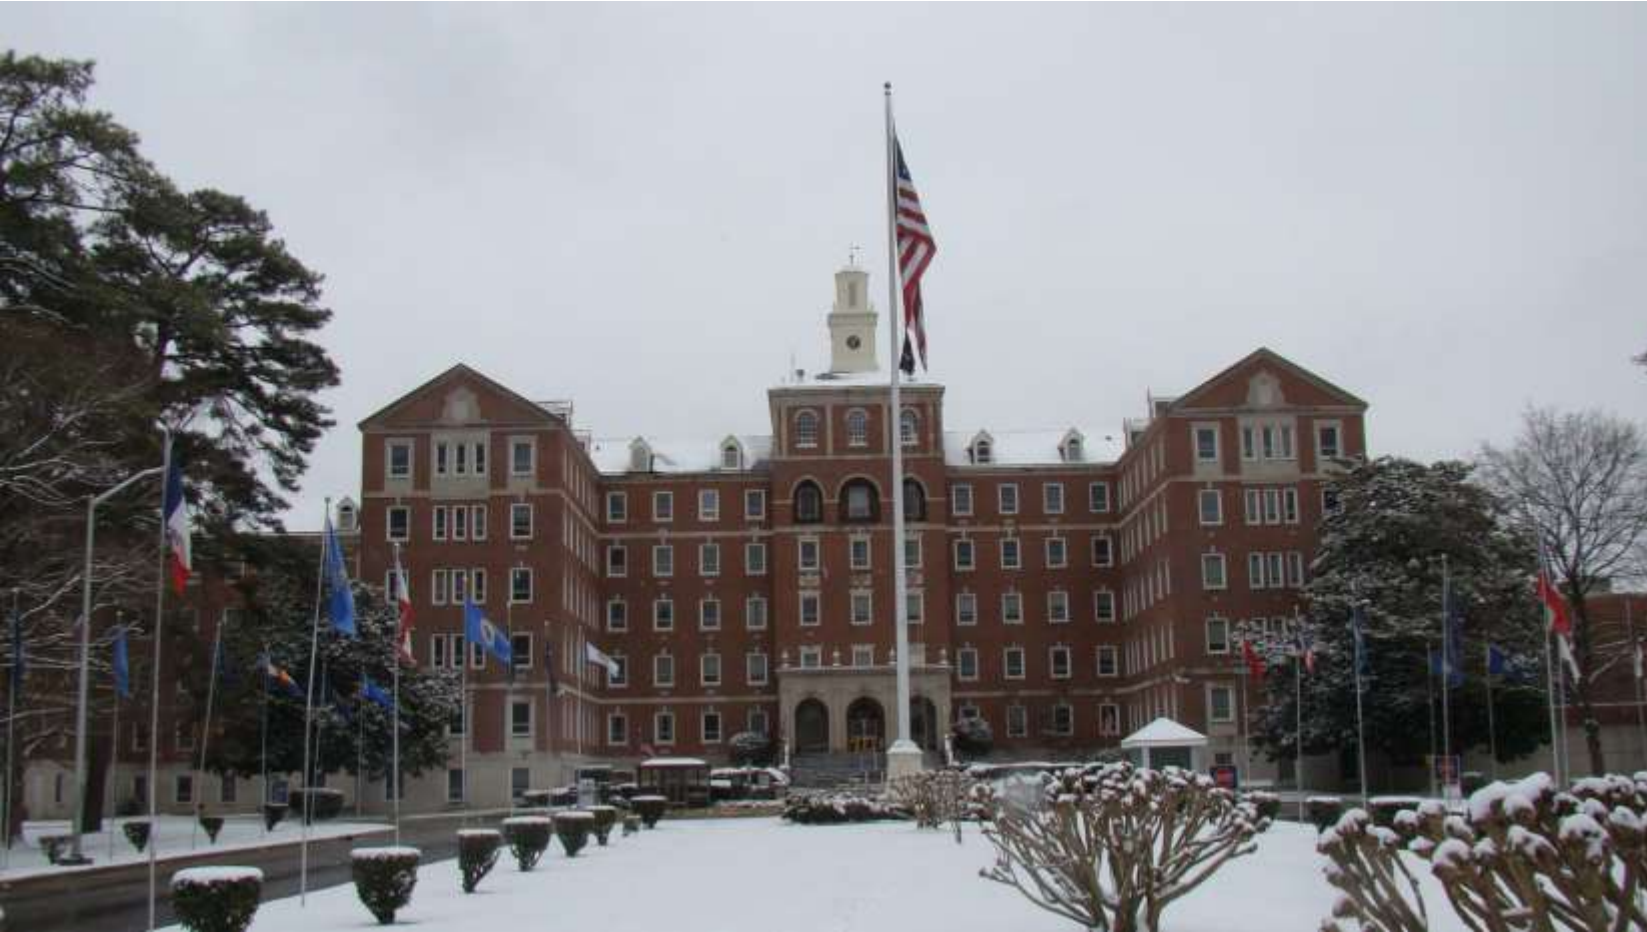
- Fayetteville, NC
- No Façade Ordinance
- Estimated Repair Costs: \$336,000

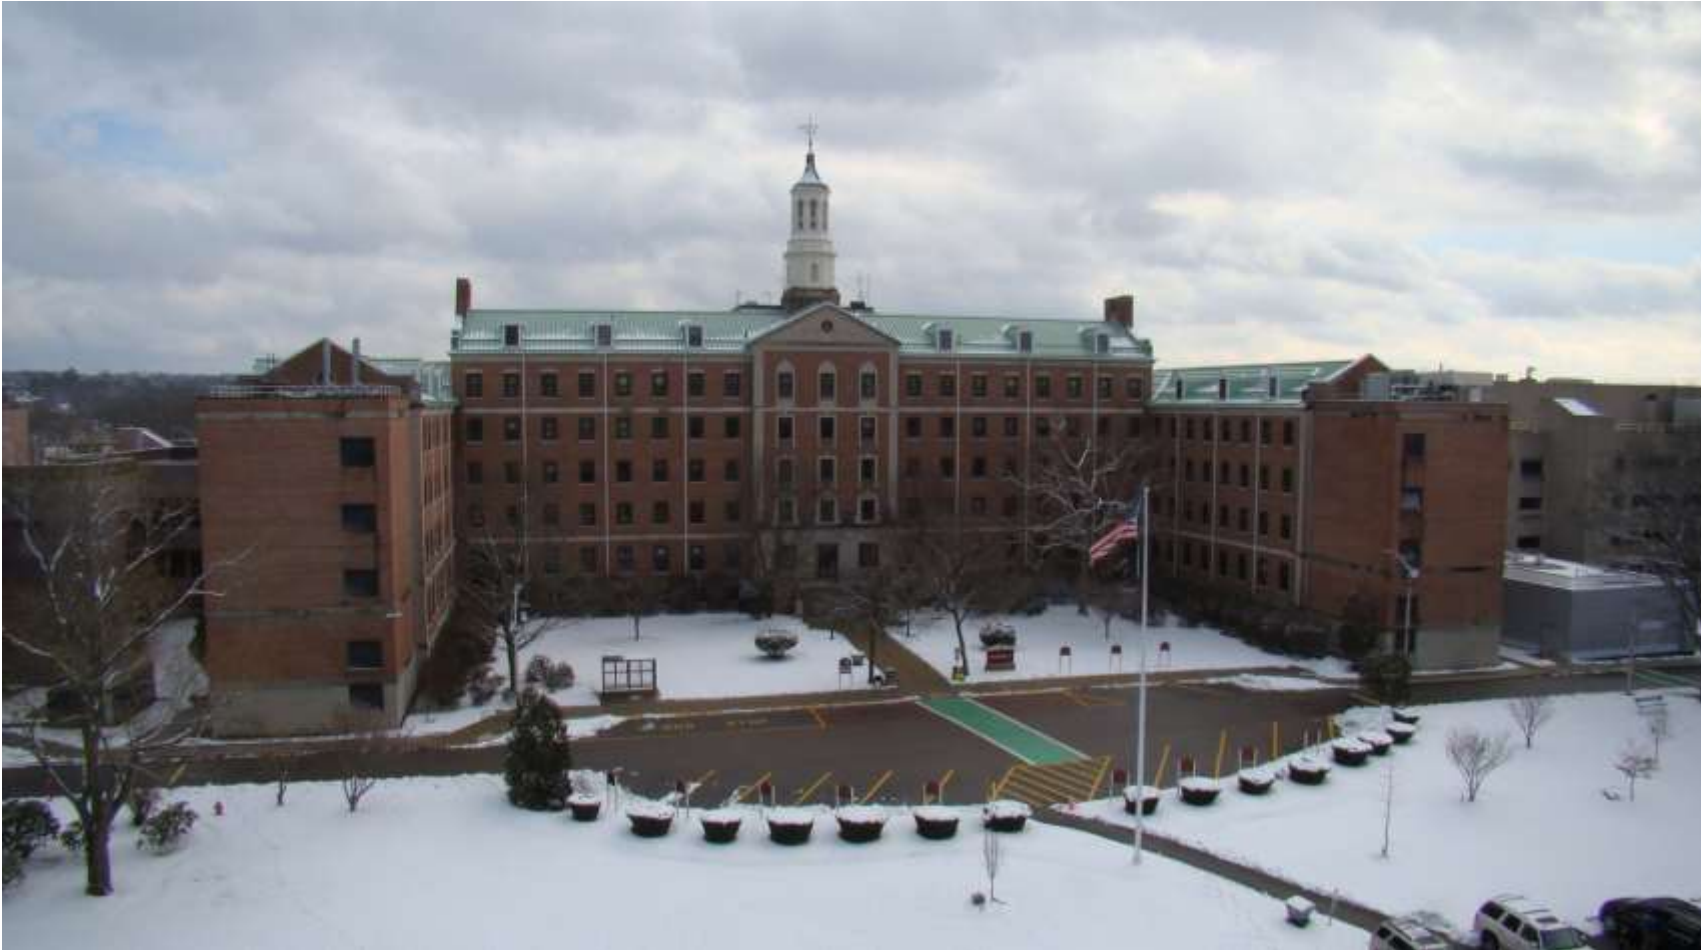
- Boston, MA
- Façade Ordinance
- Estimated Repair Costs: \$460,000

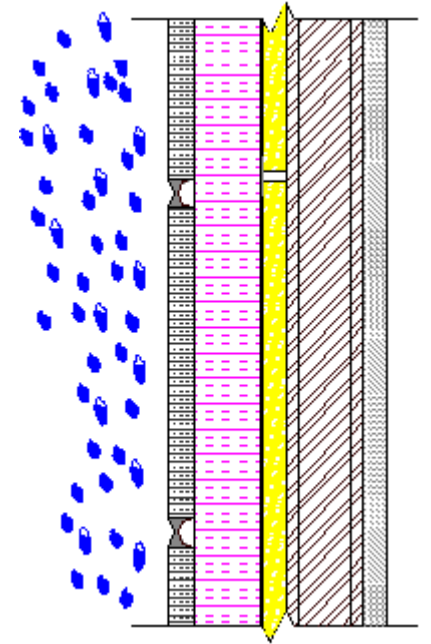
Barrier Wall Type

Barrier Wall Diagram. Digital image. Whole Building Design Guide. National Institute of Building Sciences, n.d. Web.

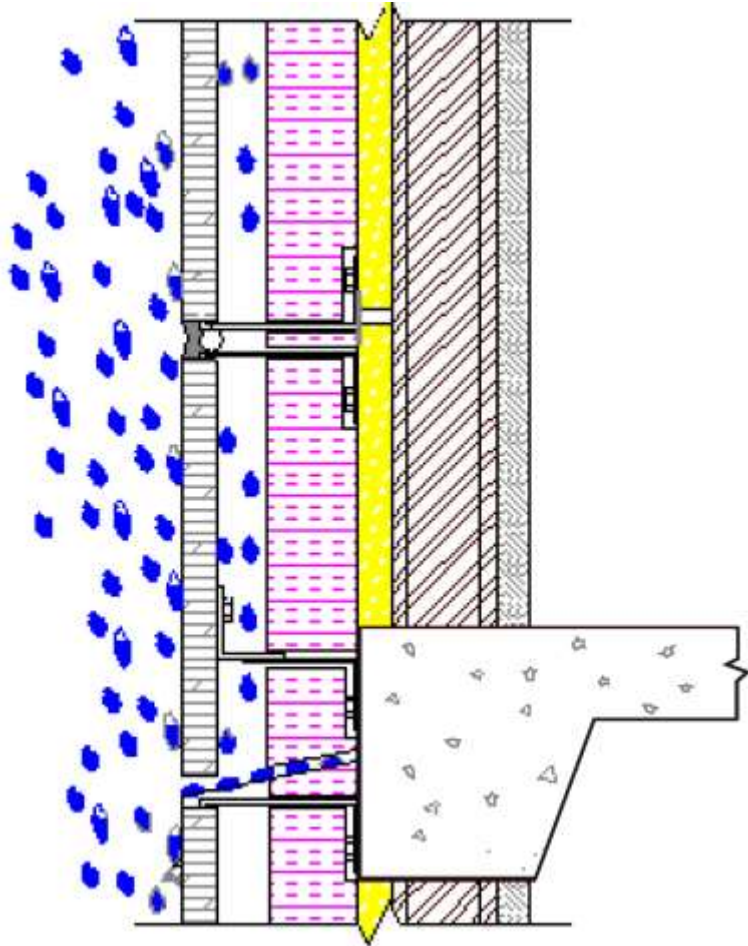
Cavity Wall Common Deficiencies

- **Non-Load Bearing Masonry Cavity Wall**
 1. Deteriorated Mortar Joints
 2. Cracks In Masonry
 3. Masonry Spalls
 4. Relief/Lintel Angle Deterioration
 5. Tie/Support Deterioration
 6. Failing Previous Repairs

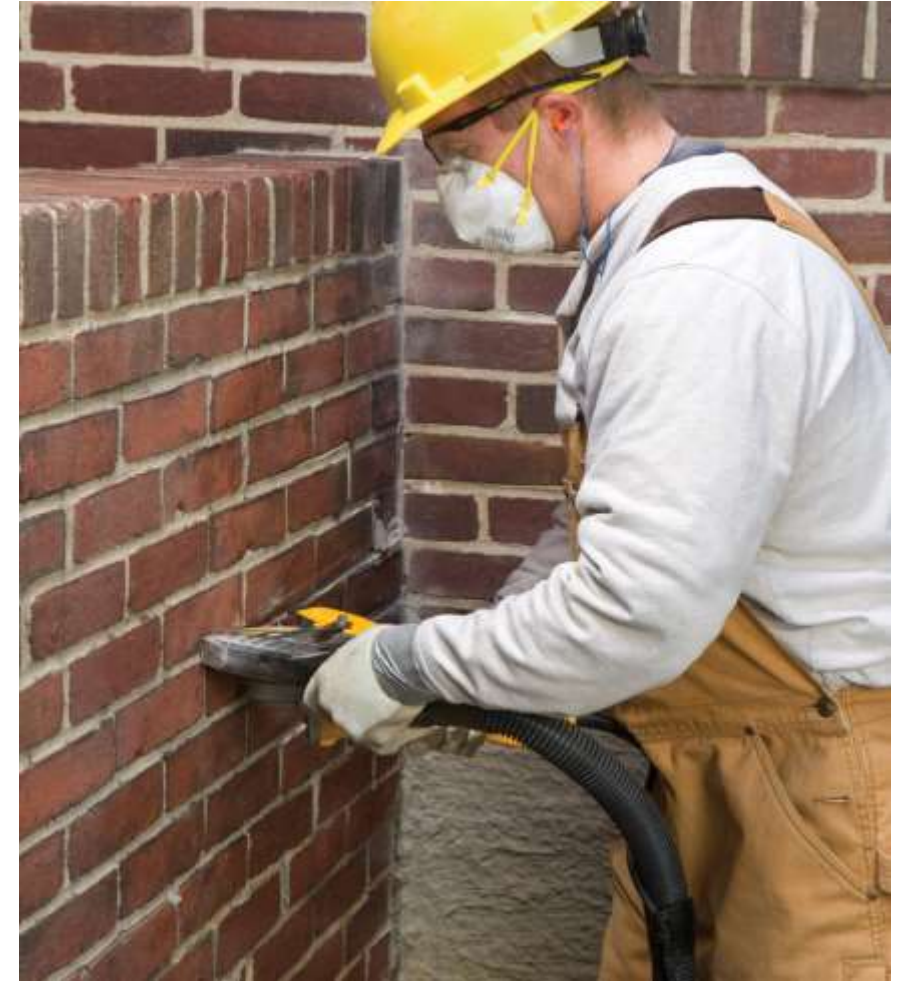
Cavity Wall Common Repairs

- **Non-Load Bearing Masonry Cavity Wall**
 1. Deteriorated Mortar – Remove loose mortar to sound substrate and repoint joint with mortar repair material similar in strength to existing
 2. Cracks In Masonry
 3. Masonry Spalls
 4. Relief/Lintel Angle Deterioration
 5. Tie/Support Deterioration
 6. Failing Previous Repairs

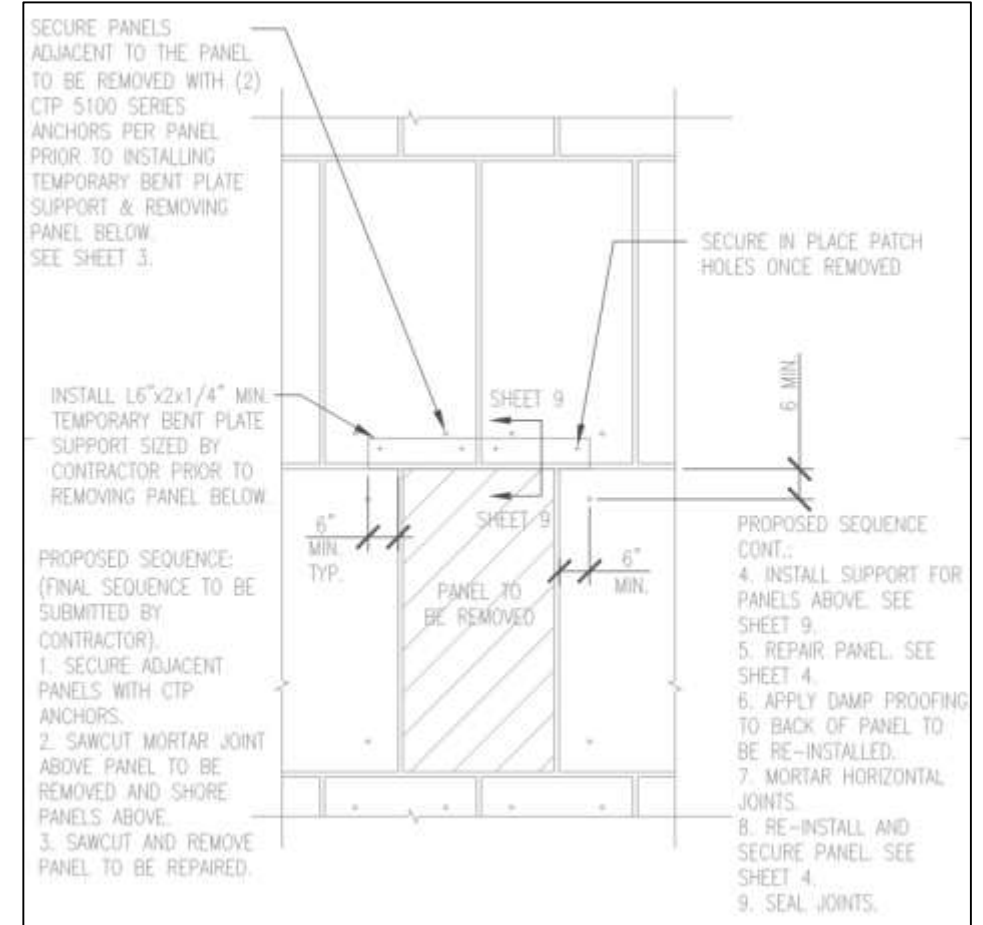
Cavity Wall Common Repairs

- Non-Load Bearing Masonry Cavity Wall
 1. Deteriorated Mortar
 2. Cracks In Masonry
 3. Masonry Spalls – Patch or Remove and replace damaged masonry. Shore existing masonry as required.
 4. Relief/Lintel Angle Deterioration
 5. Tie/Support Deterioration
 6. Failing Previous Repairs

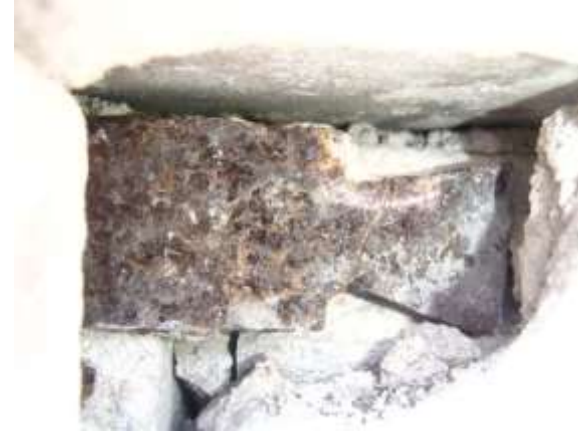
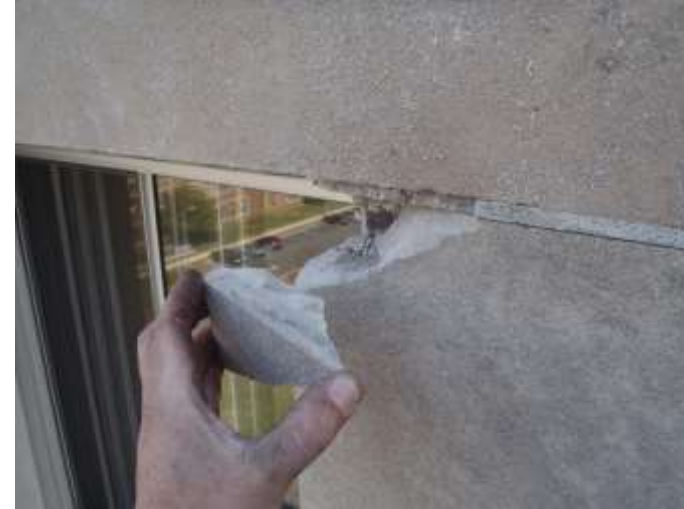
Typical Façade Deficiency Sources

- **Movement of Materials**
 - Thermal
 - Moisture
 - Elastic Deformation
 - Creep
 - **Corrosion**
 - Unstable Soils
- **Aging, Weathering, and Degradation of Materials**
- **Weather Tightness of Materials**
- **Poor Detailing and Execution**
- **Lack of Maintenance**

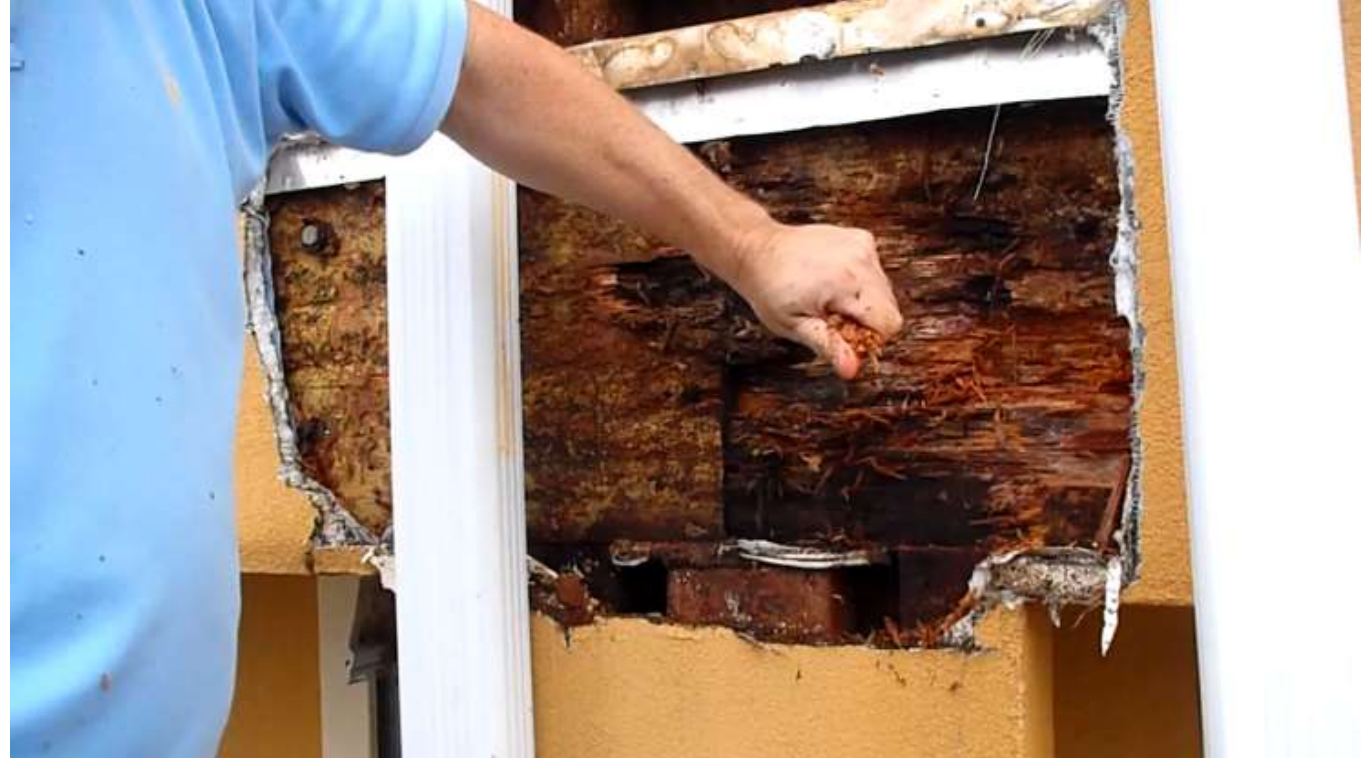
Weather Tightness of Materials

- Corrosion
- Water Staining
- Organic Growth
- Efflorescence
- Surface Scaling
- Damage to Interior Finishes
- Freeze/Thaw Damage

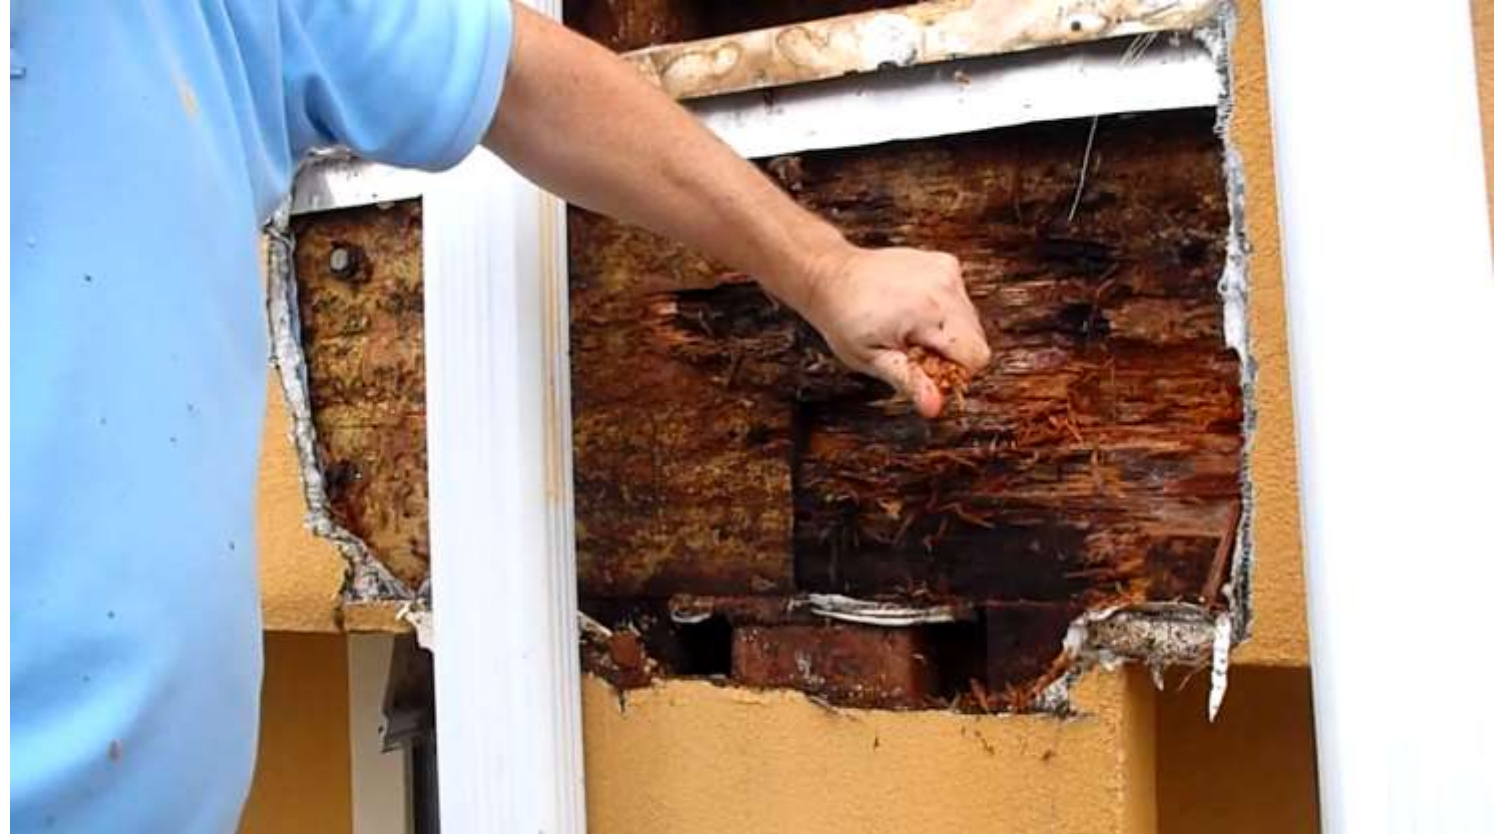
Weather Tightness of Materials

- Corrosion
- Water Staining
- Organic Growth
- Efflorescence
- Surface Scaling
- Damage to Interior Finishes
- Freeze/Thaw Damage

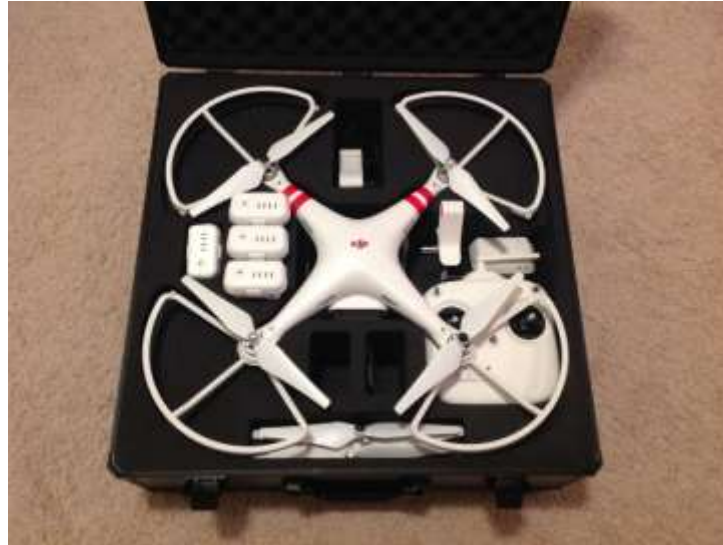
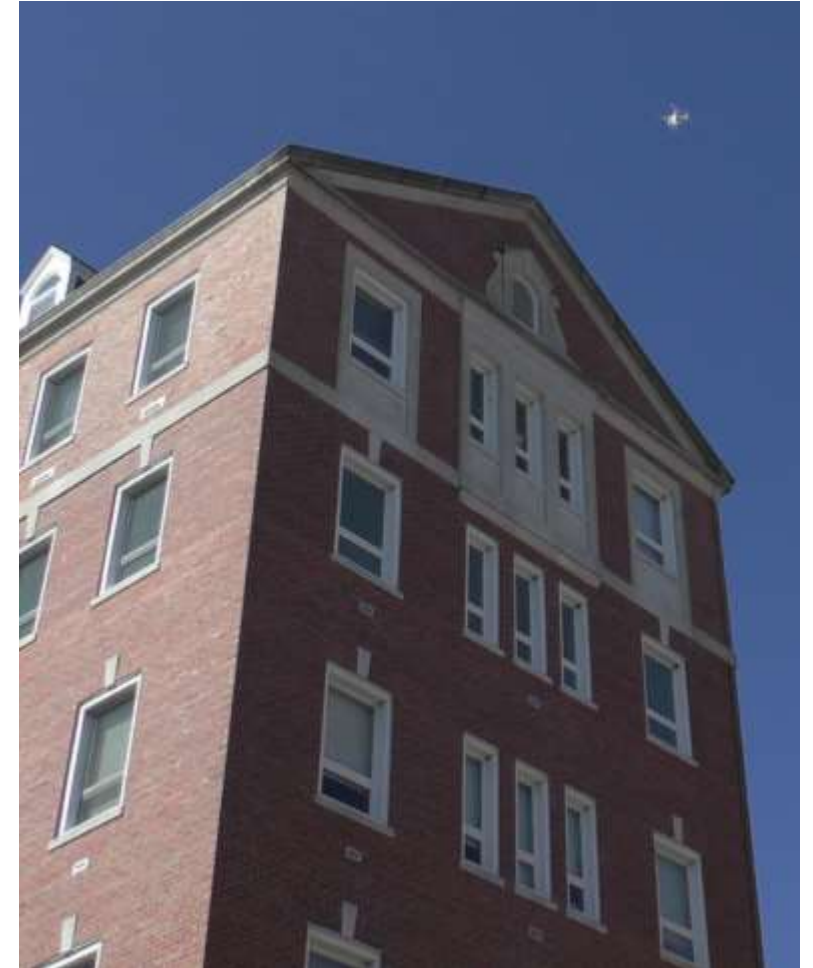
Visual Inspection: UAV (Drone)

- Define areas of interest
- Help reduce access costs
- Not a replacement for hands on up-close inspections

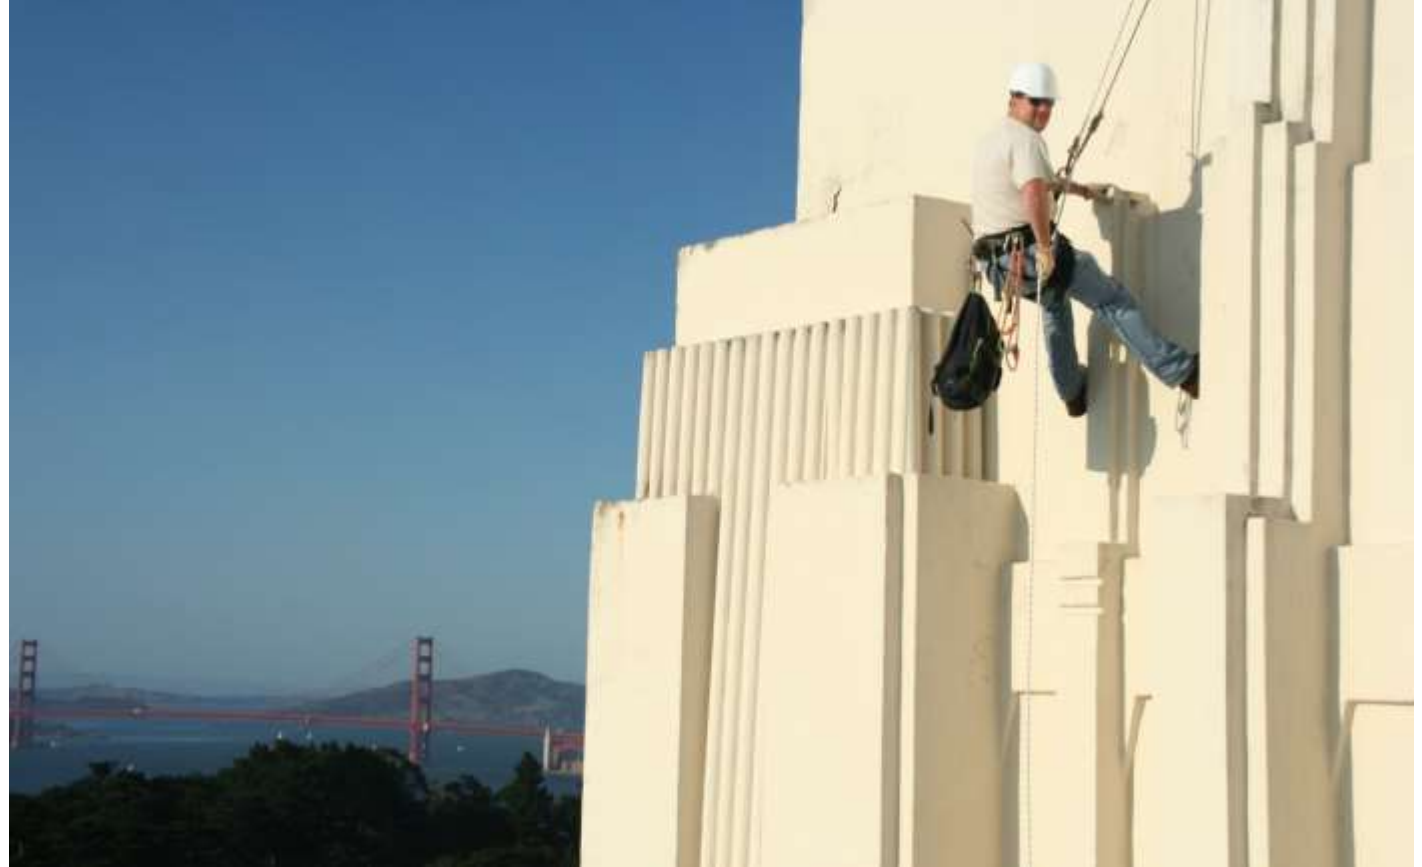
Detailed Inspection

- Ladders
- Scaffolding
- Lifts
- Buckets
- Swing Stages
- Rope Access

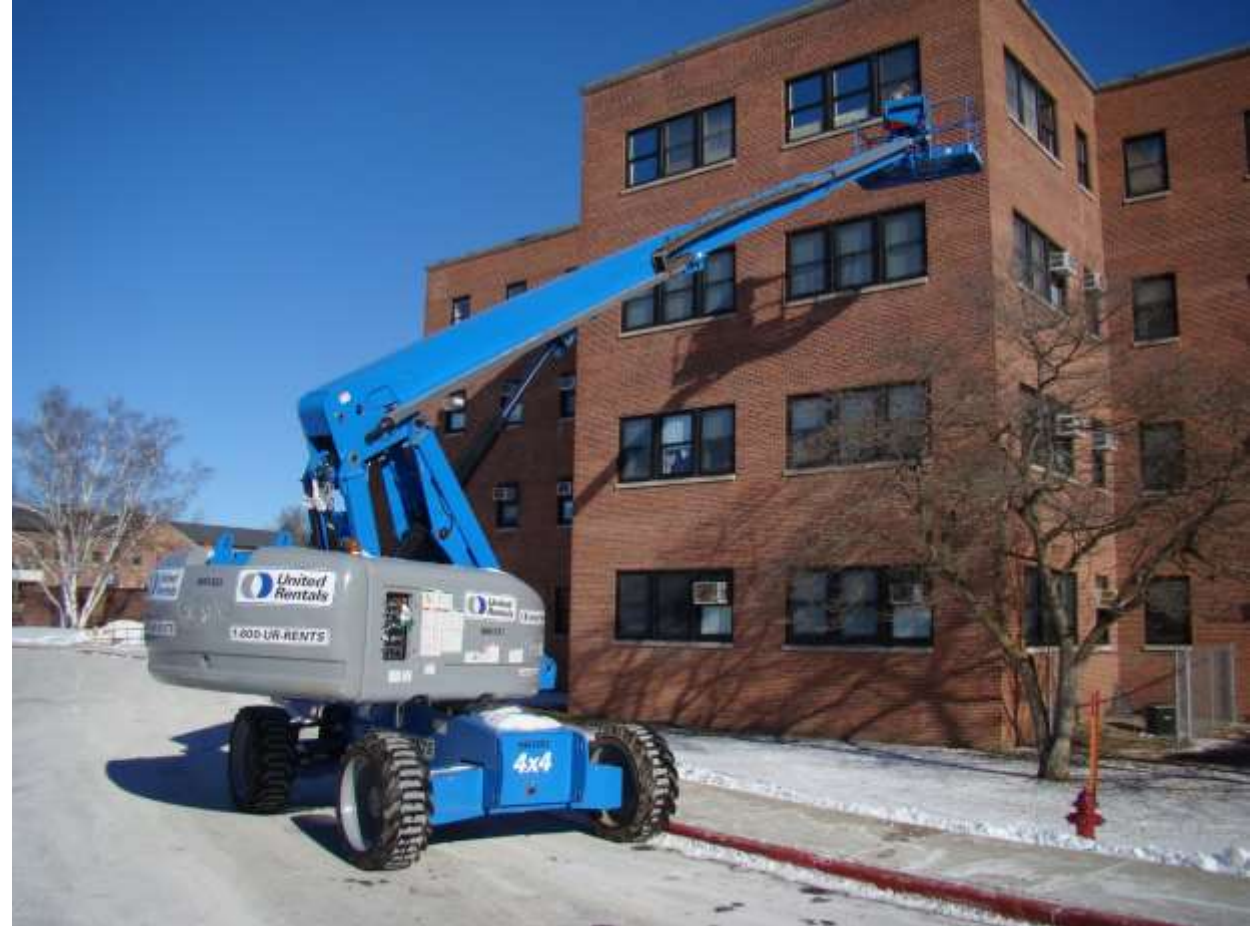
Access Techniques: Aerial Lifts

- **Advantages**
 - Mobile
 - Cost (dependent upon size)
 - Mobilization/demobilization
- **Disadvantages**
 - Special training required
 - Unique hazards
 - Cost (dependent upon size)
 - Limited reach

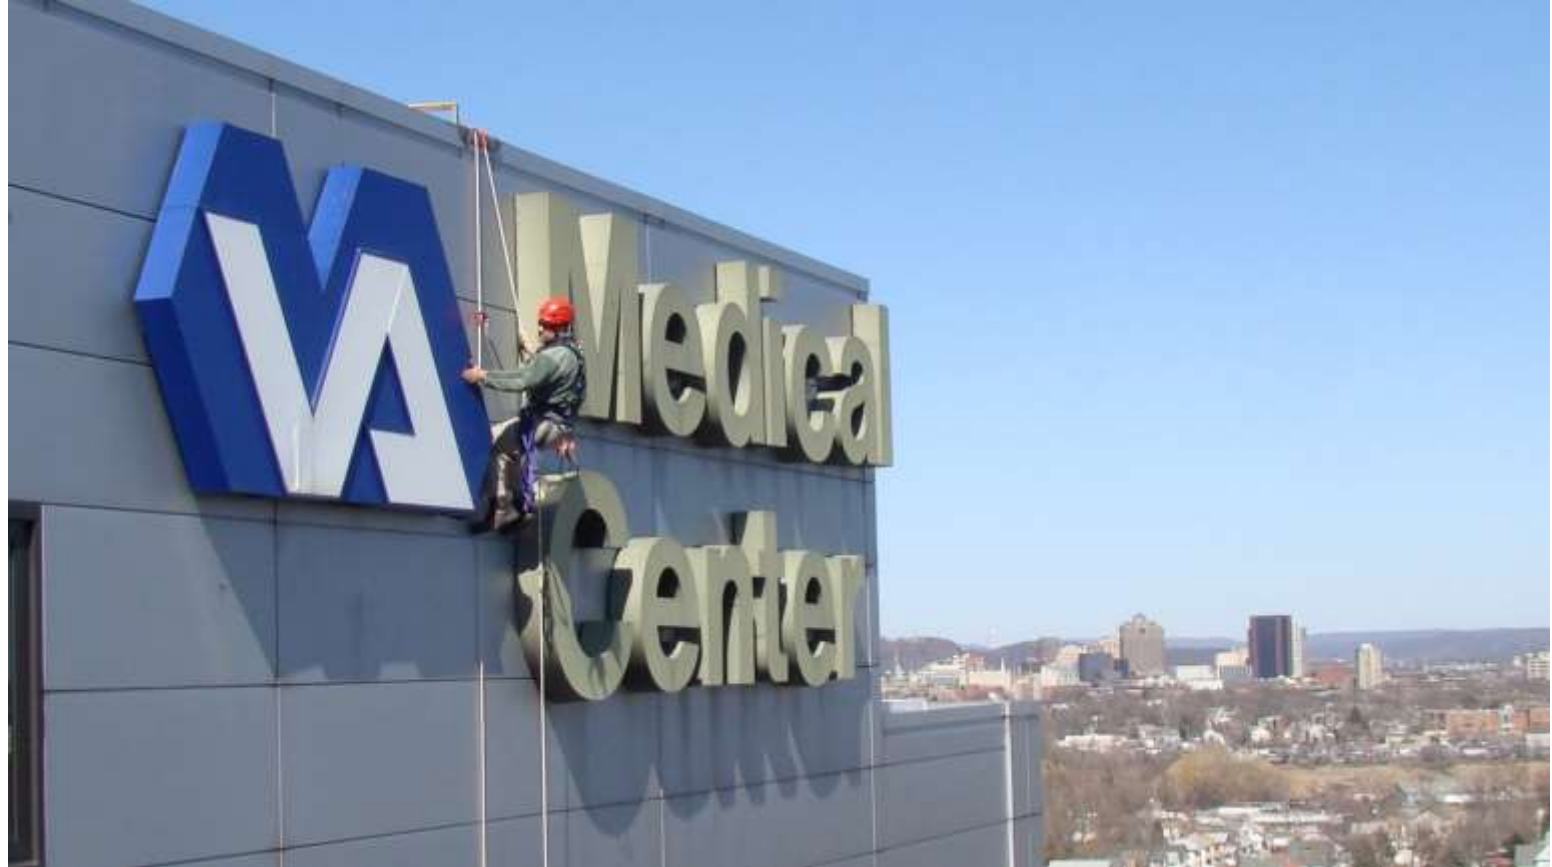
Access Techniques: Rope Access

- Ease of access
- Mobile
- Cost
- Speed of mobilization
- Less disruptive
- Versatility

- Special training required
- Unique hazards
- Public perception

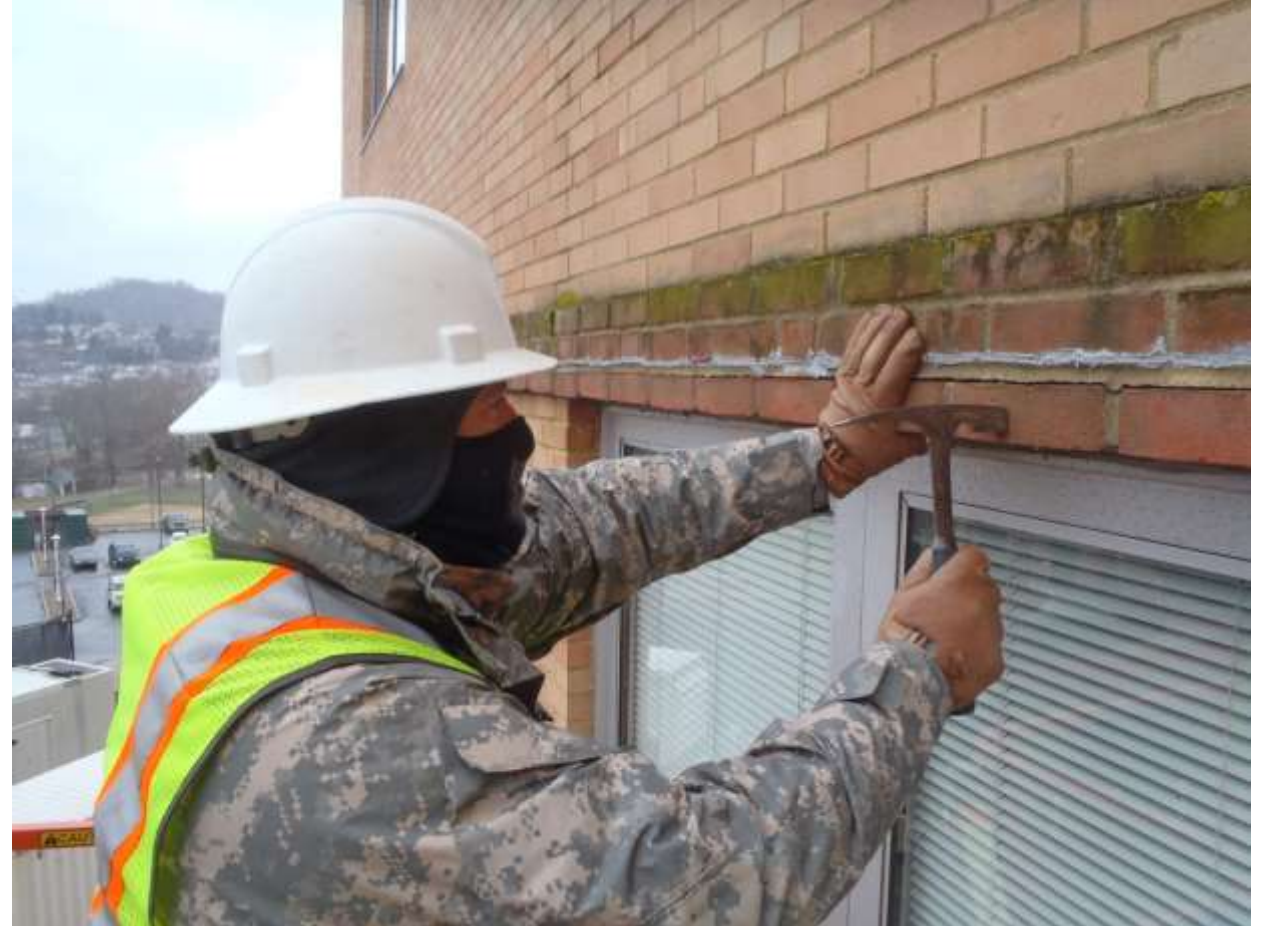
Detailed Inspection

- Some Investigative Tools and Techniques Employed
 - Crack Monitors and Gauges
 - Probing and Sounding
 - Borescope/Remote Camera
 - Metal Detector
 - Thermal Imaging Camera
 - Moisture Meter
 - Exploratory Openings

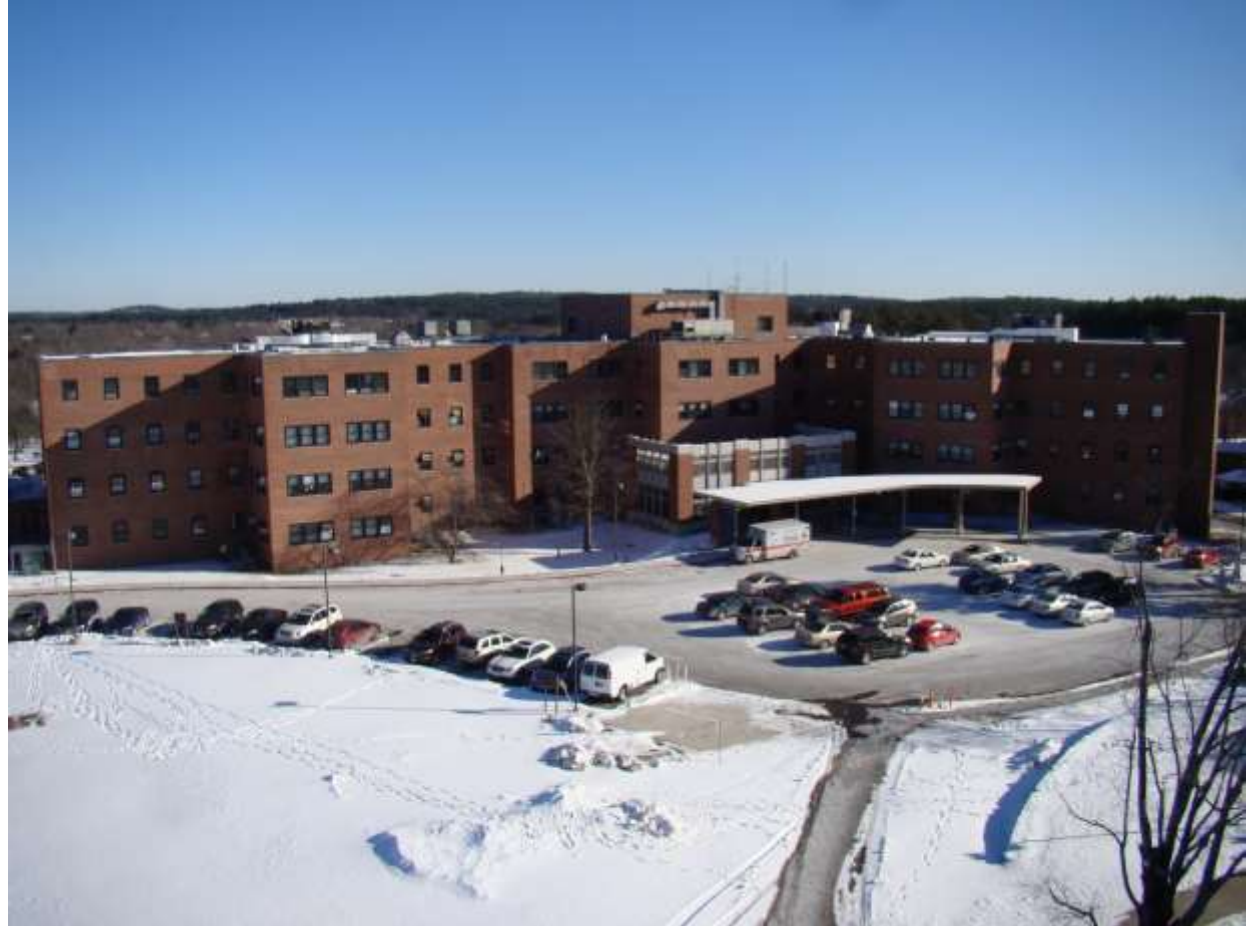
Case Study: Bedford, MA

- **Project Information**
 - Built in 1956
 - Structural System
 - Reinforced Concrete
 - Façade System
 - Non-Loading Bearing Brick
 - Cavity Wall

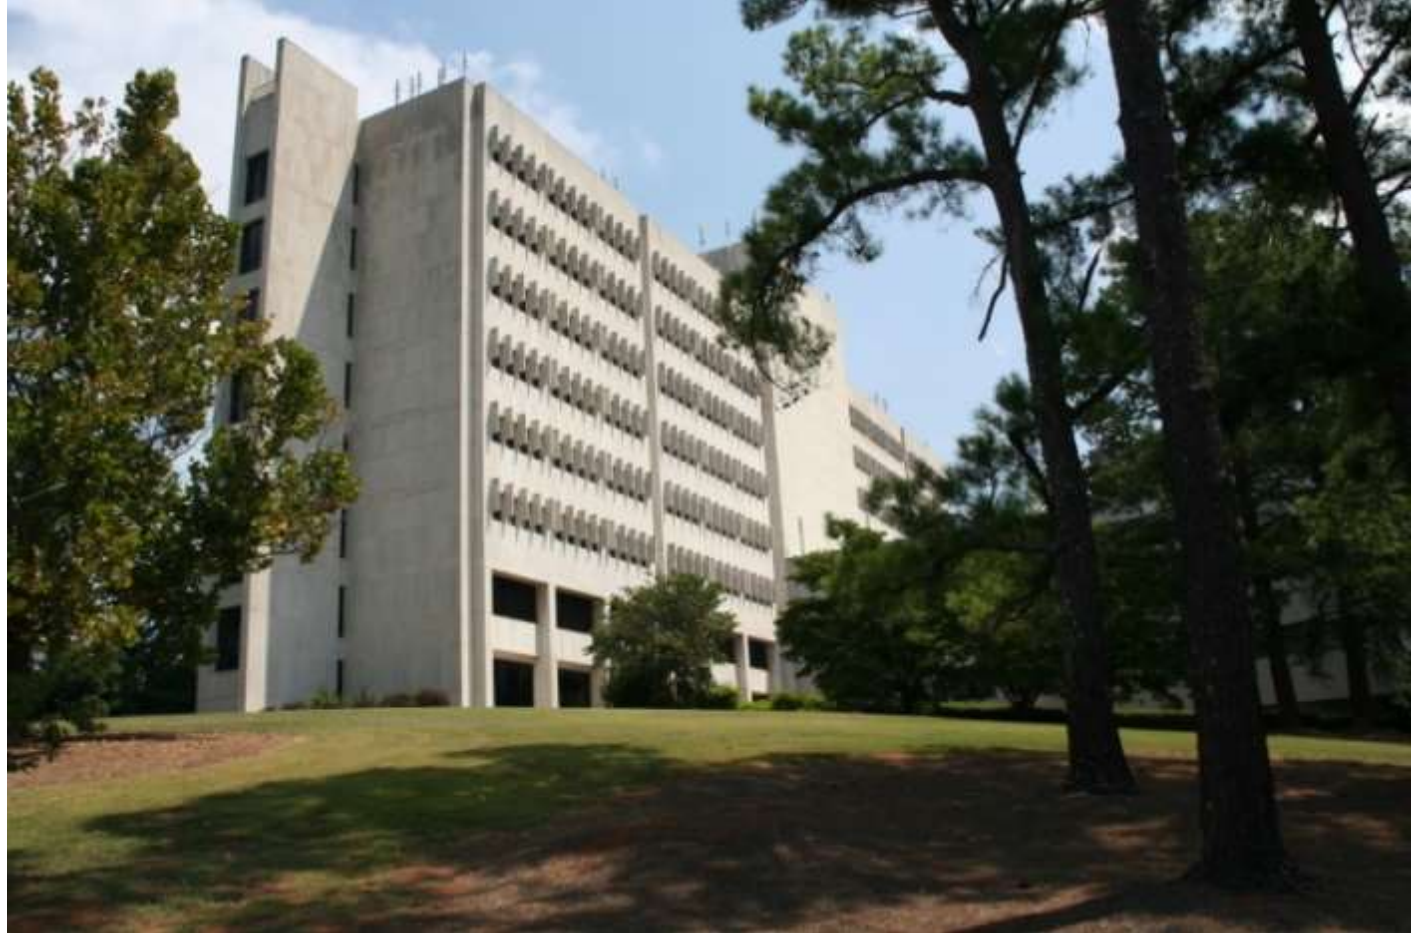
Case Study: Athens, GA

- Built in 1960
- Structural System
 - Reinforced Concrete
- Façade System
 - Limestone Panels
 - Non-Load Bearing
 - Cavity Type

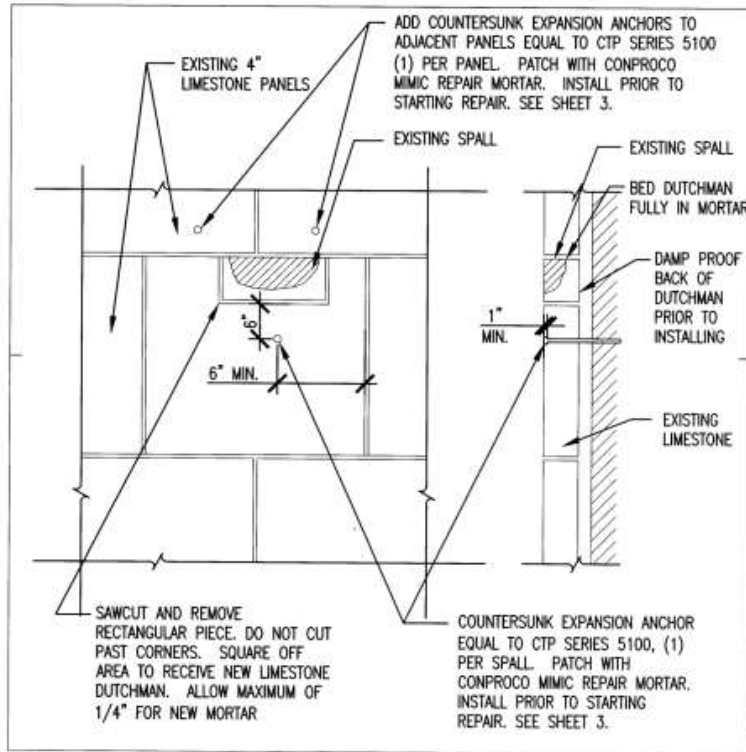
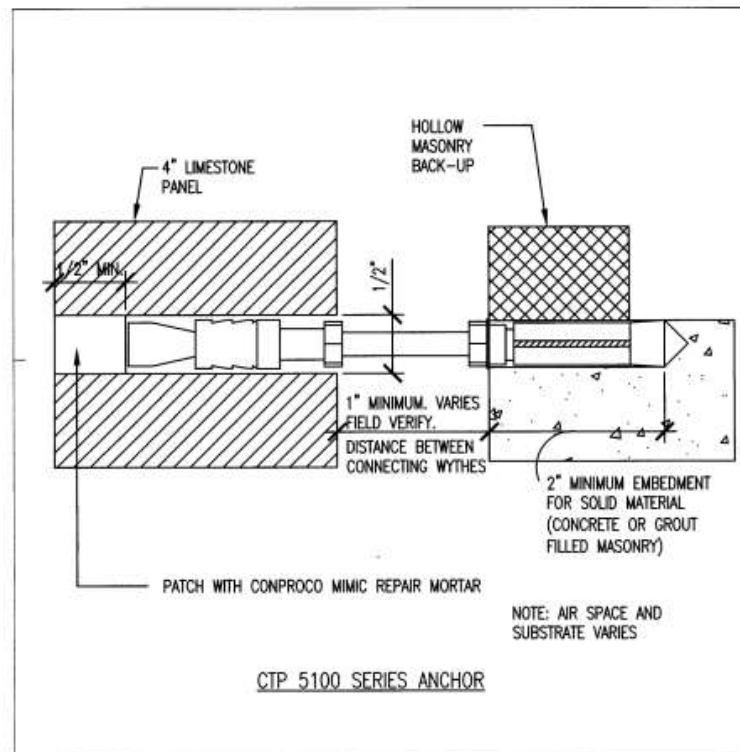
TITLE: SPALL REPAIR OPTION A (DUTCHMAN)

TITLE: STONE PANEL ANCHOR

TITLE: CRACKED PANEL REPAIR OPTION B (REPAIR IN PLACE)
